Recent Utility Experience with High Impedance Fault Detection

Jeffrey Chai, Jason Parsick, Thaddeus Potter - PEPCO

Ilia Voloh, Tirath Bains – GE Grid Solutions

2020 Minnesota Power Systems Conference

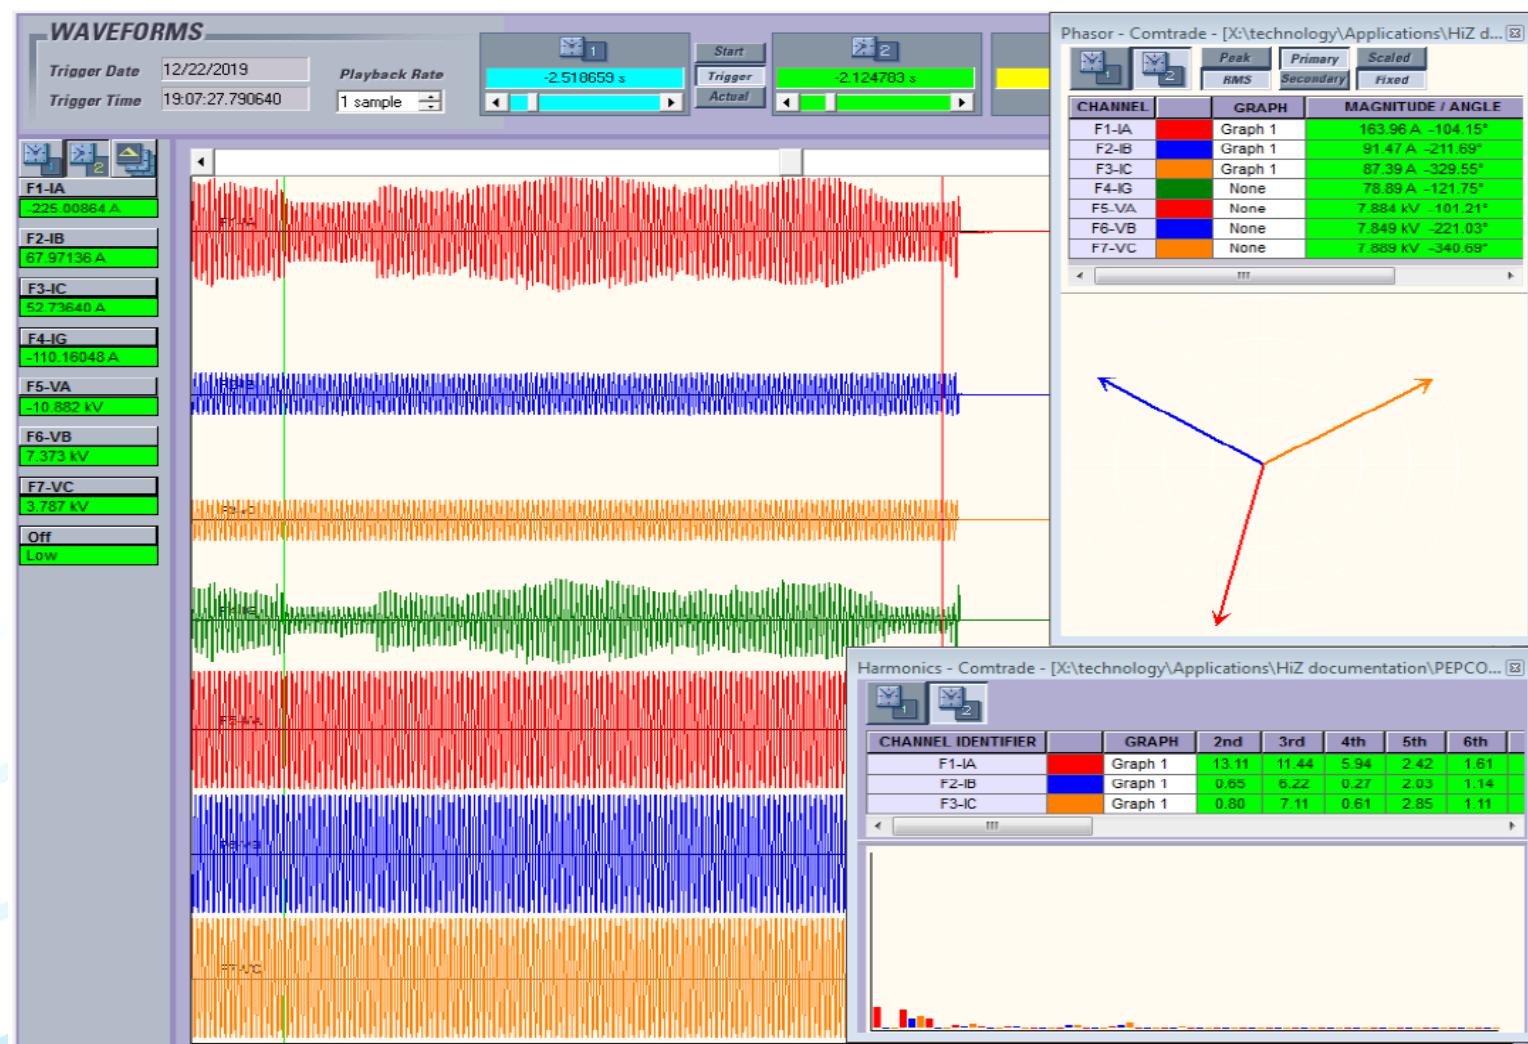
Example 1: Successful HiZ Operation

- The current in phase-A was relatively higher than the other phases with relatively higher harmonic content.
- The current waveform of phase-A shows a Loss of Load (LOL)
- Currents in healthy phases appear to be very steady with low harmonic content.
- Voltages do not show any distortion.

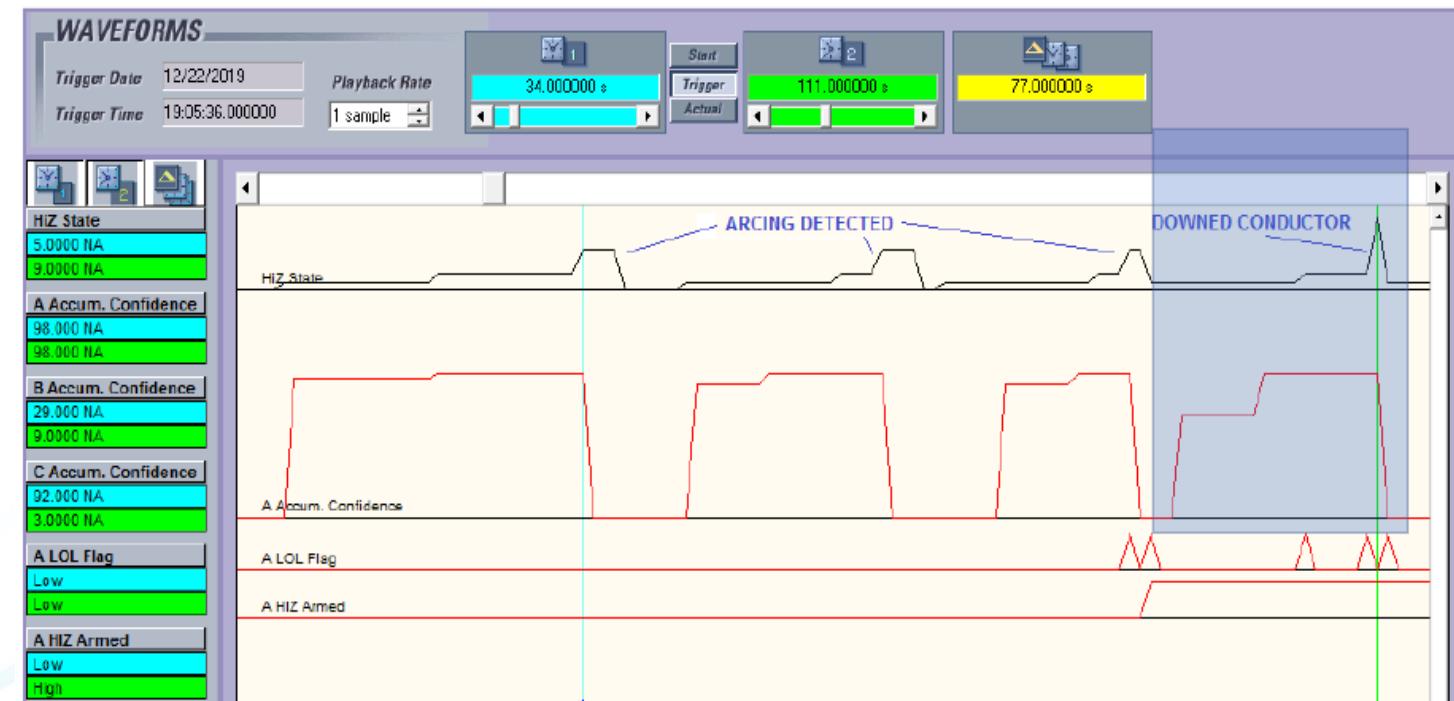
Example 1: Successful HiZ Operation

- The accumulated confidence in phase A rises very rapidly, due to high and varying harmonic content.
- ARCING DETECTED alarm was asserted three times.
- DOWNED CONDUCTOR was declared only when the HiZ Element was triggered by Loss of Load in phase A (A LOL Flag)

PEPCO service crew inspected the line and downed wires were found on the feeder with the conductor down on the ground in a right-of-way.

Result: The case was classified as Successful HiZ operation

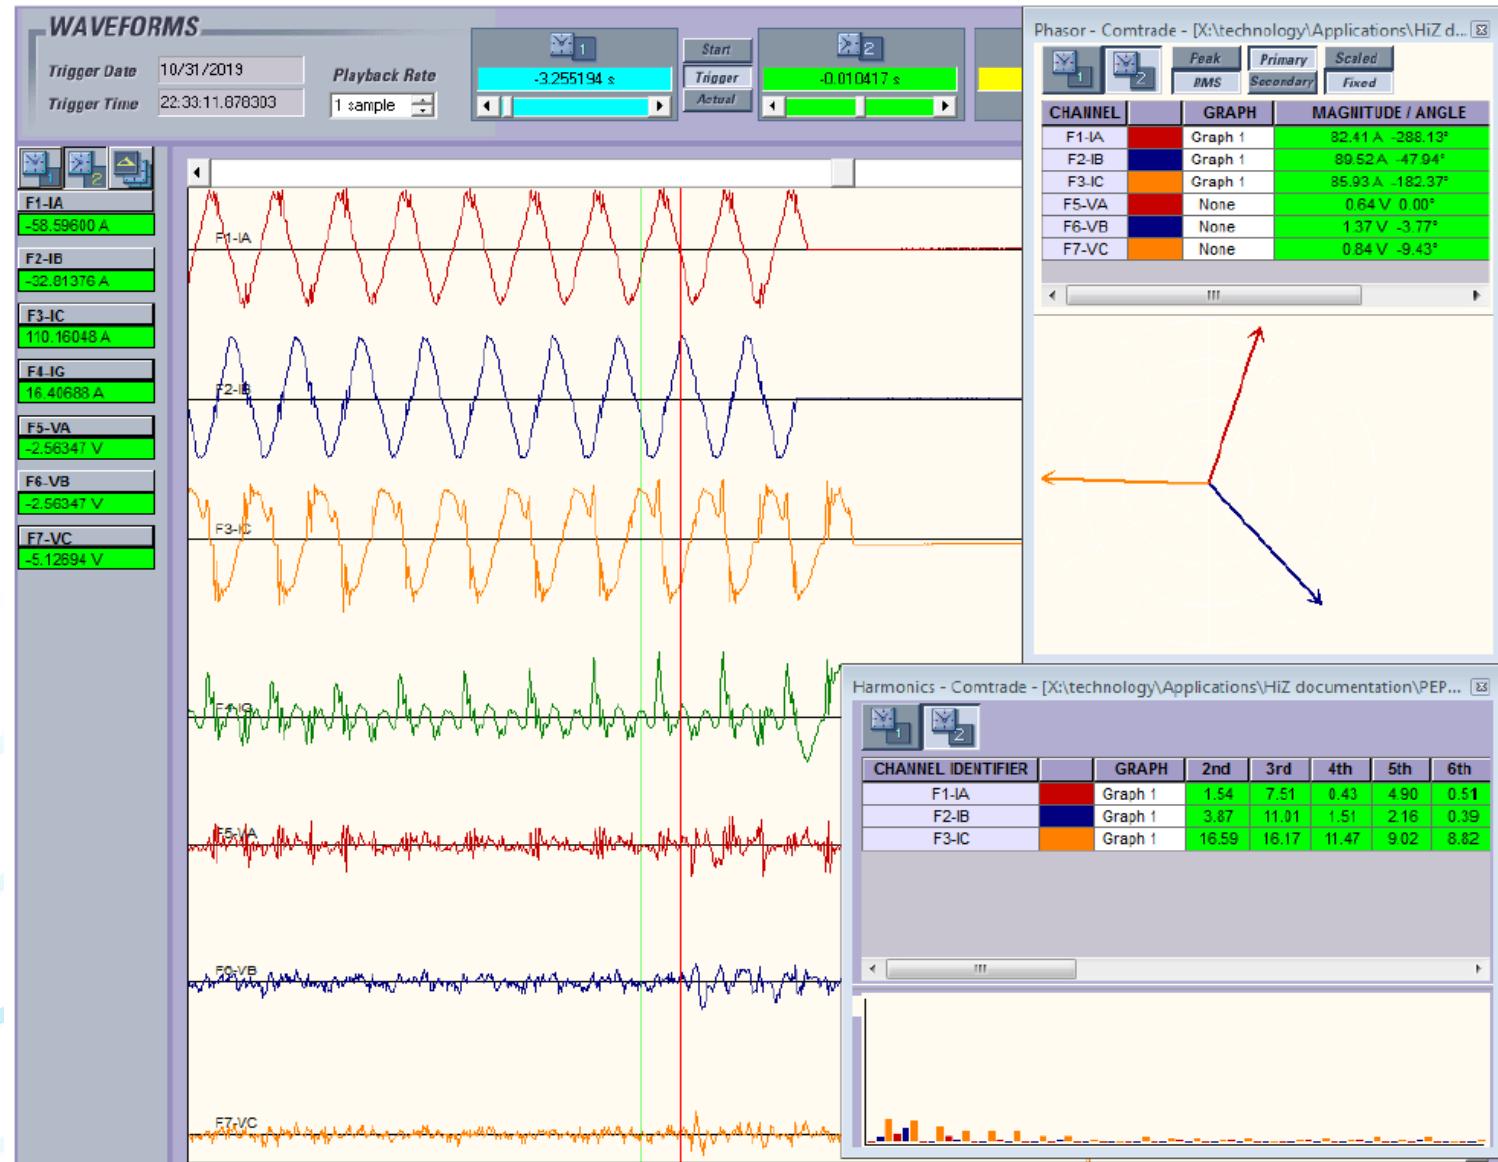
Example 2: Non-downed conductor HiZ operation

- All three phases had high content of harmonics and were carrying approximately 80A current
- Due to the stormy weather, the system was experiencing heavy switching and disturbances.
- Current in phase C showed a repeated ‘glitch’ in each fundamental cycle.

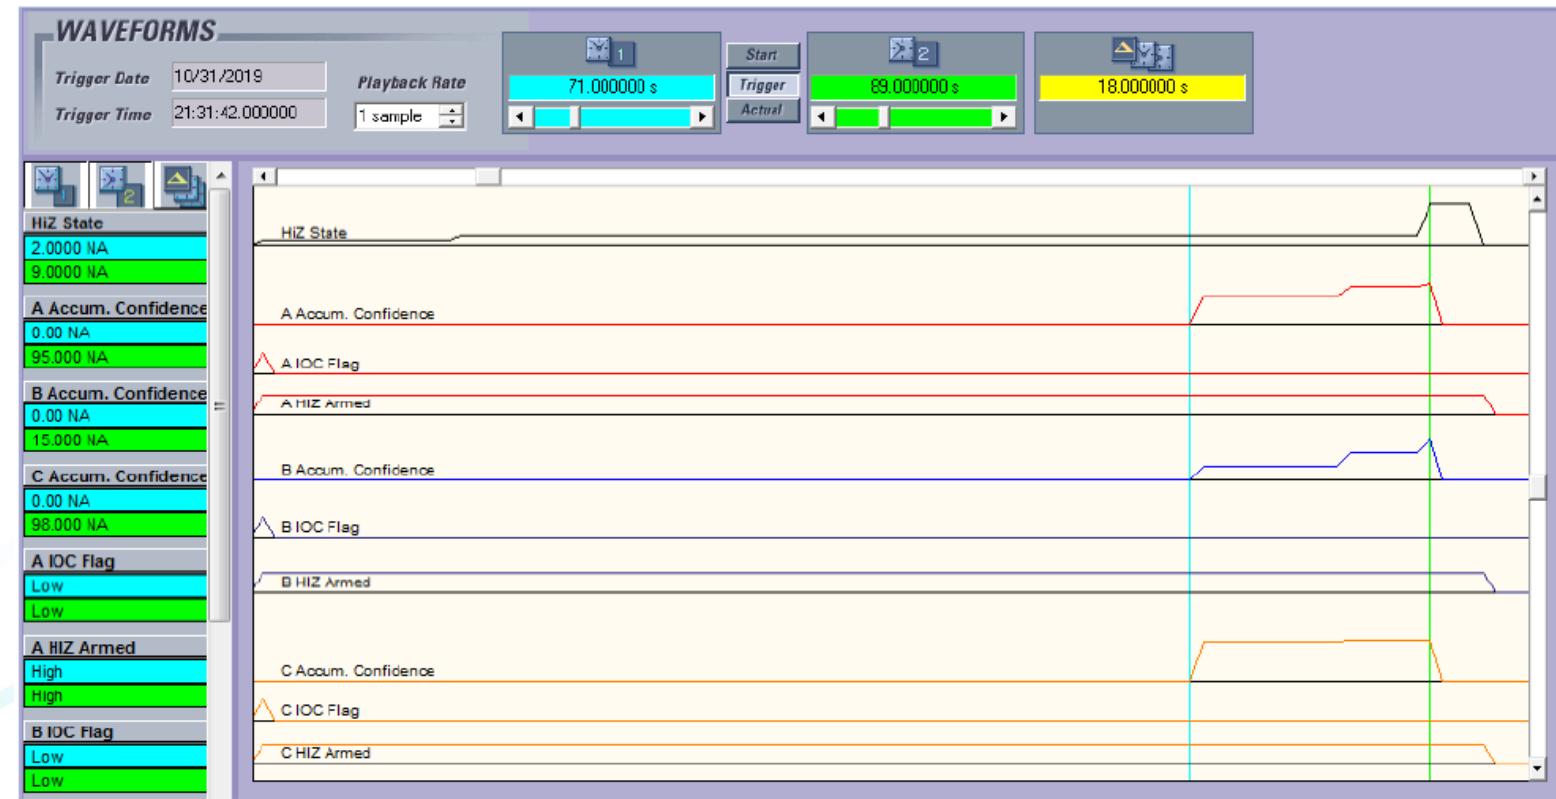
Example 2: Non-downed conductor HiZ operation

- A three phase IOC event armed the DNC logic in all three phases.
- No signature of HiZ fault was detected for next 70 seconds.
- Suddenly signature of Hi-Z fault appears, and enough confidence is built in next 18 seconds window to declare a DNC in phase-C.

- The case was initially classified as False Downed Conductor Event.
- About half an hour after the DNC operation, it was found that a tree limb was hanging on the phase C of the tie.
- Another significant observation was that 8 minutes prior to DNC operation, HiZ element asserted ‘Hi-Z ARC DETECTED Phase C alarm, 5 times within the window of approximately 3.5 minutes.
- HiZ algorithm was rightly yielding ‘Hi-Z ARC DETECTED Phase C repeatedly; however system conditions armed the DNC logic and resulted in DNC operation.

Result: The case was classified as Non-downed conductor HiZ operation.

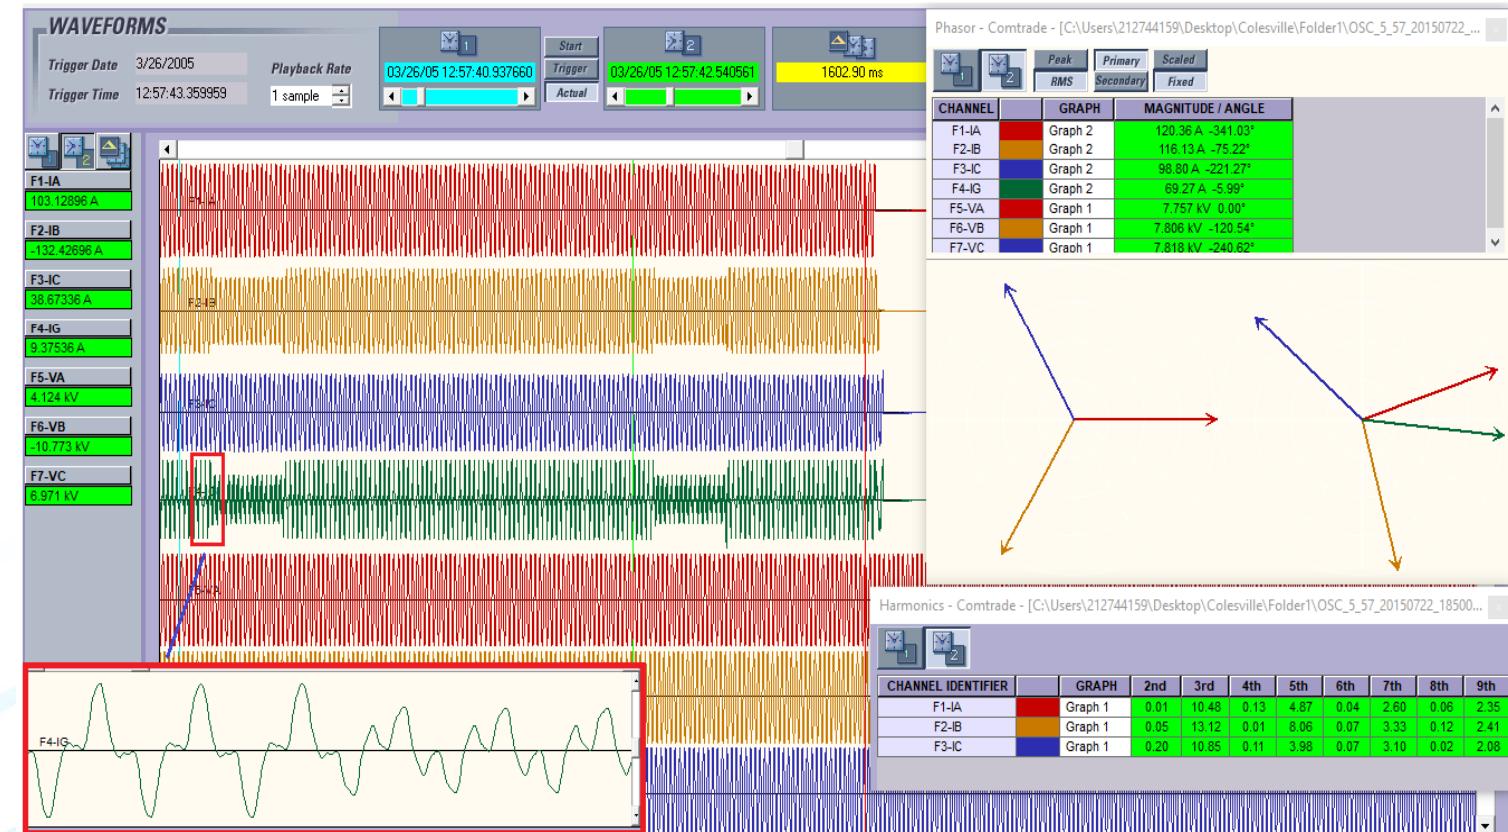
Example 3: Unsuccessful HiZ operation

- The phase currents were significantly unbalanced.
- Two 'dips' visible in phase B and neutral currents, simultaneously.
- Both 'dips' lasted about 250ms and involved identical change in the phase B and neutral fundamental currents.
- The fundamental component of the neutral current was reduced significantly during the 'dips'.

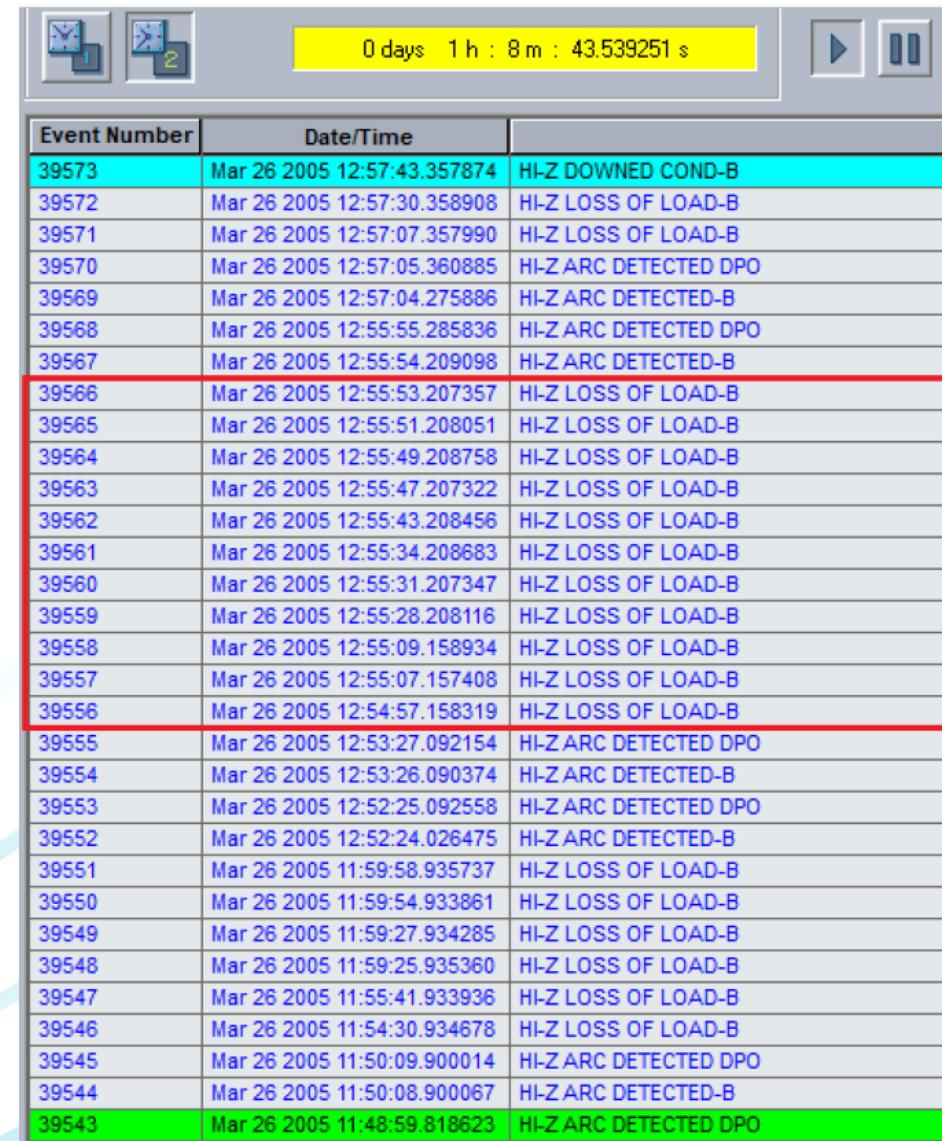
Example 3: Unsuccessful HiZ operation

- “HiZ- Loss of Load-B” was logged multiple time before HiZ algorithm declared the “HiZ-Downed Cond-B”.
- This unusual disturbance in phase-B lasted for about 3.5 hours, before the operation of “HiZ-Downed Cond-B” (not fully shown in Event log)

- It is highly likely that a relatively high-power electronic device (such as a Variable Frequency Drive or an inverter) was malfunctioning in Phase B.
- This false DNC operation occurred due to extra-ordinary system operating conditions.
- It satisfied loss of load criteria and the randomness, and energy algorithms of the HiZ algorithm.
- PEPCO crew patrolled the feeder and did not find any downed conductor or any evidence of other HiZ fault.

Result: The case was classified as Unsuccessful HiZ operation
