VEHICLE INSPECTION

# TATA NEXON CREATIVE PLUS

2024

## Comprehensive Car Inspection Report

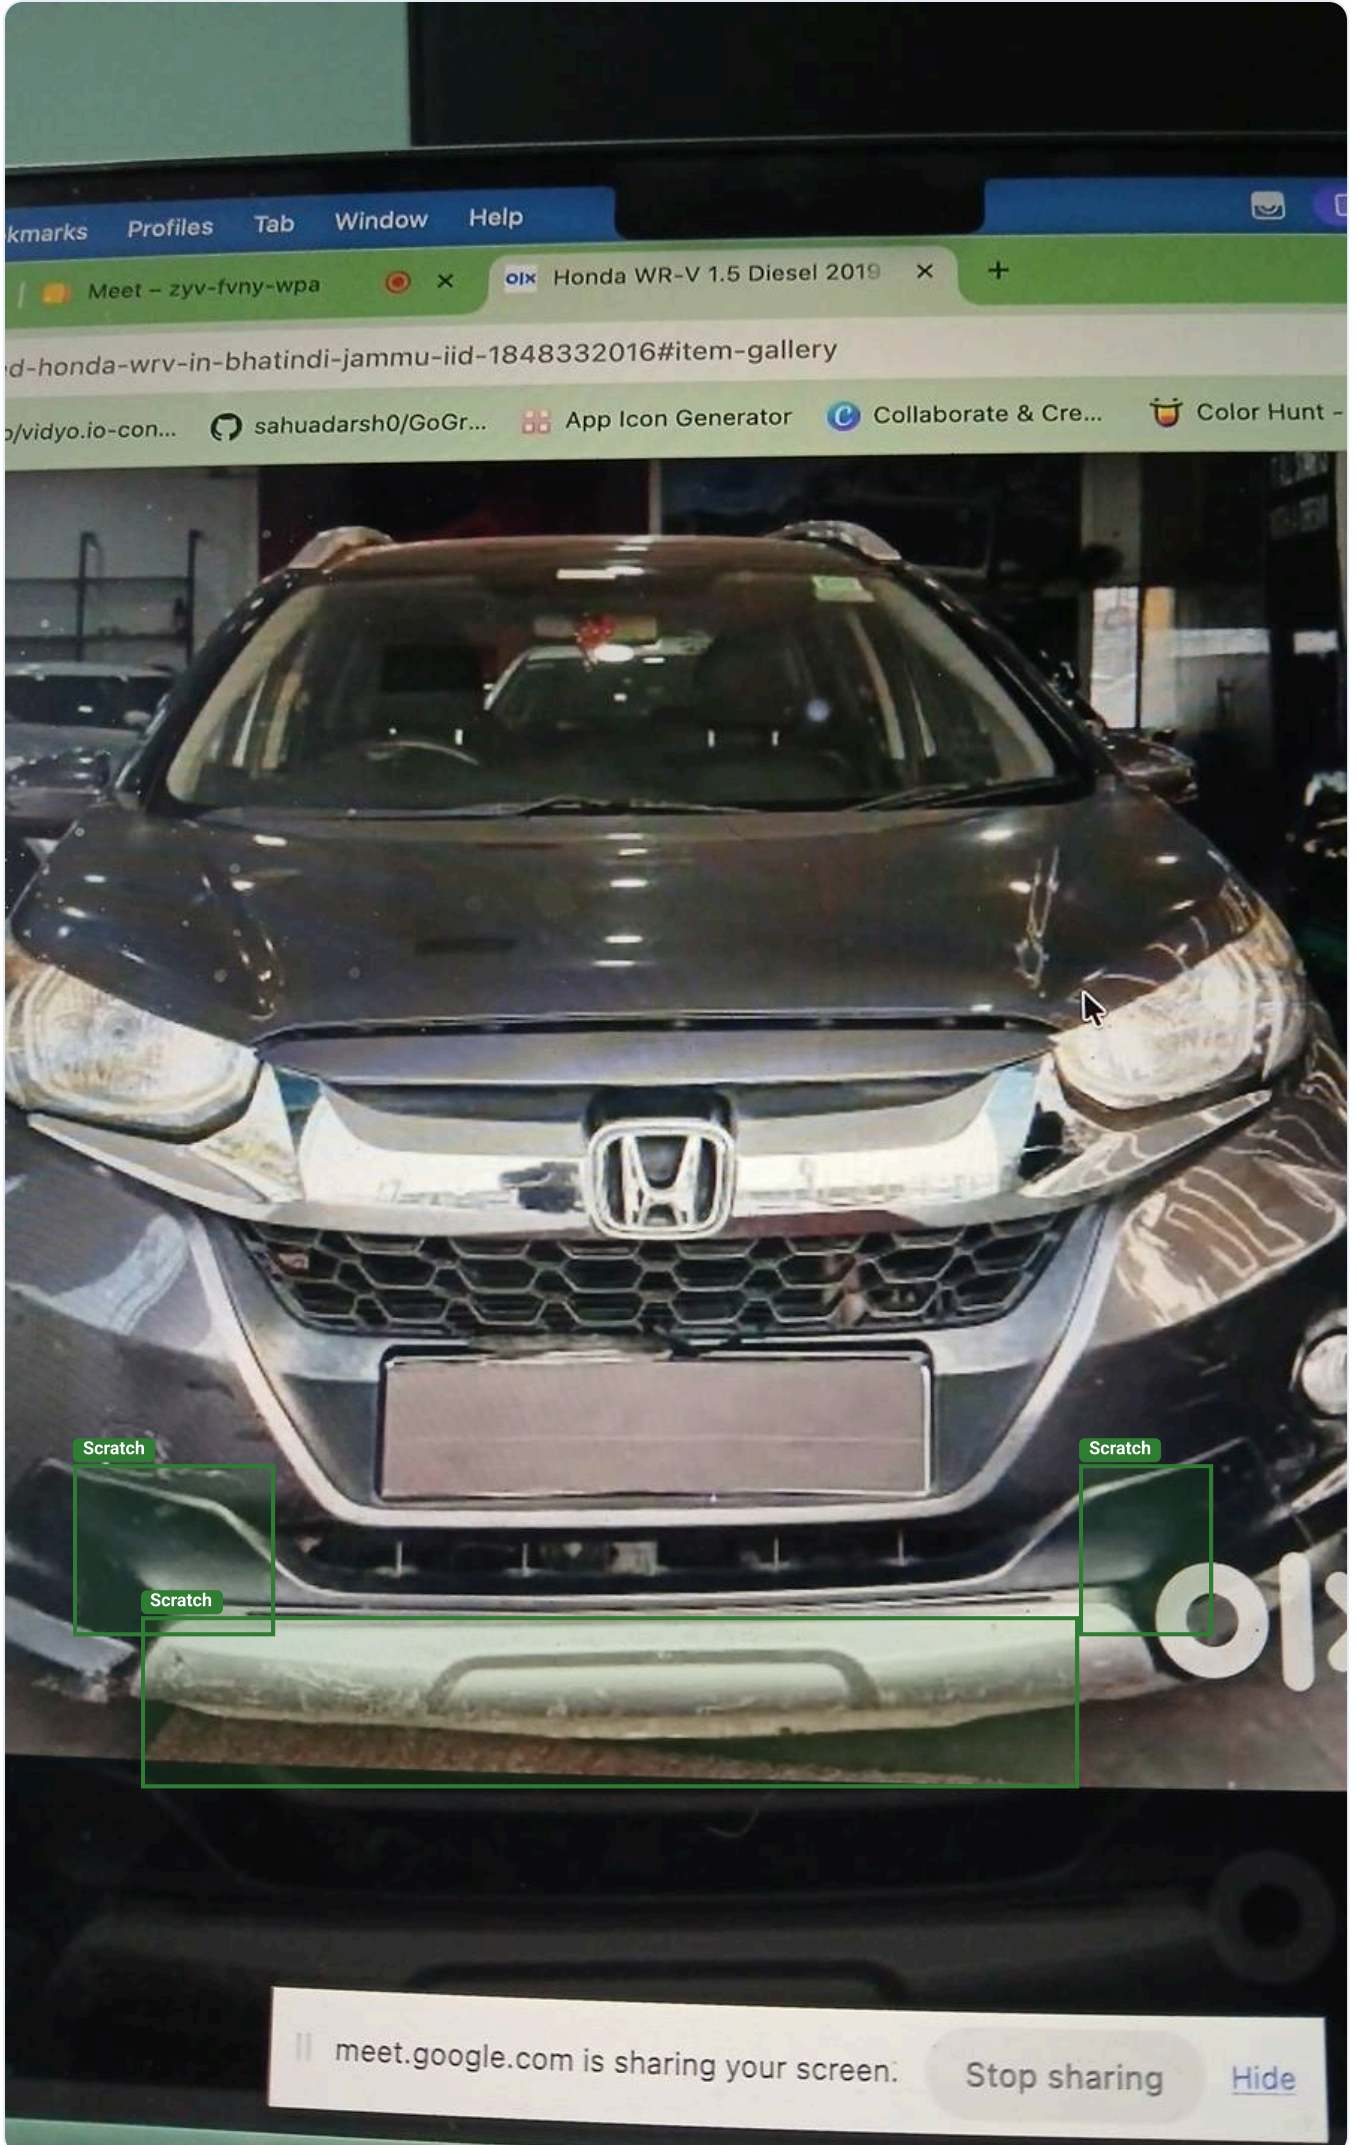
**Exterior Inspection → Front → Front Bumper**

- Scratch • MEDIUM • 85% confidence — Repair: Localized repair or repaint of the bumper corner.
- Scratch • MEDIUM • 80% confidence — Repair: Localized repair or repaint of the bumper corner.
- Scratch • HIGH • 90% confidence — Repair: Refinish or replace the front bumper guard.
