## Defect Photo Report

Structure No	R072_02E_C4047
Structure Name	Bokness River Tributary 2
Inspection Date	2016-08-06
OCI	60.15

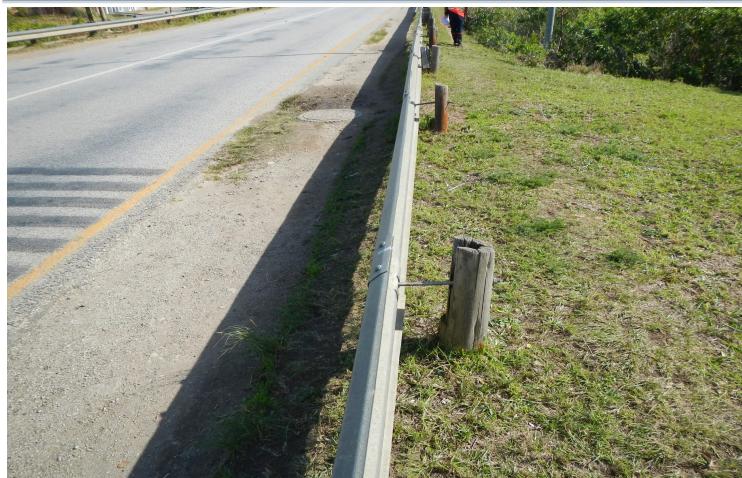
**Description****Photo Direction:** W**Consultant Description:**  
DSCN6014.JPG**Photo Number:****Repair Activity:**  
08. Guardrails-08.467. Replace posts (steel or timber)**Remarks:**

Replace guardrail blocks.

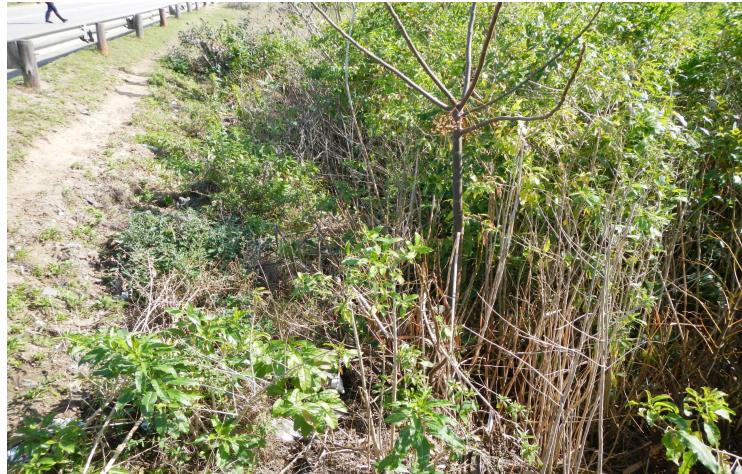
**Photo Direction:** W**Consultant Description:**  
DSCN6004.JPG**Photo Number:****Repair Activity:**  
05. Waterway-05.207. Clear debris**Remarks:**

Remove growth from the waterway.

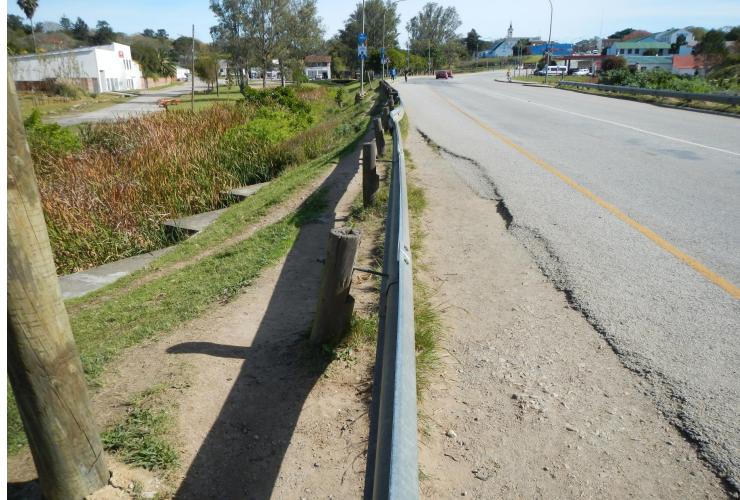
**Consultant Description:**  
DSCN6006.JPG

**Repair Activity:**  
08. Guardrails-08.463. Repair guardrail (realign, bolt replacement, etc)

**Remarks:**  
Repair guardrails.
