Defect Photo Report

Structure No	R072_02E_C4047
Structure Name	Bokness River Tributary 2
Inspection Date	2016-08-06
OCI	60.15

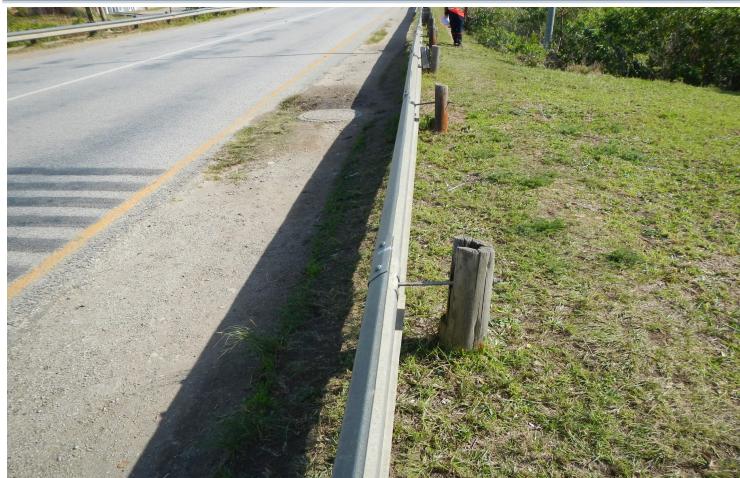
**Photo Direction:** W**Consultant Description:**
DSCN6014.JPG**Photo Number:****Repair Activity:**
08. Guardrails-08.467. Replace posts (steel or timber)**Remarks:**

Replace guardrail blocks.

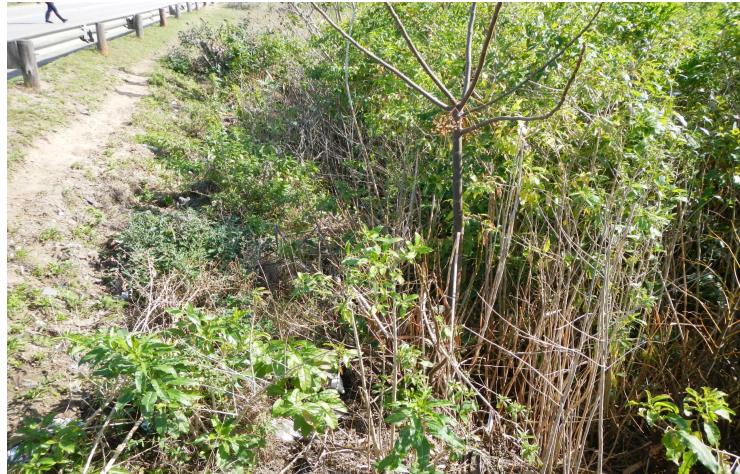
**Photo Direction:** W**Consultant Description:**
DSCN6004.JPG**Photo Number:****Repair Activity:**
05. Waterway-05.207. Clear debris**Remarks:**

Remove growth from the waterway.
