ACCESSIBILITY ASSESSMENT REPORT · SAMPLE, FOR ILLUSTRATION ONLY

Town of Clearwater

April 14, 2026

Clearwater Public Library  
1204 Main Street, Clearwater AB T0M 0M0

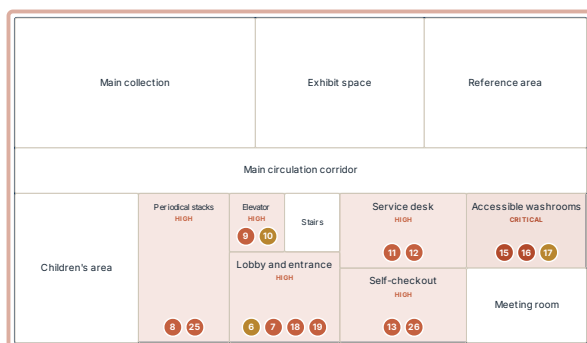
## Where the problems are — main floor

Red: critical · orange: high · amber: medium. Numbers are finding numbers. Full plans in Section 05.
