## ACCESSIBILITY ASSESSMENT REPORT

# Clearwater Public Library

1204 Main Street, Clearwater AB T0M 0M0

**April 14, 2026**

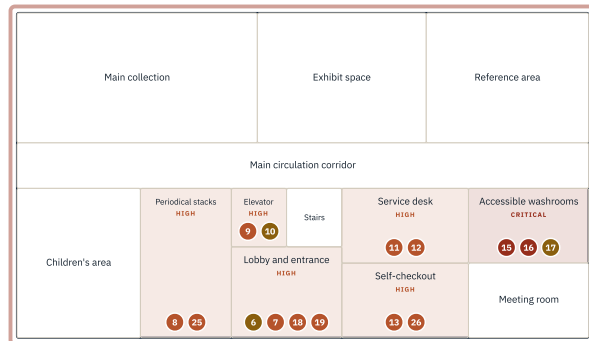
## Where the problems are – main floor

Dark red: critical · orange: high · amber: medium. Each area is also labelled in words. Numbers are finding numbers; full plans in Section 05.

The severity map in Section 05 shows where each finding sits in the building. The washrooms and the upper-floor stairwell are the two critical areas.

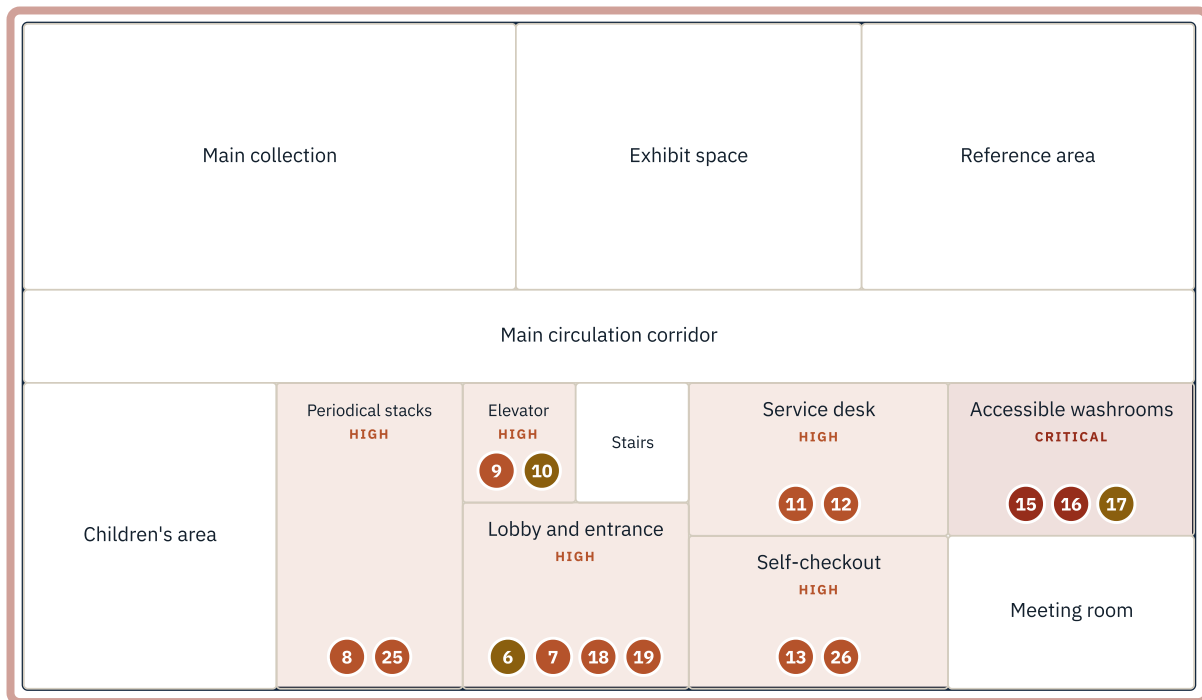
**Finding 23 — no visual fire alarm coverage on the main floor.** A whole-floor failure, so it carries no single pin. Costed once, with the upper floor, at \$8,500–\$14,000.

Main floor and site approach, Clearwater Public Library. Schematic — drawn to record where each finding was observed, not to scale, and not a construction drawing. The site approach is drawn dashed to mark it as exterior. The elevator serves both floors; its findings are pinned on this floor only, so they are counted once.

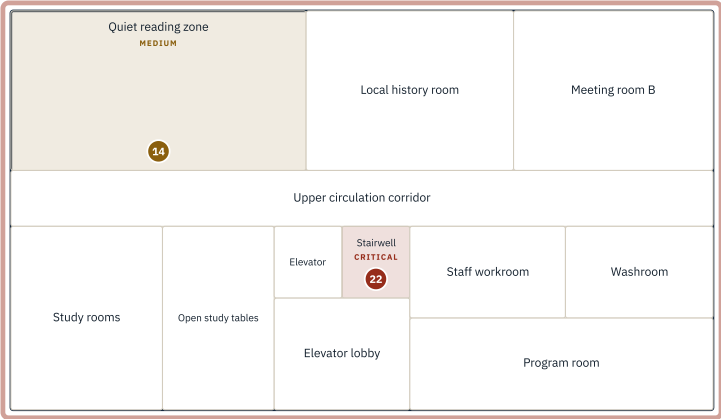
**WHOLE FLOOR** Finding 24 — no visual fire alarm coverage on the upper floor. Included in the combined \$8,500–\$14,000 estimate under finding 23.

Pin numbers are the finding numbers in Section 04. Every area is also labelled in words, so the plan does not depend on colour. The dark red band around the floor marks a finding that applies to every room on it.
