ACCESSIBILITY ASSESSMENT REPORT · SAMPLE, FOR ILLUSTRATION ONLY

Town of Clearwater

April 14, 2026

Clearwater Public Library  
1204 Main Street, Clearwater AB T0M 0M0

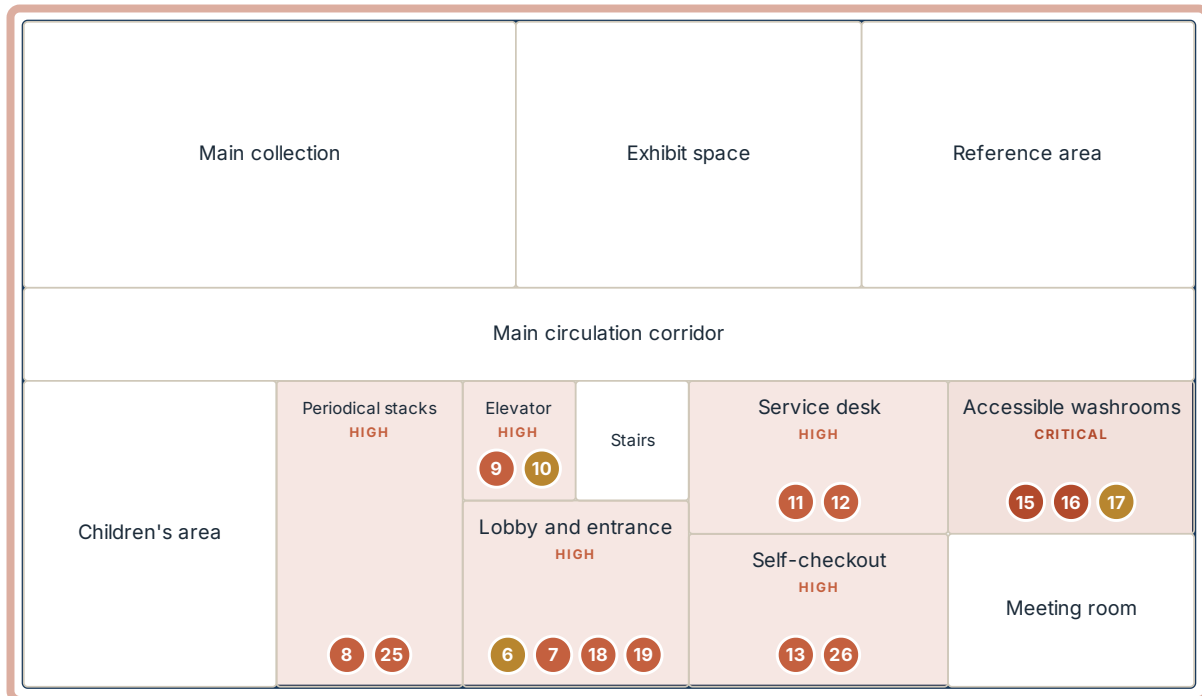
**Finding 23 — no visual fire alarm coverage on the main floor.** A whole-floor failure, so it carries no single pin. Costed once, with the upper floor, at \$8,500–\$14,000.

Main floor and site approach, Clearwater Public Library. Schematic — drawn to record where each finding was observed, not to scale, and not a construction drawing. The site approach is drawn dashed to mark it as exterior. The elevator serves both floors; its findings are pinned on this floor only, so they are counted once.

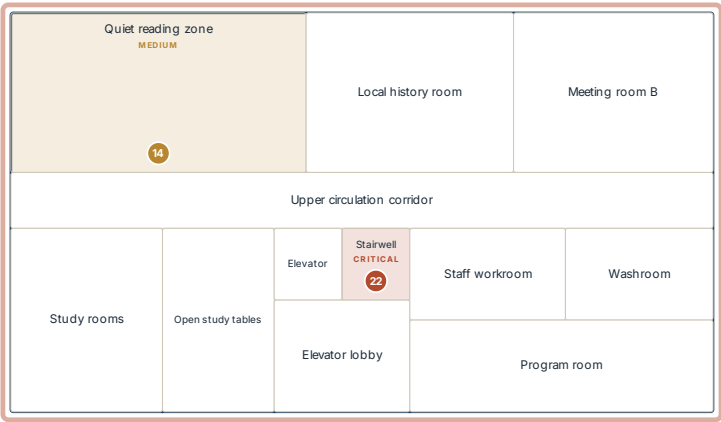
**WHOLE FLOOR** Finding 24 — no visual fire alarm coverage on the upper floor. Included in the combined \$8,500–\$14,000 estimate under finding 23.
