## HOME SAFETY ASSESSMENT REPORT · SAMPLE REPORT

Margaret Smith

123 Sample Street SW, Calgary, AB

Carl Christie, SHSS, RHFAC Professional

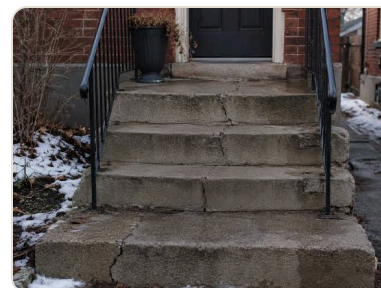
3 Front step treads are cracked and worn

**OBSERVED** Treads cracked, uneven, and without a rail to steady a slip.

**STANDARD** B652 §5.6.1 — Even height, no broken or rotted treads, slip-resistant.

Repair or resurface the treads so the walking surface is continuous, level and slip-resistant wet or dry.

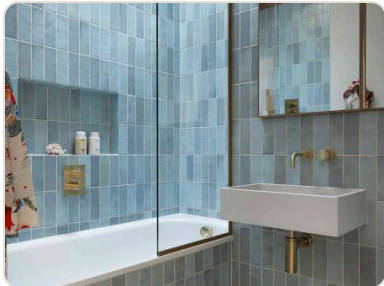
**OBSERVED** No bars at the tub or the tub entry.

Install two load-rated bars: one horizontal inside the tub, one vertical at the entry. Same blocking requirement as Finding 9.

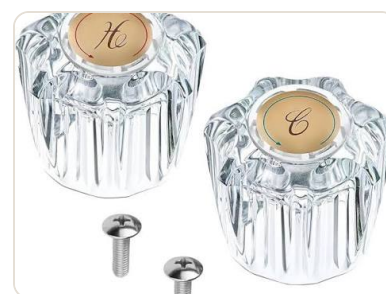
**OBSERVED** Knob handles throughout.

Replace with single-lever mixers at the sink and tub.

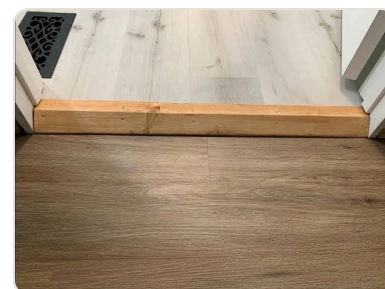
**OBSERVED** Measured 150 mm — effectively an extra step at the door.

Fit an exterior threshold ramp, or rebuild the landing so the step into the house is no more than 13 mm. This is the single change that most improves entering the home carrying anything.

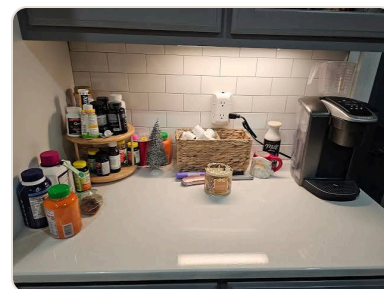
- 53 Prescription medication is kept loose on the kitchen counter **BUY** **HIGH** **\$55**

**OBSERVED** Four prescription bottles and a pill cutter, open shelf beside the kettle.

Move all prescriptions to a locked box and dispense a week at a time, or ask the pharmacy for blister packs dated by day. Blister packs cost nothing and remove the counting.

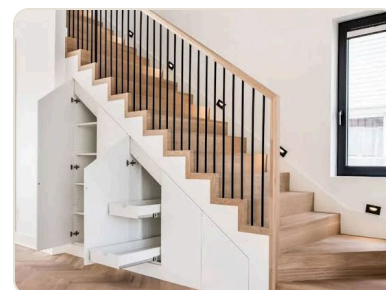
**OBSERVED** No visual contrast at any tread edge.

**STANDARD** B652 §5.6.2 — Horizontal contrast strip 50 (+/-10)mm deep at the leading edge of each tread, luminance-contrasted with tread and riser, slip-resistant.

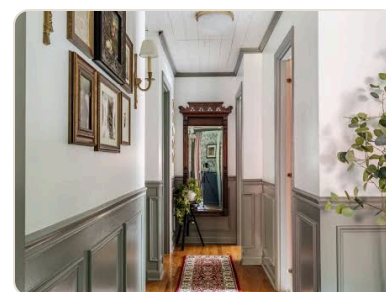
**OBSERVED** Measured 914 mm. An interior route in an altered dwelling is meant to be 1000 mm.

**STANDARD** B652 §5.8.1 — Min 1000mm for existing home alterations (1200mm new construction).
