HOME SAFETY ASSESSMENT REPORT

Margaret Chen

April 28, 2026

142 Maple Ridge Drive SW  
Calgary, AB T3E 4R7

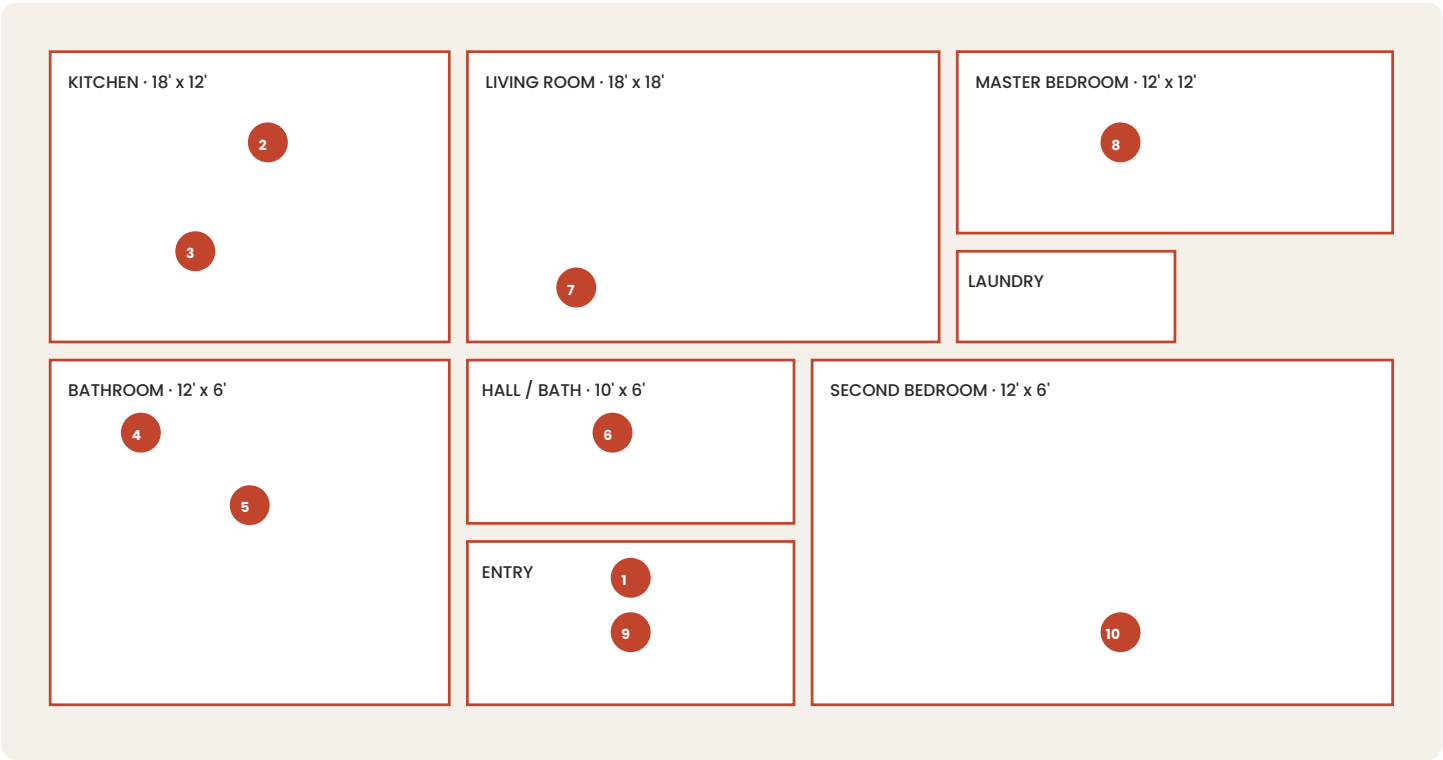
| 1 | Front steps: no handrail (left) | 6 | Hallway: no nightlight |
| 2 | Stove: no auto-shutoff | 7 | Loose area rug |
| 3 | Kitchen floor curling | 8 | Dresser clearance 62 cm |
| 4 | No grab bars at toilet / tub | 9 | Front door: no alert system |
| 5 | Tub: step-over entry | 10 | Basement stairs: no gate |
