SAMUDERA SHIPPING

DOCKING PROGRESS REPORT – Day 18	
Ship Name	GAS NURI ARIZONA
Type of Docking	INTERMEDIATE SURVEY V
Location	Semarang
Main Contractor	PT . YWTS
Date	27 July 2018

PHOTO REPORT

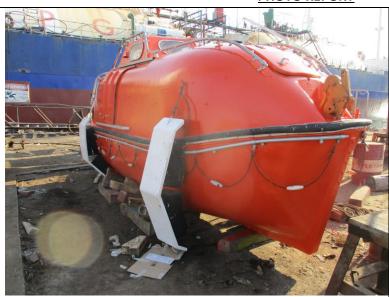
In progress application paint on lifeboats P/S

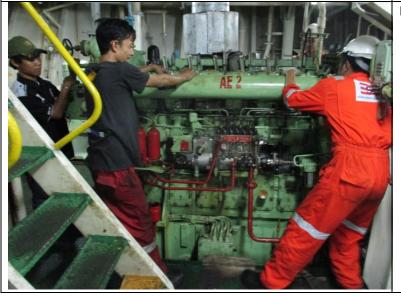
In progress start AE no 2.

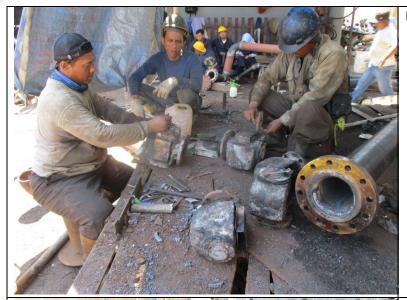
In progress service air vent head

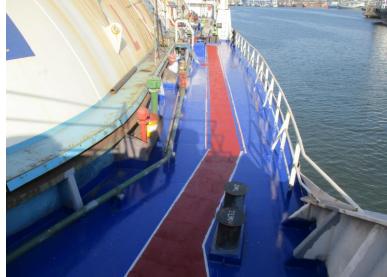
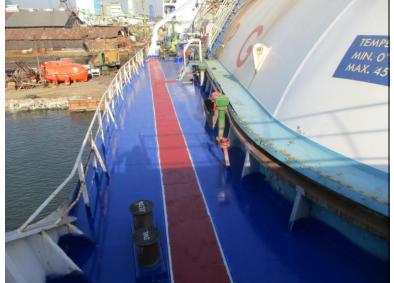
In progress marking walk line on main deck

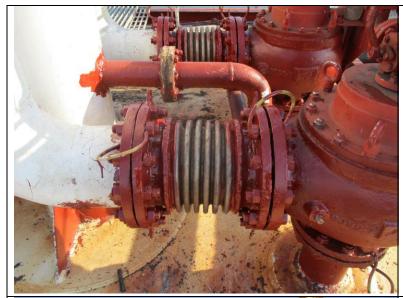
Flexible connection from pressure relief valve has been repaired

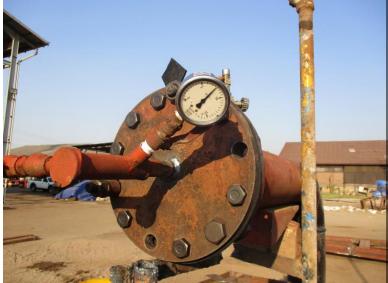
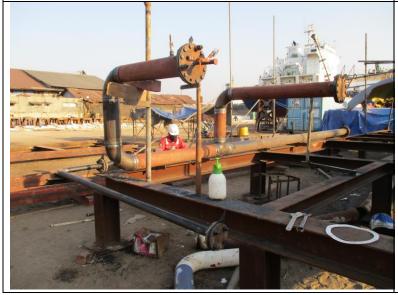
In progress air pressure test new fabricated cargo pipeline

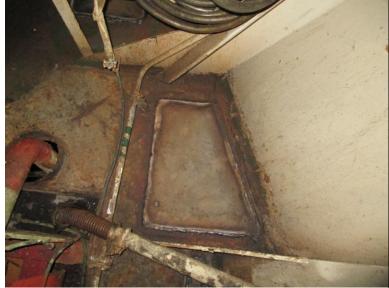
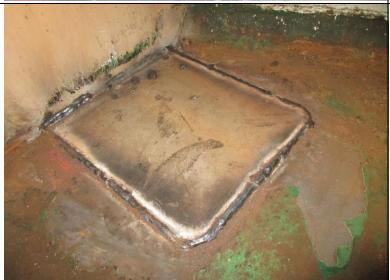
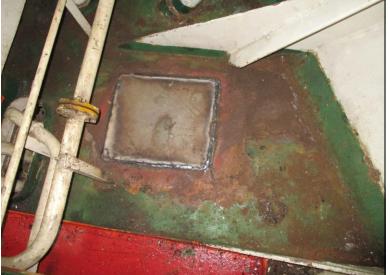
Corroded plate in engine room (2nd deck) has been doubled
