## Campaign 13

### **Operations Summary**

# Stan Mayfield Biorefinery Cellulosic Research and Demonstration Plant

Prepared by Joe Sagues, Director of Operations 07/07/2015

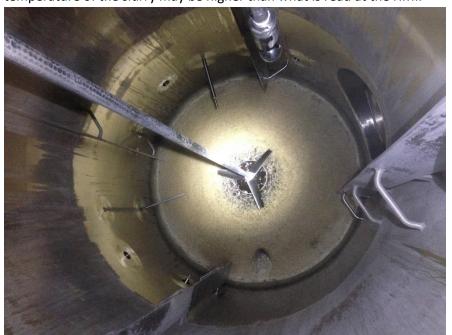
i. It was realized that the propagator 3 temperature probe's high position in the tank could give false temperature readings prior to inoculation. The temperature probe is significantly higher than the agitator and slightly higher than the pH probe (see picture below). This means that care must be taken when inoculating a propagator 3 tank with a small volume because the temperature of the slurry may be higher than what is read at the HMI.

i. A procedure was set in place to ensure the slurry is above the temperature probe prior to inoculation.
