Report Number: Inspection Date/Time: 13 Sep 2025 23:38 SIS2523781

Workplace: PPT2,PPT3

## **YARD - HYSTER OPS**

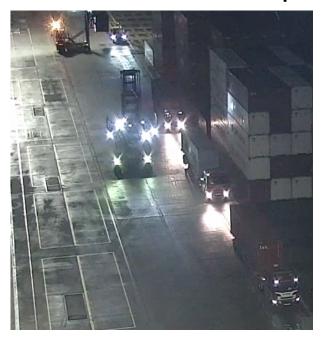
Description / Immediate Action	Follow Up / Remarks
Team conducted CCTV inspection at hyster block T09.	
Team observed FM023 operator adhered to SOP when gantrying to another block with 20ft spreader close.	
Team observed FM023 operator also come to a complete stop at unbroken white line before crossing.	SOP complied / SBR awarded.
Team commended the FM023 operator for complying to SOPs and to continue practicing good safety habits at all times.	
Team also reminded the FM023 operator to report any hazard immediately to his superiors and /or control centre.

Caption: FM 023 gantry ops

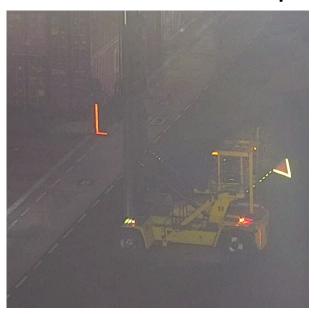
Description / Immediate Action	Follow Up / Remarks
Team conducted CCTV inspection at hyster block S10.	
Team observed that FM051 operator was on stationary position with spreader closed to 20-footer and hoist to 3 high.	
Team commended FM051 operator for complying to SOP and to continue practicing good safety habits at all times.	SOP complied / SBR awarded.
Team also reminded the FM051 operator to report any hazard immediately to his superiors and /or control centre.

Caption: FM 051 on standby
