Risk Mitigation Framework for Urban Cultural Heritage

CASE STUDY of Walled City, Ahmedabad

National Institute of Disaster Management (NIDM), New Delhi
in collaboration with
Ahmedabad Municipal Corporation (AMC)

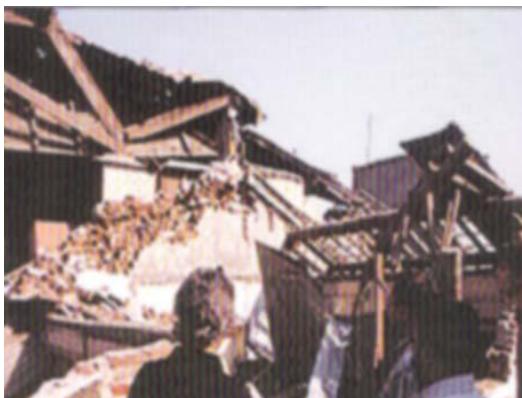
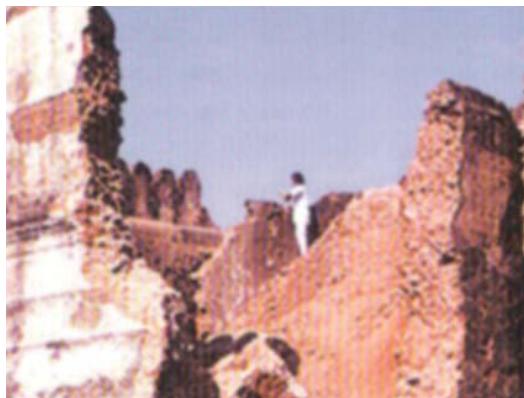
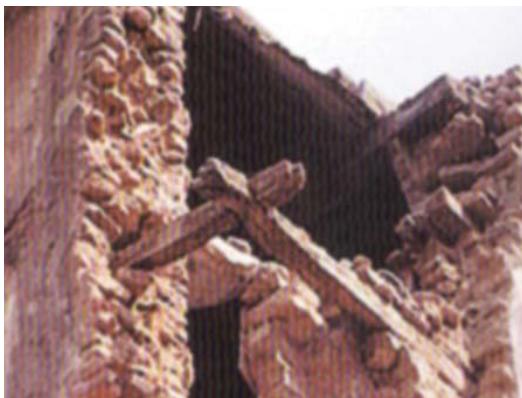
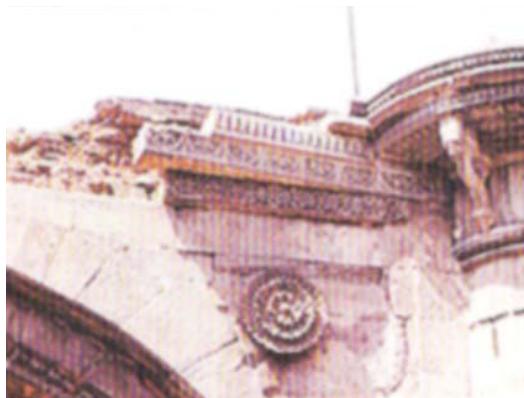
Demolished floors (pictures above)

Damaged monuments - Bhadra fort (top picture)

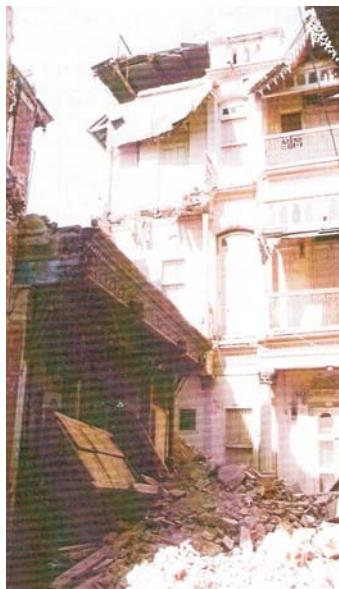
Collapse of upper floors has also damaged the neighbouring house

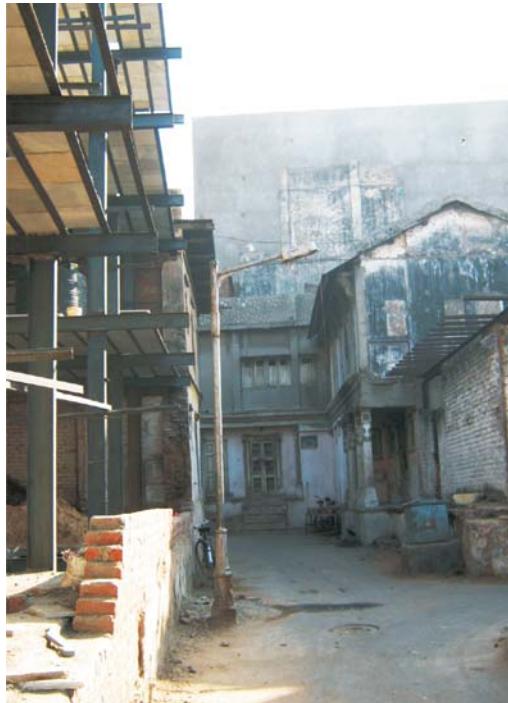
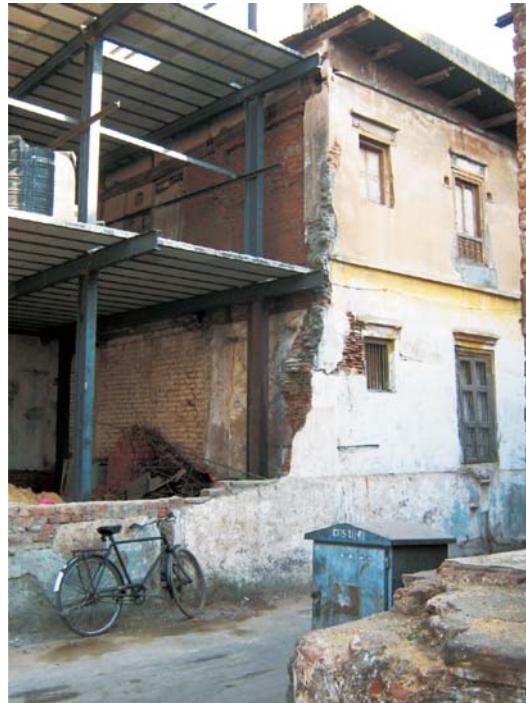
Construction trend - I section and Kotah stone slabs replace the irreplaceable wooden havelis

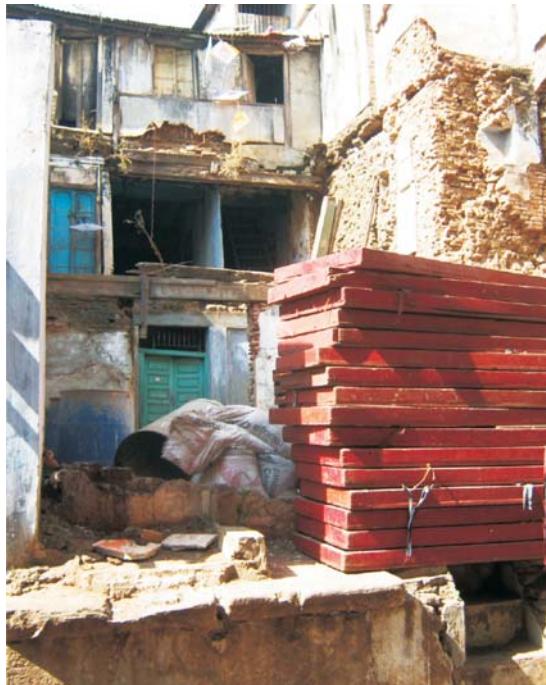
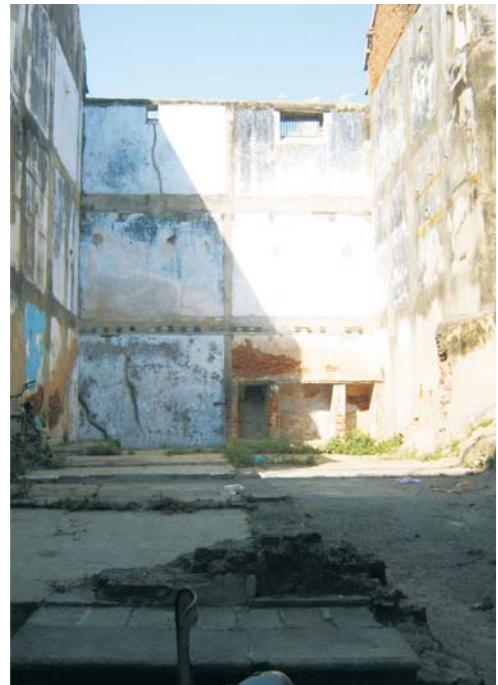
Insensitive destruction of traditional houses a. along the main road b. inside a residential Pol

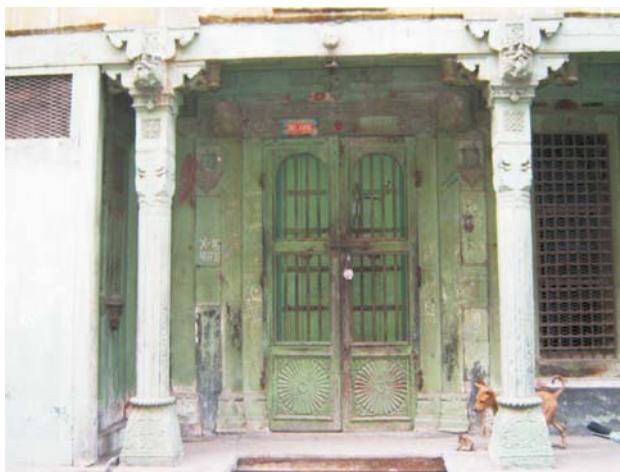
Locked & vacant houses in Jada Bhagat ni Pol

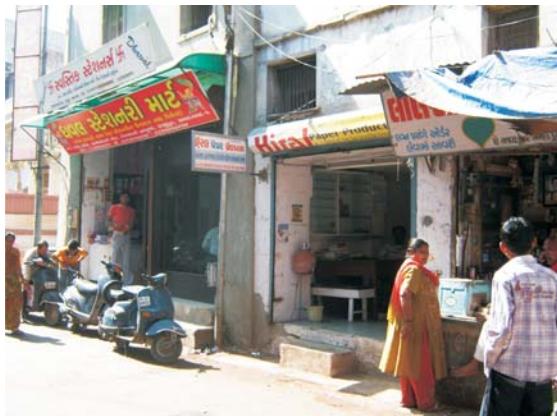
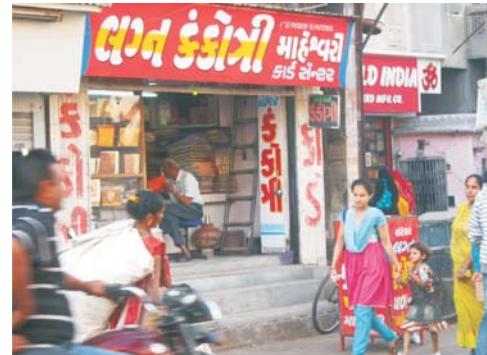
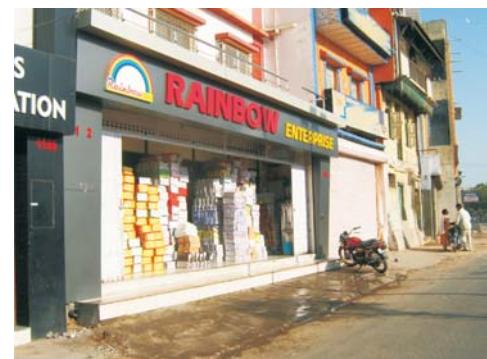
The houses in Shantinath ni Pol facing the main road are either converted into shops or has atleast one room as shop. Right above - Kankotri shop & below- the shoe market

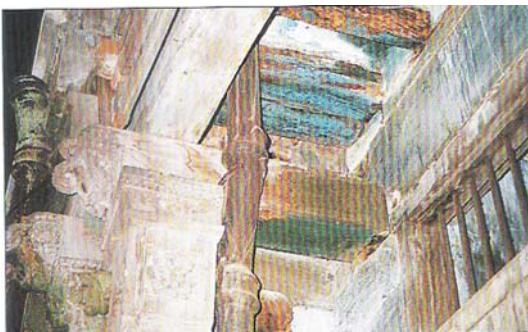
J. Dampness and termite attack - Water seepage due to defective roof, leaking of sanitary installations and capillary action

cause rotting of exposed members such as beam ends and the column bottoms. When teak wood is attacked by moisture, it softens. Termites climb up via columns or masonry and attack floors and roof frames. The termite attack reduces wood member cross section to an insufficient dimension bringing about deformations and load shifting which cause deformation and eventual collapse of the structure. The termite infested weak structures are subjected to sudden collapse during earthquake and heavy rains.

Damage caused by water seepage

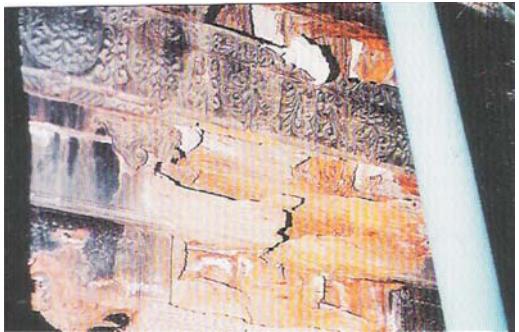
wooden members infested by termites

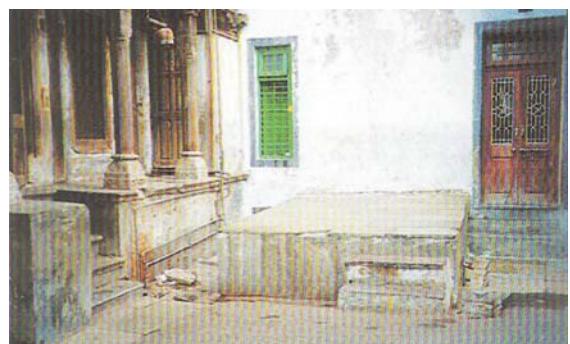
Sealed off tanka and the well

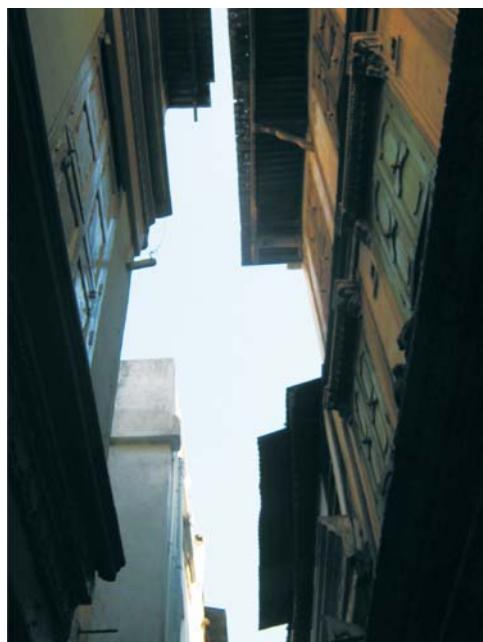
Narrow lanes inside the Pol with the roofs of opposite houses almost touching each other- very clever planning and design to prevent hot sun rays to enter the houses could pose problem during the event of hazard such as fire. In such cases, concerted efforts towards prevention of hazard and use of suitable equipments are imperative.

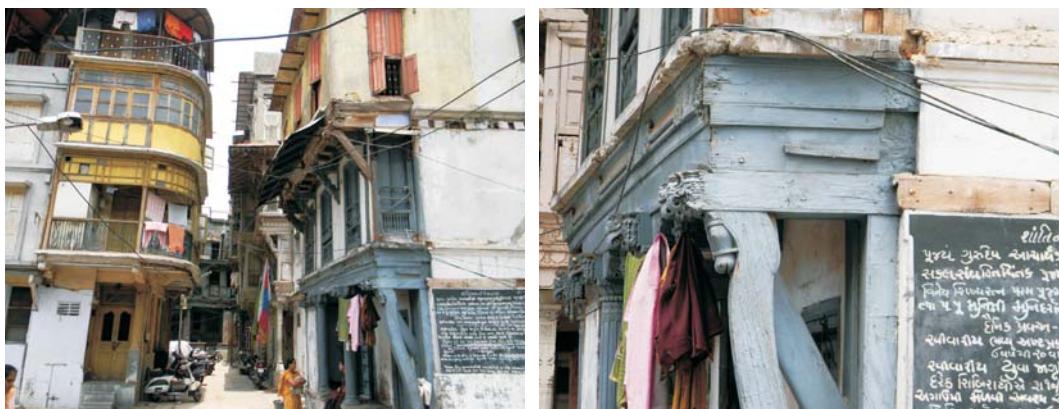
Photographs taken in Aug 2010

Out of the 64 properties, 20 traditional houses have been demolished. The demolition takes place in a very planned manner. For example, the recent demolition of the house with survey no. 857 & 858 was started in July 2010. The Photograph taken in August 2010, did not show any work from the exterior; however, the work was on going in the interior in a discreet manner. After the interior demolition accomplished, new frame in MS girder was erected, following which the exterior too was demolished. The house had the most unique wooden column / bracket with a horse head apt for a corner property.

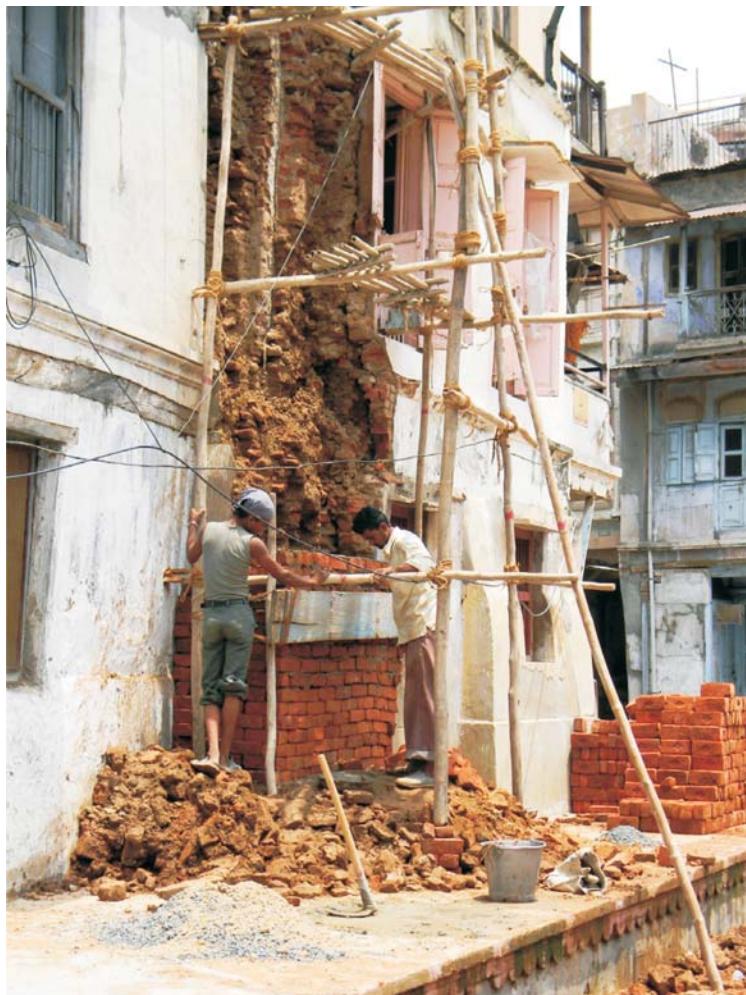
In Shantinath - ni - Pol, out of 50 houses, 22 houses have been found to be either rebuilt or highly altered. The reconstruction and alteration of the buildings have been done without following any minimum structural / building standards, which have replaced the high quality designed traditional construction. General trend has been employing the easy to install MS girders and kota stone flooring.

demolition in progress

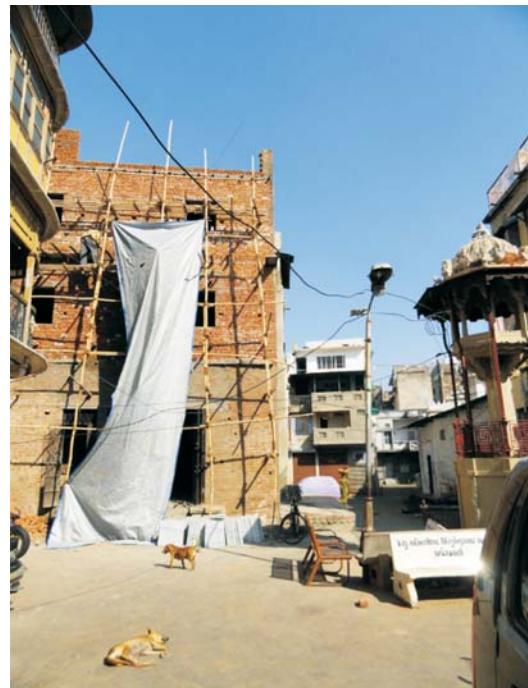
In the Pol, although grouping of plots/ houses has not taken place, but many of the plots have been subdivided to create small houses. This has not only resulted in the destruction of the original house entity, but also created multiple ownership which further leads to many problems. In some cases, subdivision of the houses in vertical manner has also happened. For example, the house with survey no. 803 has been divided into 6 portions with different owners for the second and third floor which are later additions. All these factors have contributed towards increasing vulnerability to earthquakes due to loss of structural integrity.

Demolition and Reconstruction

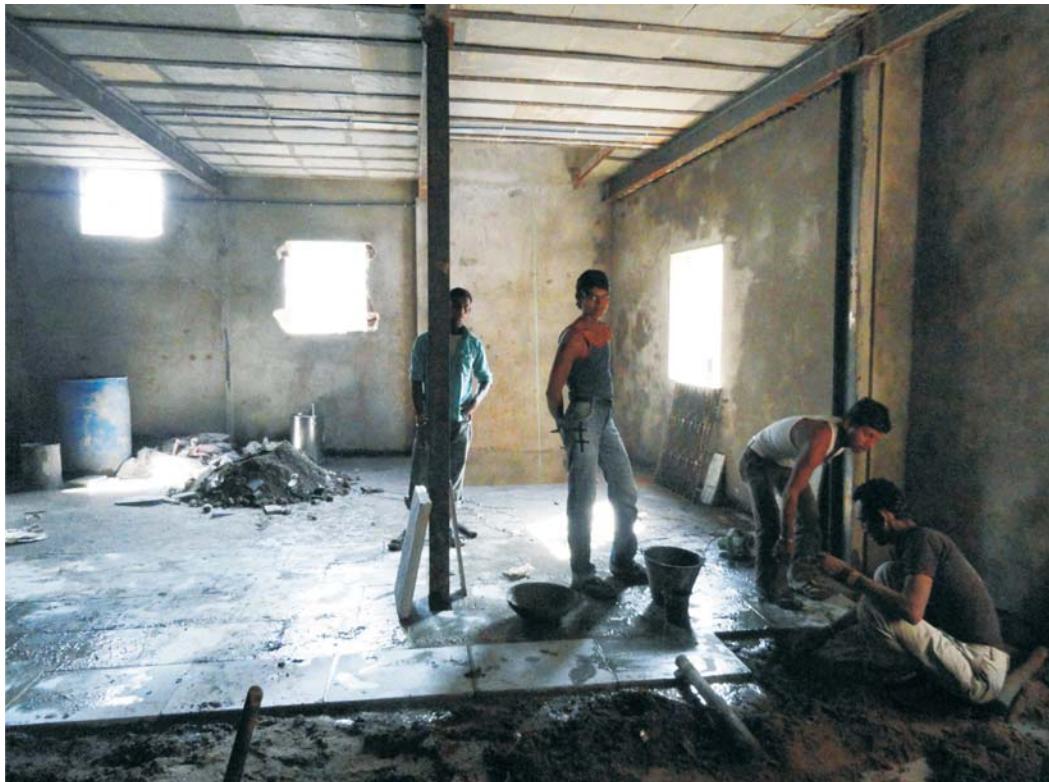
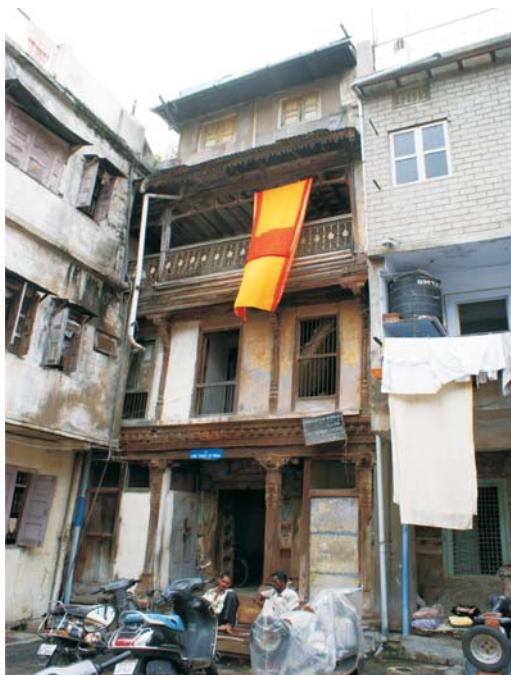
Survey no 803 - Multiple ownership

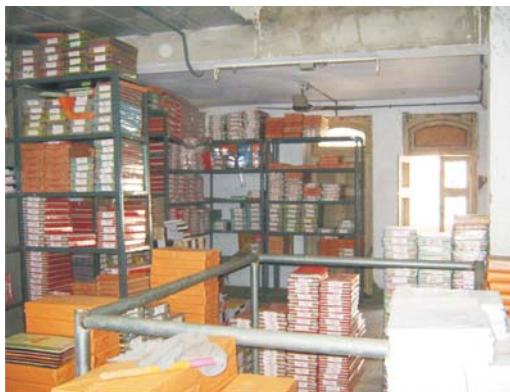
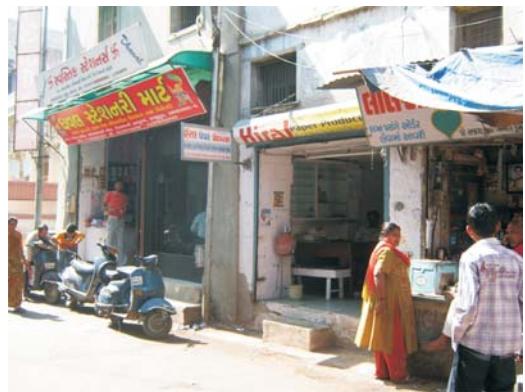
Houses on the periphery converted to Commercial use

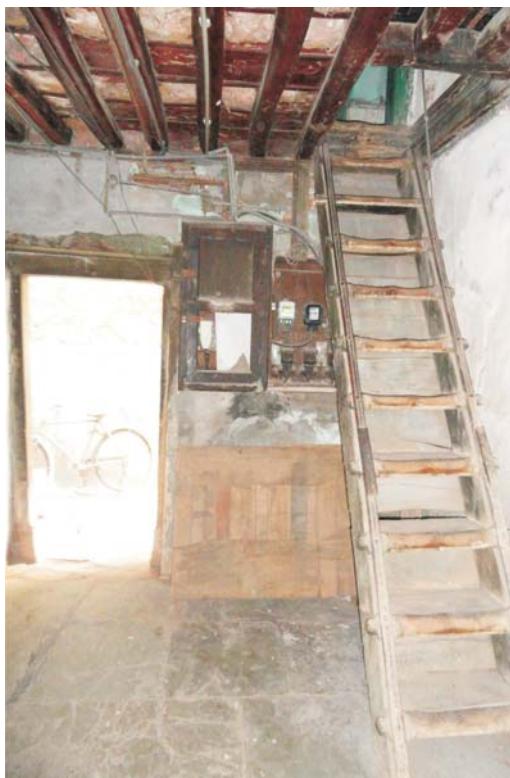
General trend of alteration to a exquisite wooden carved traditional house

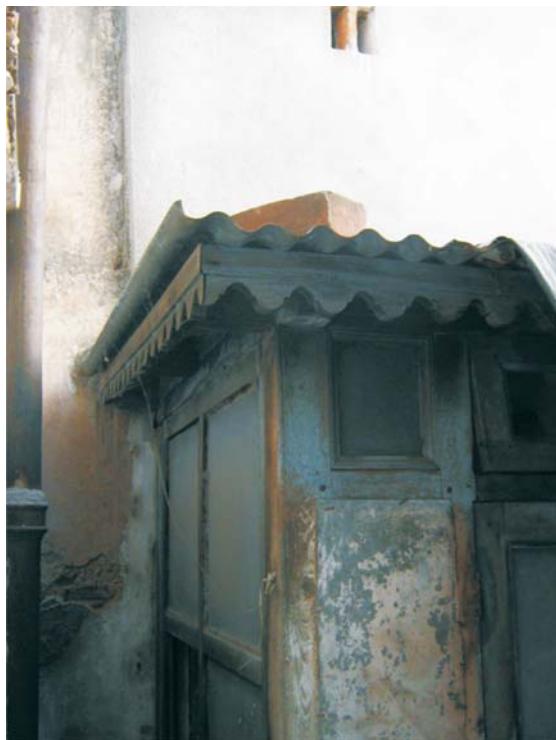
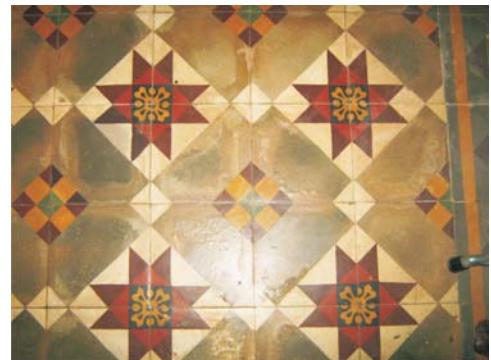
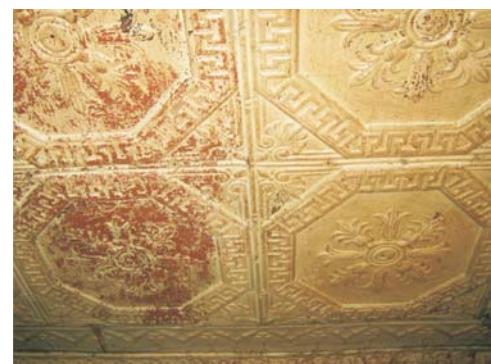
5.	Vulnerability	<ul style="list-style-type: none"> a. Multiple owners creating different use / handling of the house. b. Change in materials such as false ceiling with thermacool (combustible material) beneath the wooden joists and planks - on the ground floor rooms. c. Lack of maintenance. d. Tanka non-functional e. Inappropriate additions and alterations on the first floor, such as toilets, RCC beams and columns, balcony (eastern side) overlooking the main road. f. Narrow staircase to the first and second floor. g. Neighbouring commercial property, 876A & B and poorly rebuilt houses.

Old bathroom inside the chowk on north side, Floor pattern, moulded tin ceiling

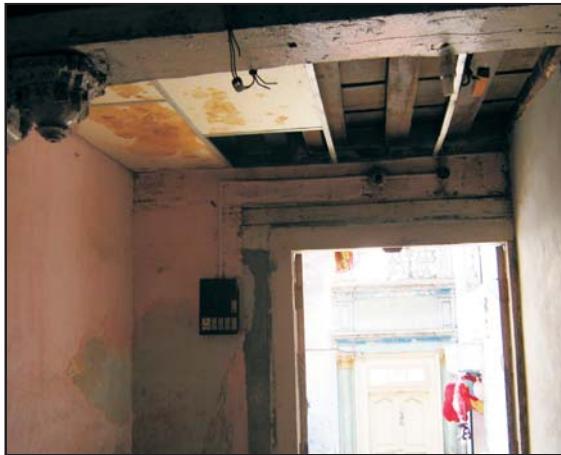
Ceiling with thermacool sheets on ground floor

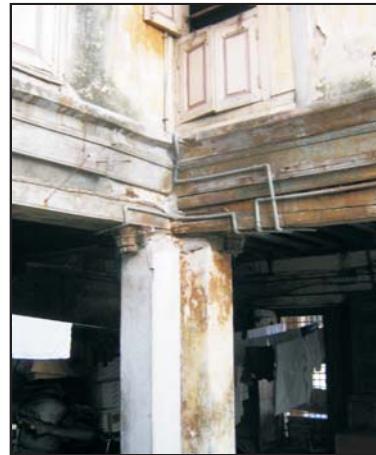
Wooden column replaced by RCC / brick column

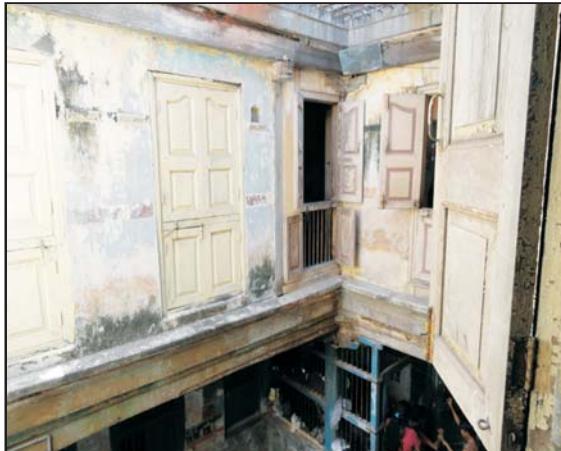
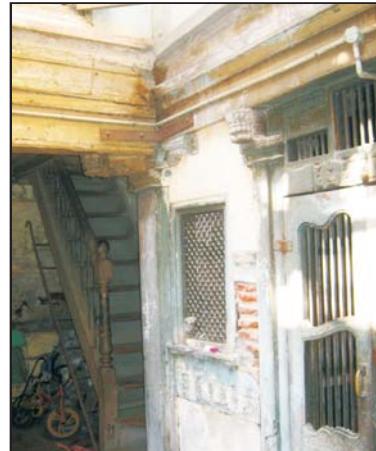
Lack of maintenance

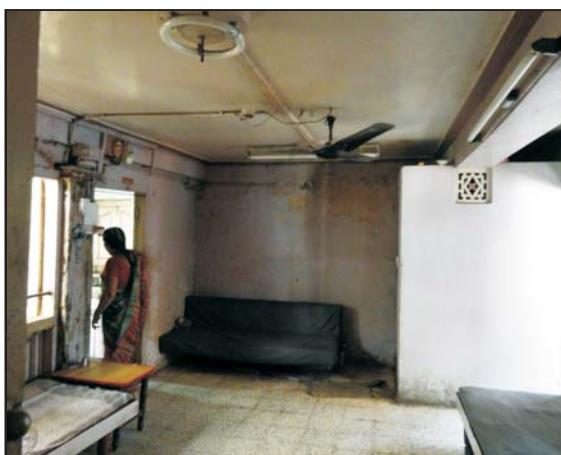
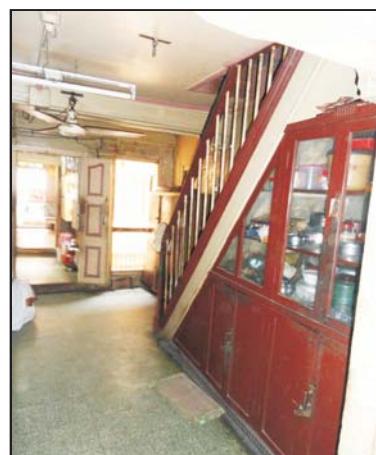
Alteration made on first floor

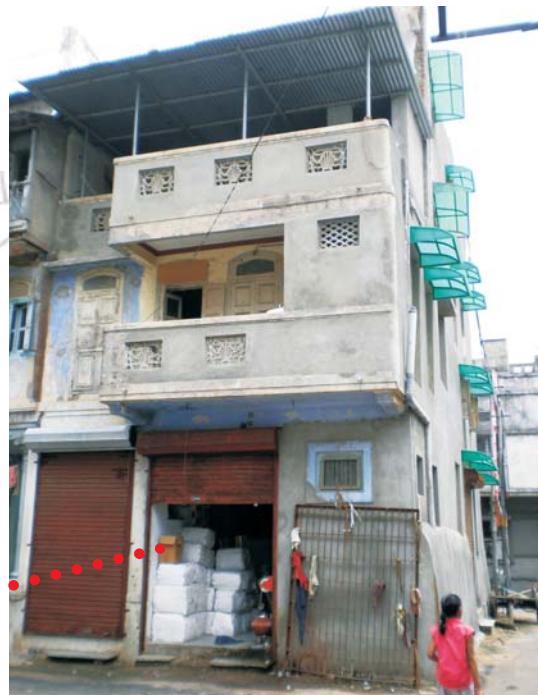
2. Survey no. 884 A & B Dhavaal Stationery Mart

1.	Building details	GF+3, corner house area (ground coverage) = 92 Sqmt.
2.	Description	The residential building has been converted into a wholesale shop of paper stationery. The plan and form of the building though remains the same as the original building would have been, the interior has been totally reconstructed. The traditional wooden joists, beam roof is replaced by T-girders and kota stone above which a 4" PCC slab is laid. The wooden staircases have been retained for access to the upper storeys. A dumb weight machine helps the paper goods to move up and down. Remains of Tanka can still be seen.
3.	Ownership	Private owner. Part of the same house with survey no.884B has different owner.
4.	Capacity	none

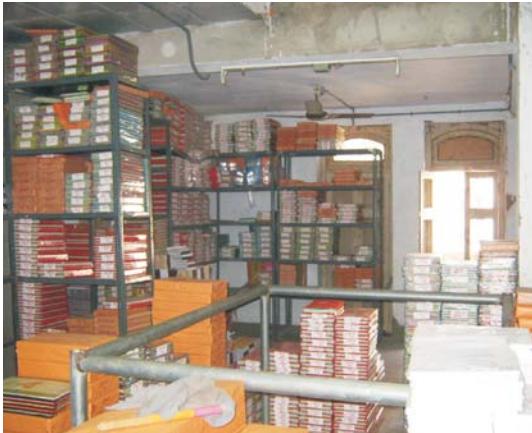
5.	Vulnerability	<ul style="list-style-type: none"> a. Commercialization of the property and heavy storage of papers and other combustible materials. b. Change in materials such as T- girders and kota stone slab. c. Tanka used as storage. structure dilapidated with broken arches. d. Narrow staircase to the first and second floor. e. Corner house. f. Lack of warning system and preparedness.
6.	Risk to Hazards	High risks to occupants and the house during earthquake and fire.

Storage of paper materials

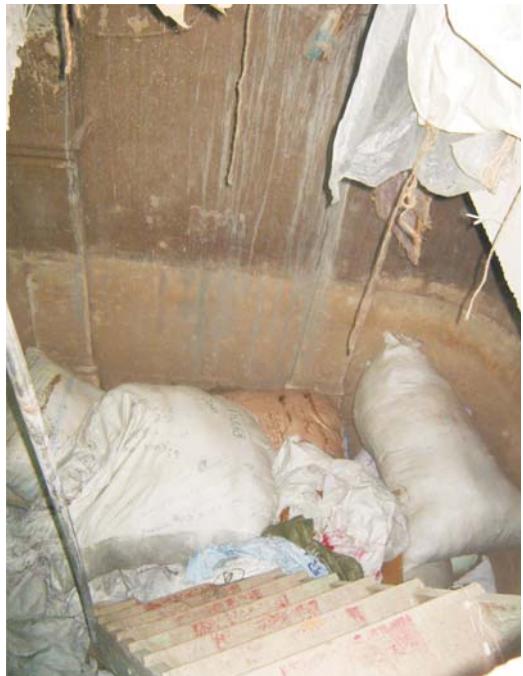
Tanka used for storage - dilapidated

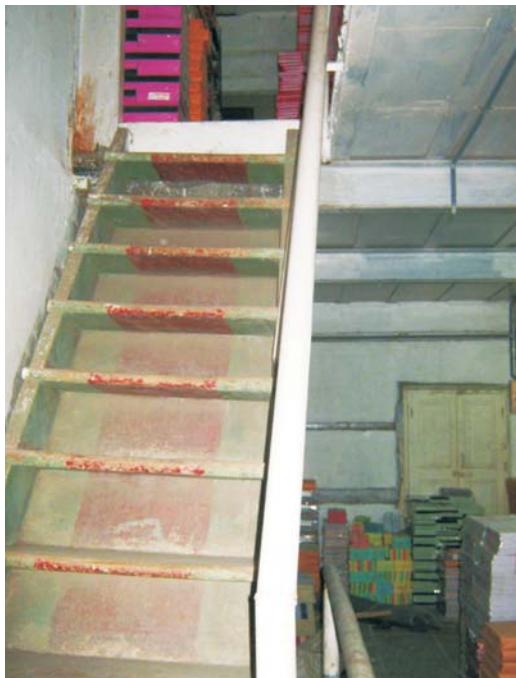
Staircase inside the building

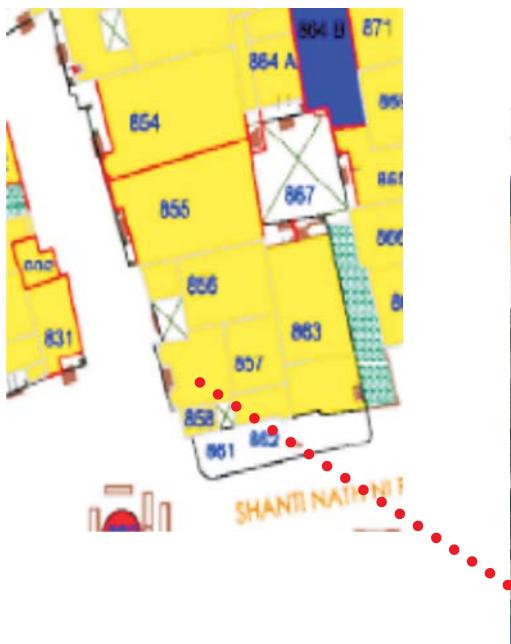
3.	Ownership	Single ownership.
4.	Capacity	none. Corner House.
5.	Vulnerability	Commercialization creeping inside the residential pol is hazardous. New construction with steel sections and kota stone increases the vulnerability of the adjacent traditional houses.

earlier house and now under reconstruction

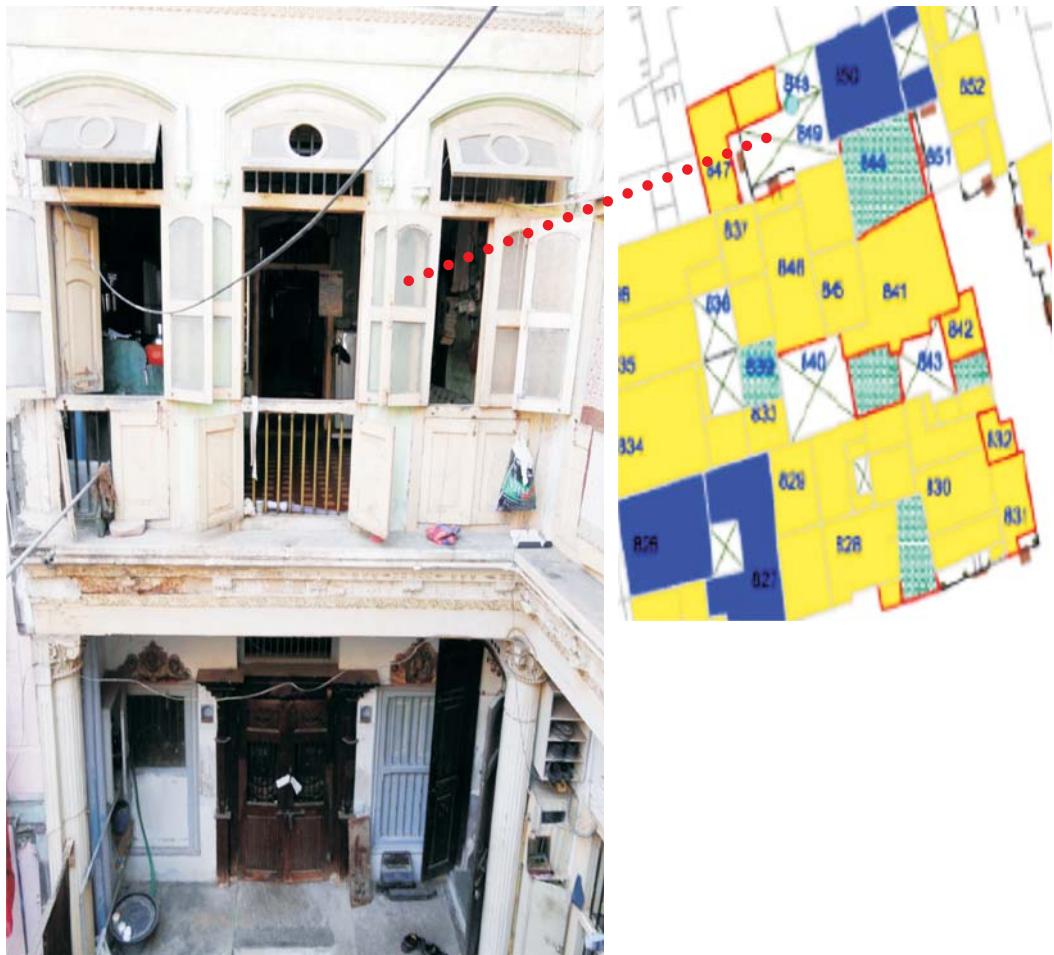
3.	Ownership	Multiple ownership.
4.	Capacity	Traditional construction is still retained. Tanka works.
5.	Vulnerability	Commercialization in one of the neighbouring houses. Damaged entrance portion. Altered houses around the Khadki (no. 845) increases vulnerability. Restricted access and exit.

Damaged entrance portion of the khadki

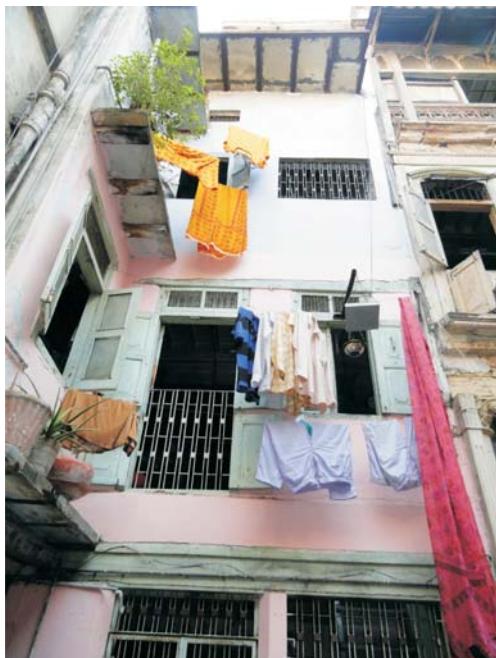
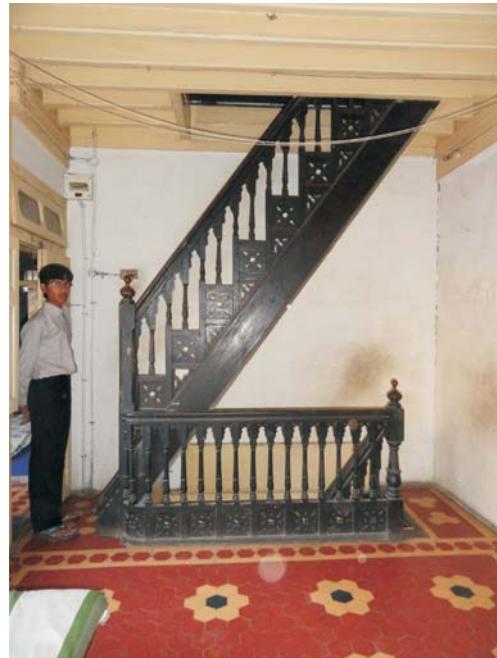
Inappropriate additions and alterations to survey no. 845

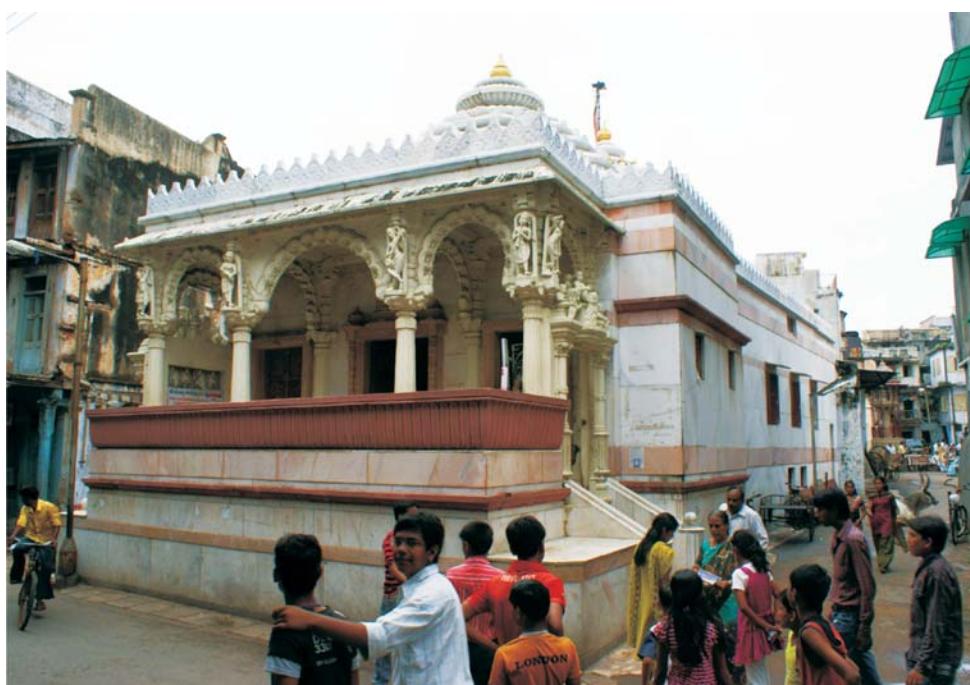
2

Survey no. - 798
School

1. **Ownership** - Trust
2. **User Type-** Children of age group 4 -8 and teachers (20-60)
3. **Income source** -
4. **Change** - Additions
5. **New Material** - Steel sections+kota stone
6. **Total floors-** GF+1
7. **Tanka System** - No Tanka
8. **Any damage** - due to earthquake
9. **Facility/ equipment** - no
(for emergency)
10. **Vulnerability**- Yes. (fire)
11. **Remarks** - Only one access from the street.
At risk

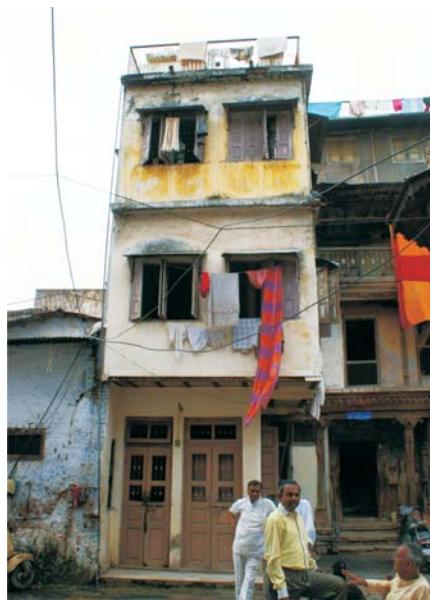
4a

Survey no. - 800
Residence - Closed

800, 801, 802 - created by dividing original property and completely altered / rebuilt poorly. At risk category.

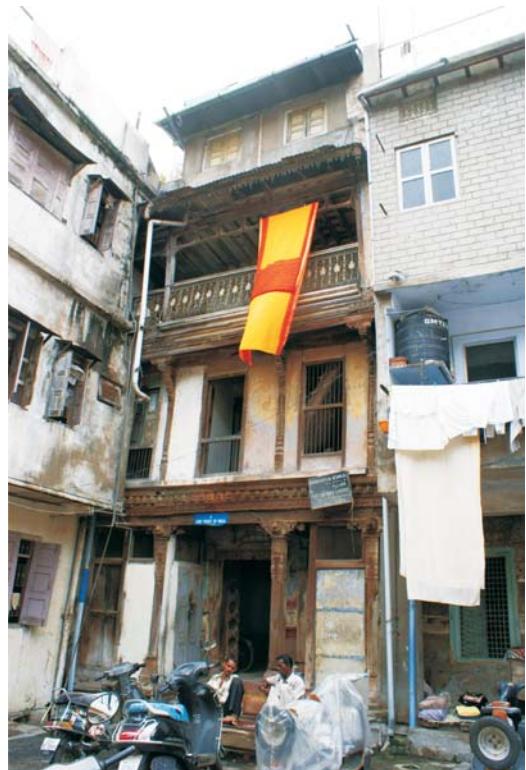
4d

1. **Ownership** - Privately owned
2. **User Type-** Old people-1
Children (below 10)-1
Youth (20-45)- 2
3. **Income source** - Job
4. **Change** - Alterations
5. **New Material** -
6. **Total floors**-
6. **Tanka System** - No Tanka
7. **Any damage** - earthquake
8. **Facility/ equipment** - no
(for emergency)
9. **Vulnerability**- Yes.
10. **Remarks** -

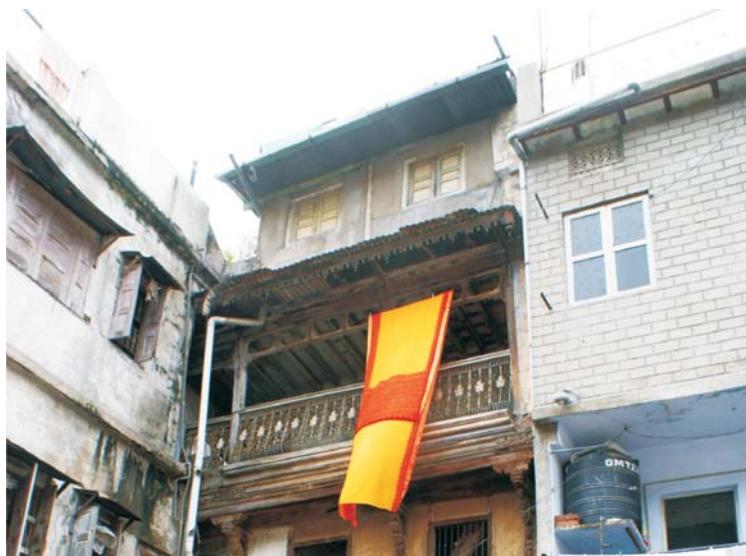
5

1. **Ownership** - Privately owned
2. **User Type**- Old people (above 70)-2
Youth (20-45)- 3
3. **Income source** - Job
4. **Change** - Alterations
5. **New Material** - RCC + Brick wall
6. **Total floors**-
6. **Tanka System** - No Tanka
7. **Any damage** - earthquake
8. **Facility/ equipment** - no
(for emergency)
9. **Vulnerability**- highly vulnerable.
10. **Remarks** - Poorly built addition to the original property.
At risk.

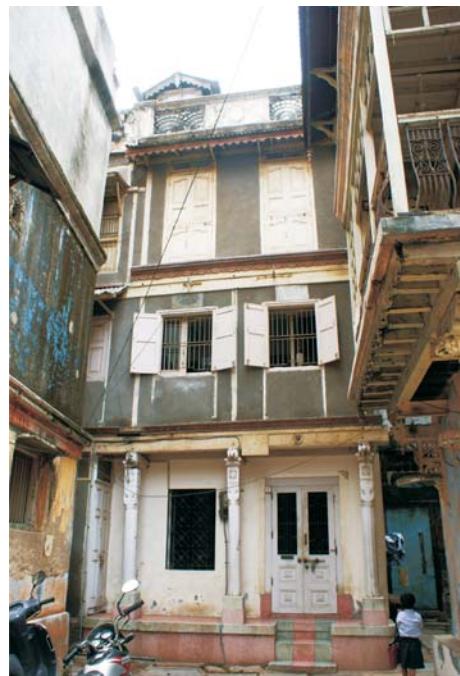
7

1. **Ownership** - Privately owned
2. **User Type**- Youth (20-45)- 3
Single women - 1
Youth (20-45) - 1
3. **Income source** - Business
4. **Change** - Alterations
5. **New Material** - RCC + Brick wall
6. **Total floors**- GF+2
7. **Tanka System** - No Tanka
7. **Any damage** - earthquake
8. **Facility/ equipment** -
(for emergency)
9. **Vulnerability**- Vulnerable due to new use
10. **Remarks** - At Risk

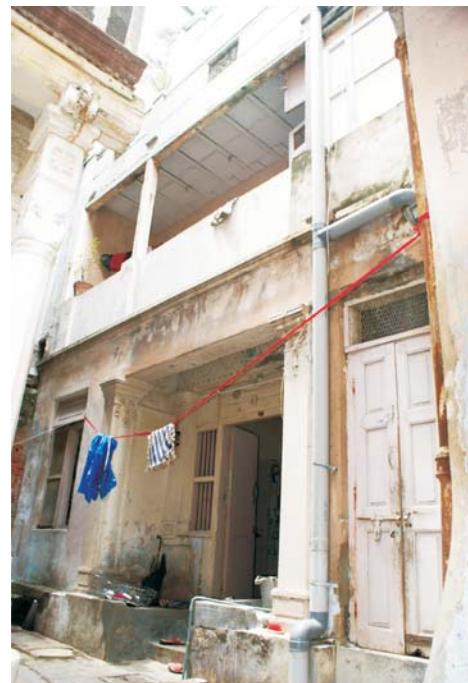
8

1. **Ownership** - Privately owned
2. **User Type-** Children (below10)- 3
Single women - 1
Youth (20-45) - 1
3. **Income source** - Job
4. **Change** - Additions (2010)
5. **New Material** - RCC + Brick wall
6. **Total floors-** GF+2
7. **Tanka System** - No Tanka
8. **Any damage** - earthquake
9. **Facility/ equipment** - (for emergency)
10. **Vulnerability**- Due to improper alterations
10. **Remarks** - At risk

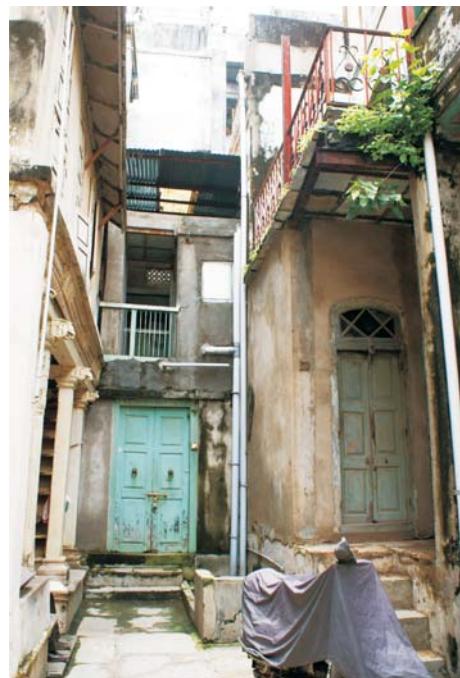
9

1. **Ownership** - Privately owned
2. **User Type**-
3. **Income source** - Business
4. **Change** - Alterations (2000)
5. **New Material** -
6. **Total floors**- GF+1
6. **Tanka System** - No Tanka
7. **Any damage** - No damage
8. **Facility/ equipment** - (for emergency) no
9. **Vulnerability**- Vulnerable due to use.
- 10 **Remarks** - rebuilt poorly. used as godown.
At risk.

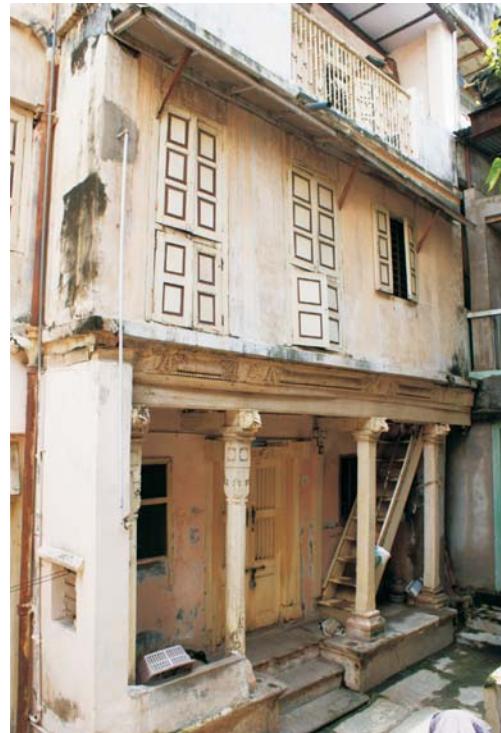
12

1. **Ownership** - Privately owned
2. **User Type-** Youth (20-45) - 3
3. **Income source** - Job
4. **Change** - Additions
5. **New Material** - RCC+Brick wall
6. **Total floors**- GF+2
7. **Any damage** - Earthquake damage
8. **Facility/ equipment** - (for emergency) no
9. **Vulnerability**- Vulnerable due to additions on 2nd floor
10. **Remarks** -

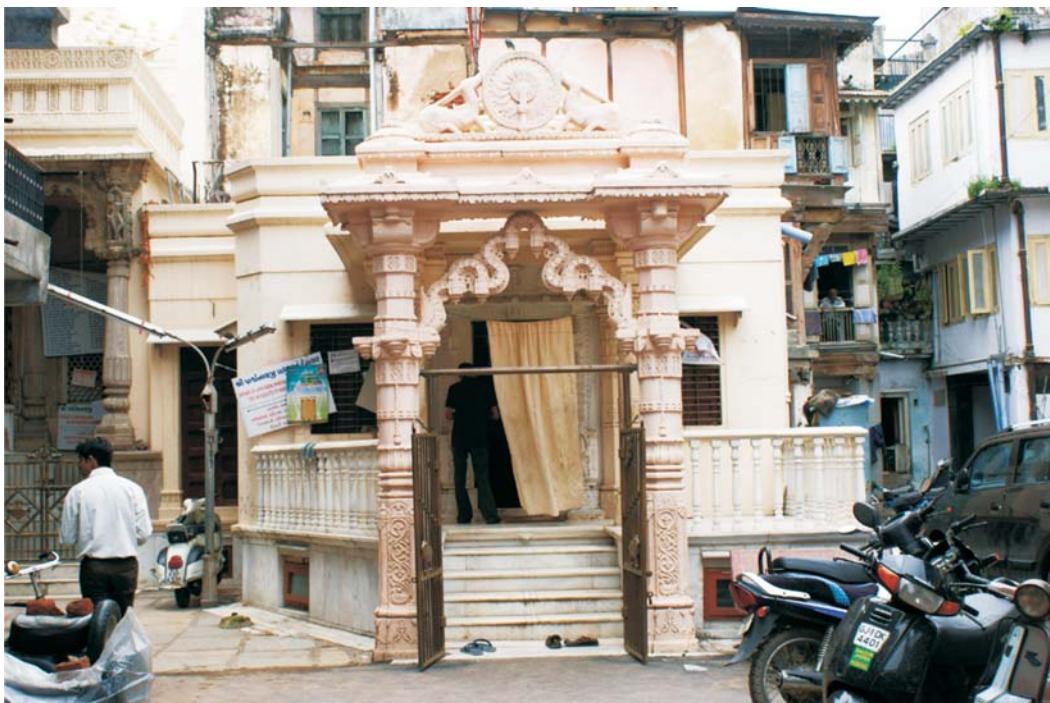
14

Survey no. - 821

**Residence - disintegrating due to lack
of maintenance**

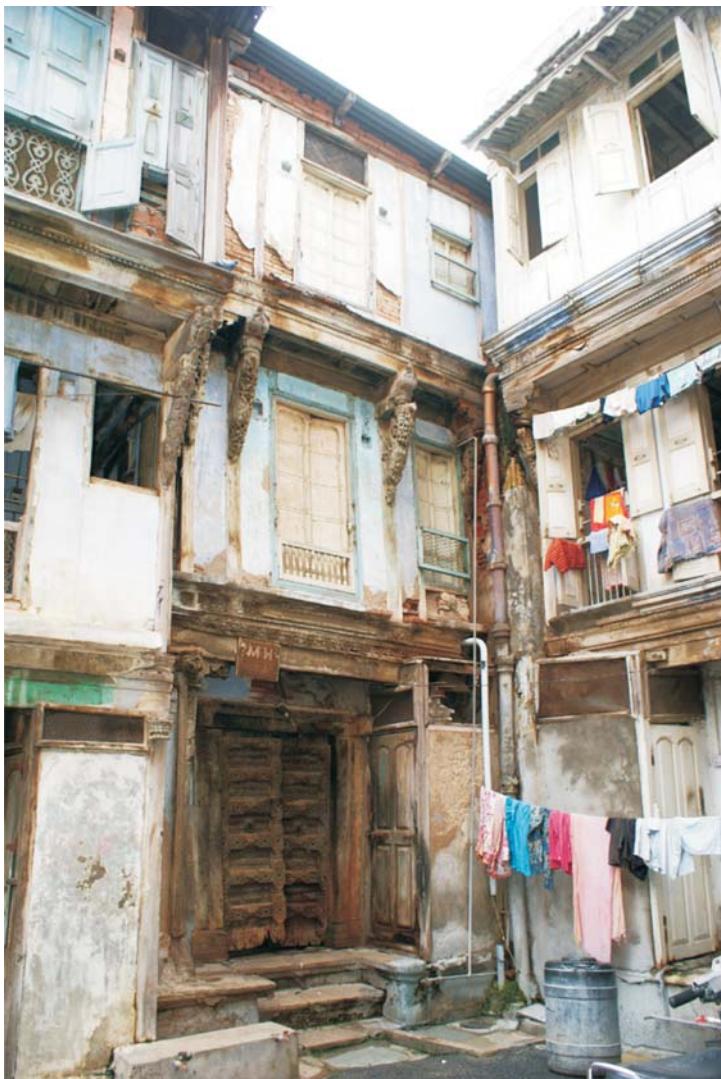
16

Survey no. - 824
Residence

1. **Ownership** - Privately owned
2. **User Type**- Old (above70)-1
Children (below10)-2
Youth(20-45)-2
3. **Income source** - Business
4. **Change** - No change
5. **New Material** -
6. **Total floors**- GF+2
7. **Tanka System** - No -Tanka
8. **Any damage** - No damage
9. **Vulnerability**- due to lack of maintenance & corner wall.
10. **Remarks** -

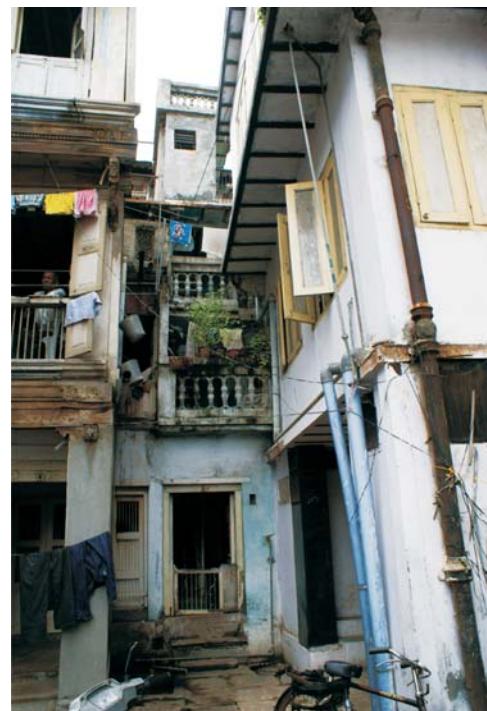
18

1. **Ownership** - Privately owned
2. **User Type-** Children (below10)-1
Single women - 1
Youth(20-45)-1
3. **Income source** - Job
4. **Change** - Altered (1998)
5. **New Material** - RCC + brick
6. **Total floors-** GF+2
7. **Tanka System** - No -Tanka
8. **Any damage** - No damage
9. **Vulnerability**- Internal rooms- lack of maintenance.
10. **Remarks** - Facade is rebuilt with extensions and alterations.

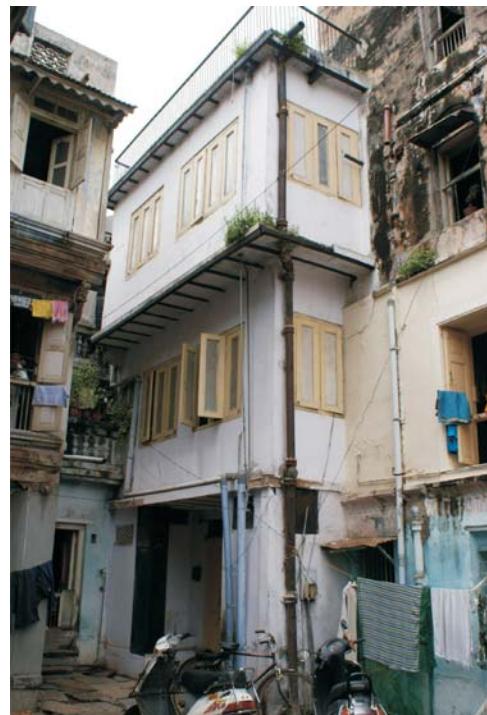
19a

1. **Ownership** - Privately owned
2. **User Type**- Youth(20-45)-2
3. **Income source** - Business
4. **Change** - Additions (2000)
5. **New Material** - RCC+Brick
steel section +Kota stone
6. **Total floors**- GF+2
7. **Tanka System** - No -Tanka
8. **Any damage** - No damage
9. **Vulnerability**-
10. **Remarks** - Poorly rebuilt without considering the traditional structural qualities.

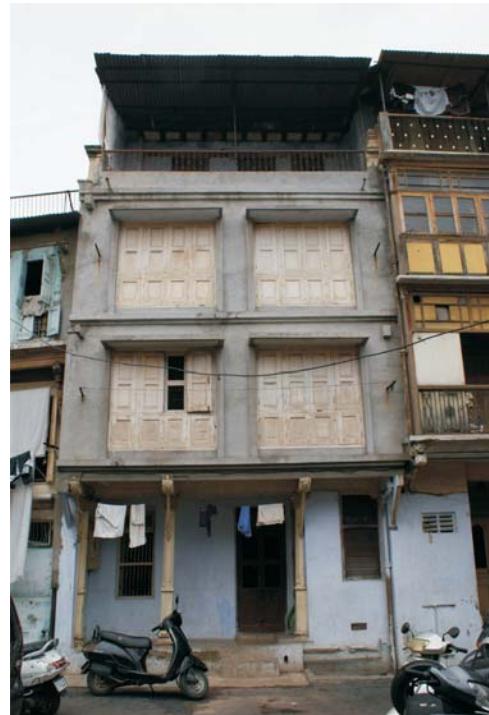
22

1. **Ownership** - Privately owned
2. **User Type**- Single woman-1
Youth(20-45)-2
3. **Income source** - Job
4. **Change** - Additions & Alterations
5. **New Material** - RCC+brick wall
6. **Total floors**- GF+3
7. **Tanka System** - No -Tanka
8. **Any damage** - Earthquake damage
9. **Infrastructure** - Satisfied
10. **Vulnerability**-
11. **Remarks** - Poorly altered with inappropriate materials & technique.

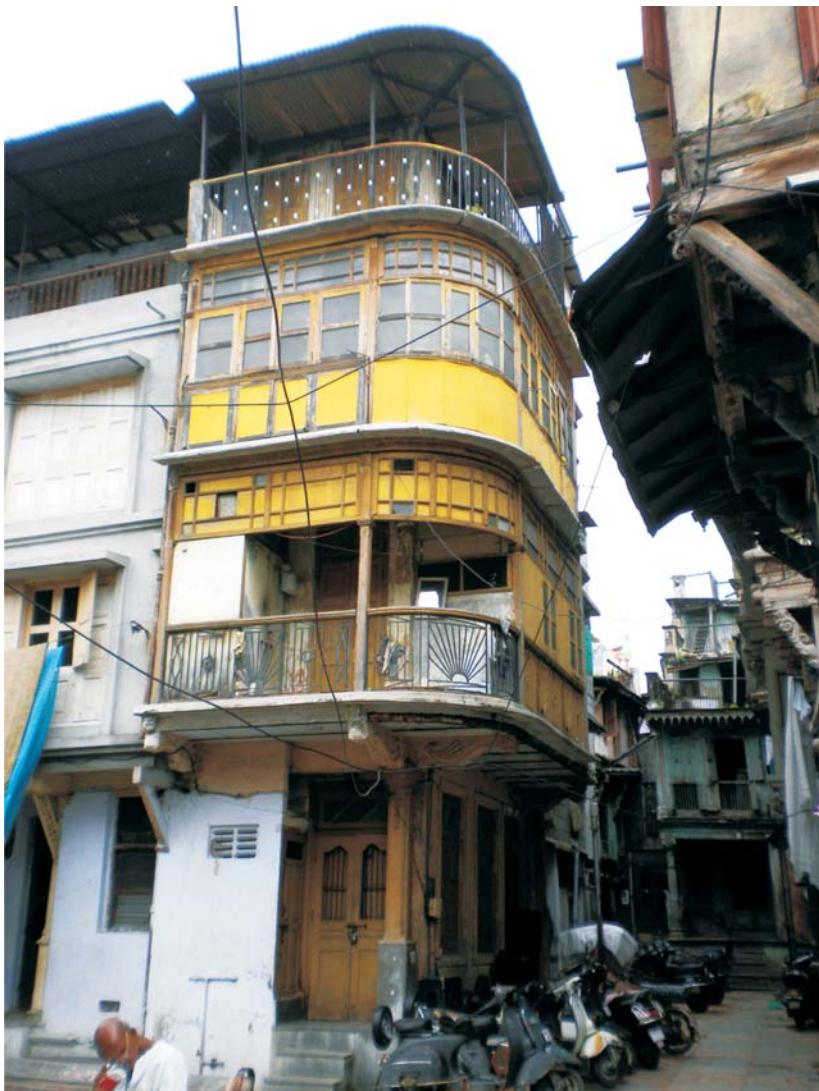
23

Survey no. - 832
Residence
