Risk Mitigation Framework for Urban Cultural Heritage

CASE STUDY of Walled City, Ahmedabad

National Institute of Disaster Management (NIDM), New Delhi
in collaboration with
Ahmedabad Municipal Corporation (AMC)

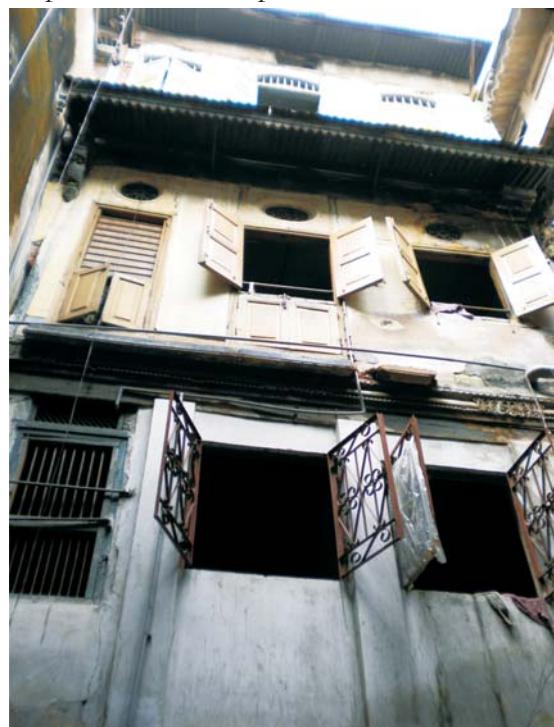
25

1. **Ownership** - Privately owned
2. **User Type-** Children (below10)-2
Youth(20-45)-2
3. **Income source** - Business
4. **Change** - No change
5. **New Material** -
6. **Total floors**- GF+3
7. **Tanka System** - No -Tanka
8. **Any damage** - Earthquake damage
9. **Infrastructure** - Satisfied
10. **Vulnerability**-
11. **Remarks** - efforts to repair is seen. Escape route is limited.

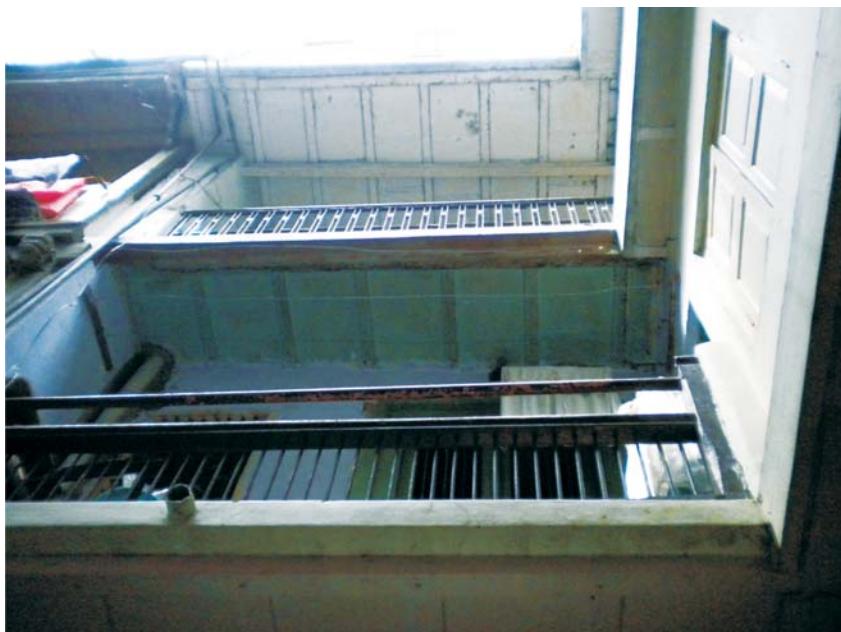
26

1. **Ownership** - Privately owned
2. **User Type**- Old (above 70) - 2
Children (below10)-2
Youth(20-45)-7
3. **Income source** - Business
4. **Change** - Additions
5. **New Material** - Steel section+kota stone
6. **Total floors**- GF+3
7. **Tanka System** - No -Tanka
8. **Any damage** - Earthquake damage
9. **Infrastructure** - Not Satisfied
10. **Vulnerability**- high.
11. **Remarks** - Khadki is highly densed. Access / escape route is very limited.

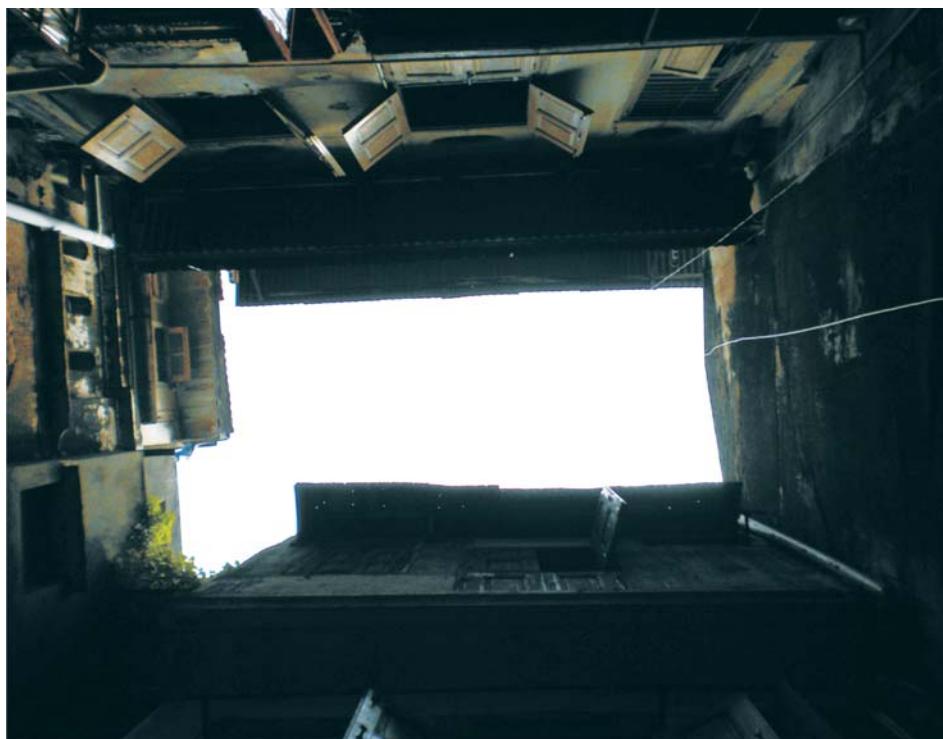
27

Survey no. - 841

1. **Ownership** - Privately owned
2. **User Type**- Old (above 70)-2
3. **Income source** - Job
4. **Change** - Additions (1985)
5. **New Material** - RCC + brick wall
6. **Total floors**- GF+2
7. **Tanka System** - Tanka (doesn't work)
8. **Any damage** - Earthquake damage
9. **Infrastructure** - Satisfied
10. **Vulnerability**-
11. **Remarks** - Poorly rebuilt without considering the traditional structural qualities.

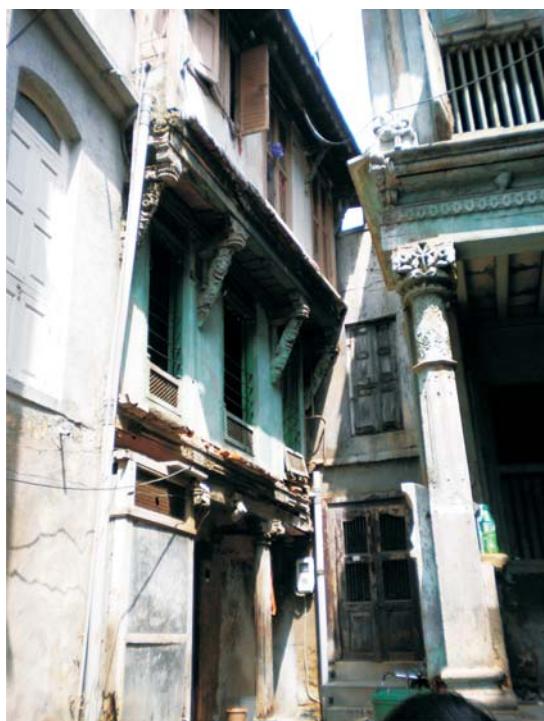
31

Survey no. - 845
Residence

1. **Ownership** - Privately owned
2. **User Type**- Old- 2
Youth (20-45)-3
3. **Income source** - Job
4. **Change** - Alterations
5. **New Material** - RCC + brick wall
6. **Total floors**- GF+2
7. **Tanka System** - No Tanka
8. **Any damage** - Earthquake damage
9. **Infrastructure** - Satisfied
10. **Vulnerability**- poor quality construction
11. **Remarks** - only the original wooden entrance door remains

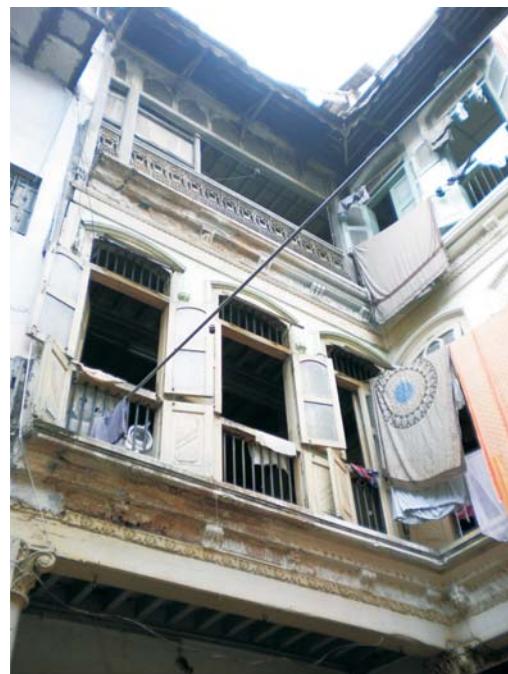
33

1. **Ownership** - Privately owned
2. **User Type-** Old (above 70)- 1
Children (below 10)-1
Youth (20-45)-4
3. **Income source** - Business
4. **Change** - No change
5. **New Material** -
6. **Total floors-** GF+2
7. **Tanka System** - Tanka works
8. **Any damage** - No damage
9. **Infrastructure** - Satisfied
10. **Vulnerability**-
11. **Remarks** - Vulnerable due to adjacent properties.

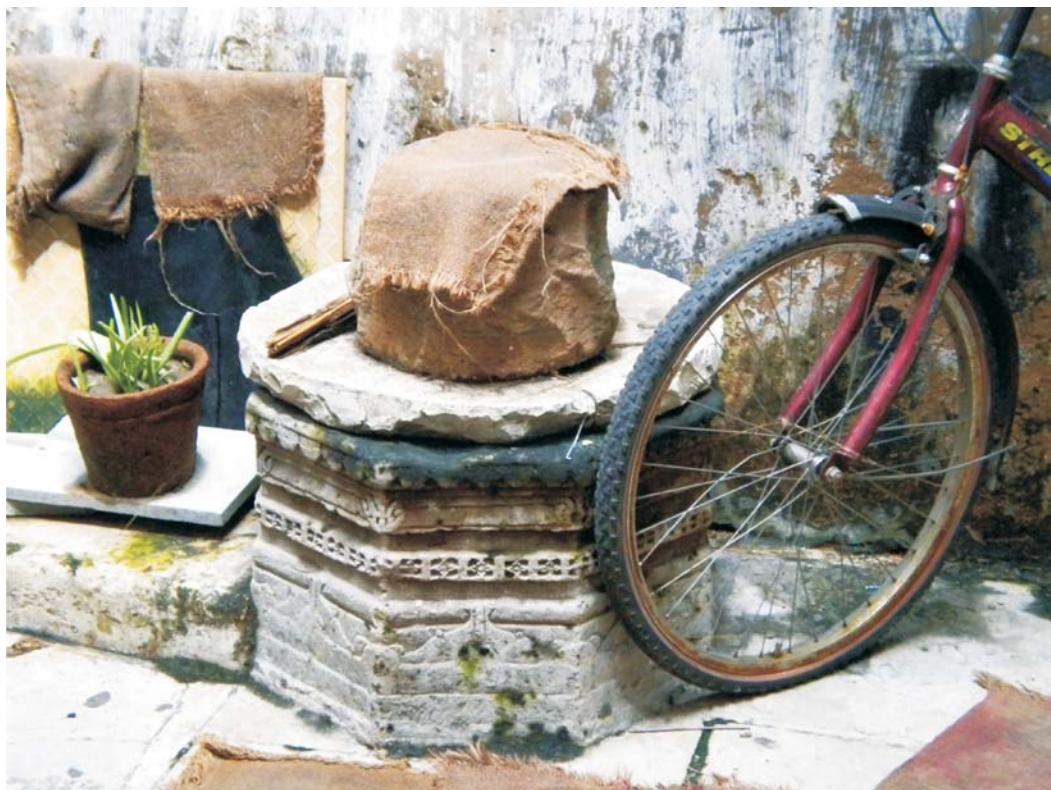
34

Survey no. - 850

Commercial

1. **Ownership** - Privately owned
2. **User Type-** Youth (20-45)-3
3. **Income source** - Business
4. **Change** - Alterations (2010)
5. **New Material** -
6. **Total floors**- GF+2
7. **Tanka System** - No Tanka
8. **Any damage** - Earthquake damage
9. **Infrastructure** - Satisfied
10. **Vulnerability**-
11. **Remarks** -

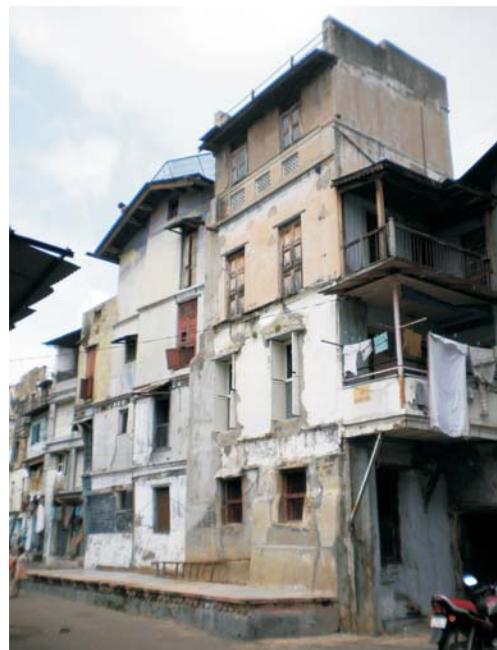
46

**Survey no. - 864A
Residence**

1. **Ownership** - Privately owned
2. **User Type**- Old (above70)- 1
Youth (20-45)-4
3. **Income source** -
4. **Change** - Alterations
5. **New Material** - RCC+brick wall
6. **Total floors**- GF+2
7. **Tanka System** - No Tanka
8. **Any damage** - Earthquake damage
9. **Infrastructure** - Not Satisfied
10. **Vulnerability**- High due to limited escape routes, which is through the courtyard and the narrow passage surrounded by 8 houses.
11. **Remarks** -

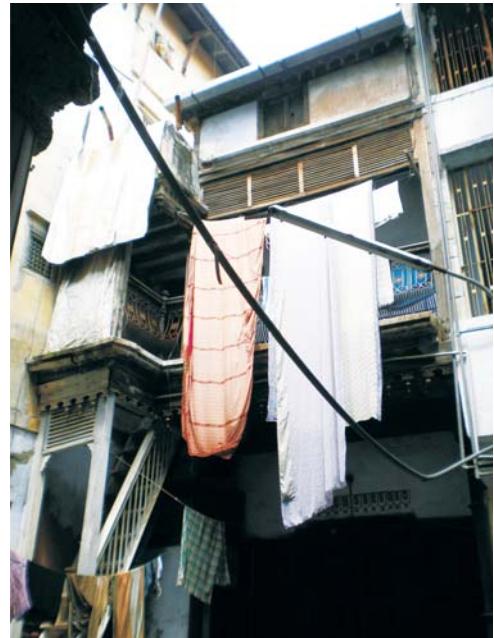
47

Survey no. - 864B

highly vulnerable and at risk due to inappropriate use and located at the rear end of khadki. Access is limited which is through the courtyard and passage surrounded by 8 houses.

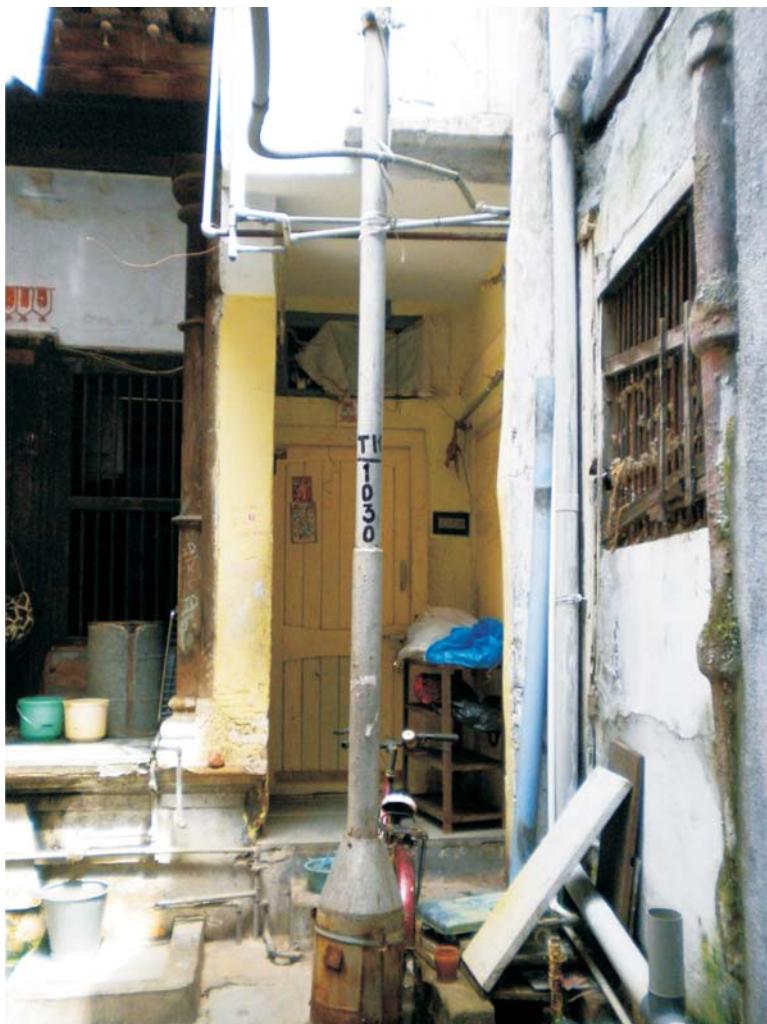
48

Survey no. - 865

1. **Ownership** - Privately owned
2. **User Type**- Children (below10)- 1
Youth (20-45)-3
3. **Income source** -
4. **Change** - Additions
5. **New Material** - RCC+brick wall
6. **Total floors**- GF+2
7. **Tanka System** - No Tanka
8. **Any damage** - No damage
9. **Infrastructure** - Not Satisfied
10. **Vulnerability**-
11. **Remarks** - Completely altered exterior. Room on the ground floor has roof with wooden joists and beam-.

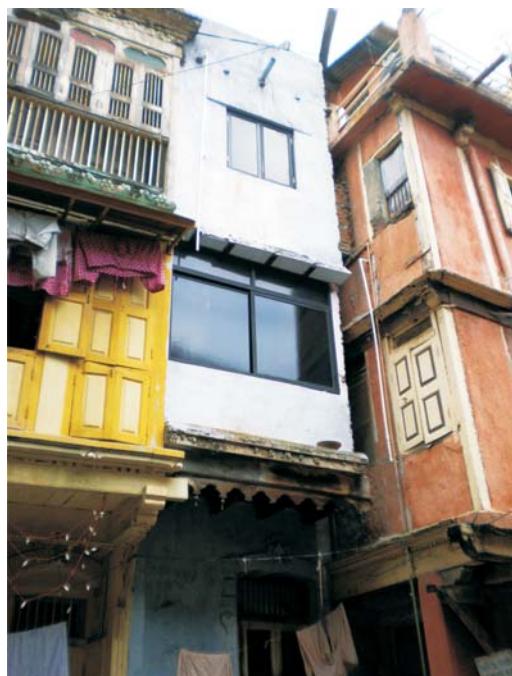
49

Survey no. - 866

1. **Ownership** - Privately owned
2. **User Type-** Youth (20-45)-4
3. **Income source** - Job
4. **Change** - No change
5. **New Material** -
6. **Total floors**- GF+2
7. **Tanka System** - No Tanka
8. **Any damage** - No damage
9. **Infrastructure** - Satisfied
10. **Vulnerability**-
11. **Remarks** - Original structure.

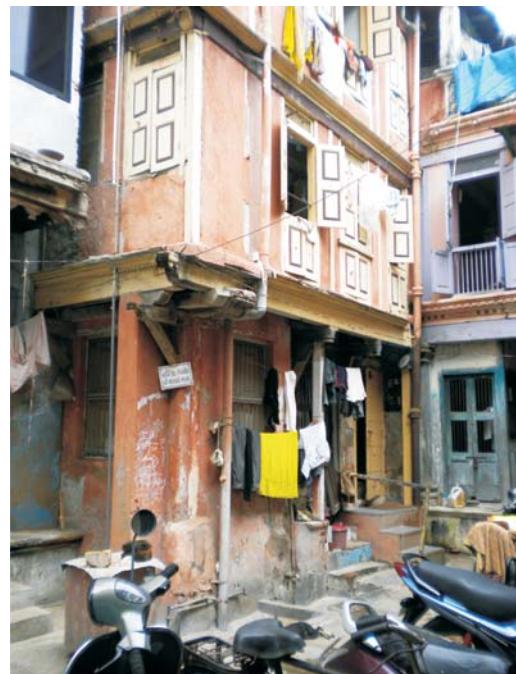
53

Survey no. - 870 & 871 Residence

1. **Ownership** - Privately owned
2. **User Type-** Old (above 70)-1
Children (below10)-1
Youth (20-45)-2
3. **Income source** - Job
4. **Change** - No change
5. **New Material** -
6. **Total floors-** GF+1
7. **Tanka System** - No Tanka
8. **Any damage** - Earthquake damage
9. **Infrastructure** - Not Satisfied
10. **Vulnerability**-
10. **Remarks** - Lack of maintenance

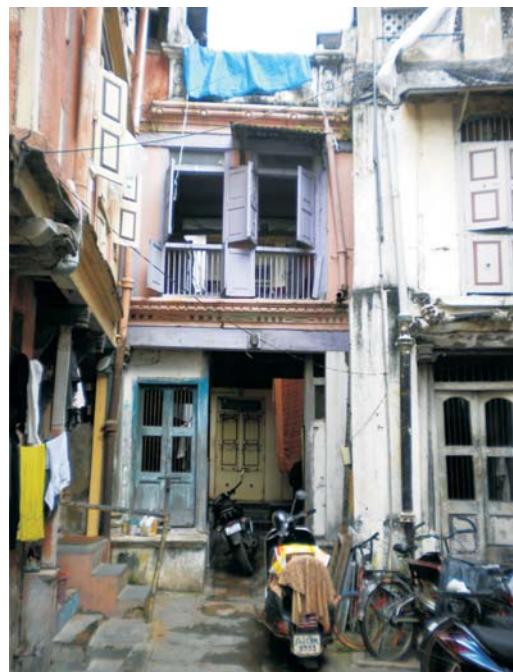
54

Survey no. - 872
Residence

1. **Ownership** - Private Owned
2. **User Type**- Children (below10)-1
Youth (20-45)-4
3. **Income source** - Job
4. **Change** - Additions
5. **New Material** - Steel section+kota stone
6. **Total floors**- GF+2
7. **Tanka System** - No Tanka
8. **Any damage** - Earthquake damage
9. **Infrastructure** - Satisfied
10. **Vulnerability**- high
11. **Remarks** - Completely altered and limited access

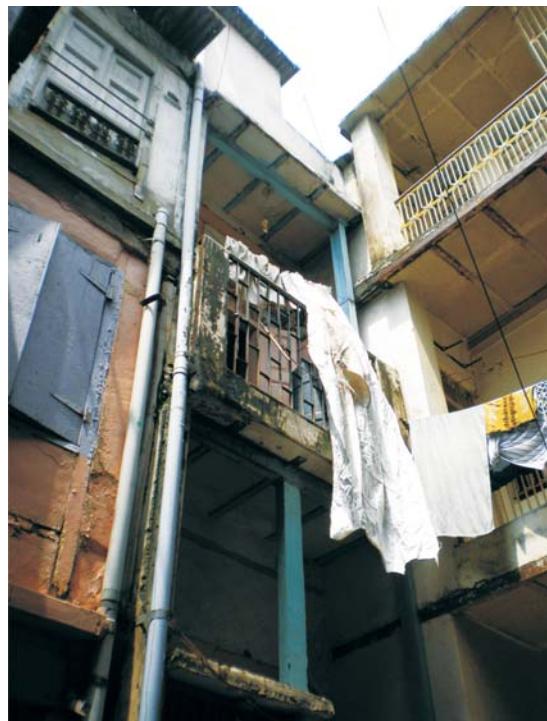
55

Survey no. - 873

1. **Ownership** - Privately owned
2. **User Type-** Old (above 70)-2
Children (below10)-2
Youth (20-45)-2
3. **Income source** - Job
4. **Change** - Additions
5. **New Material** - Steel section+kota stone
6. **Total floors-** GF+2
7. **Tanka System** - No Tanka
8. **Any damage** - Earthquake damage
9. **Infrastructure** - Not Satisfied
10. **Vulnerability**- High
11. **Remarks** - Completely rebuilt. poor quality construction and limited access

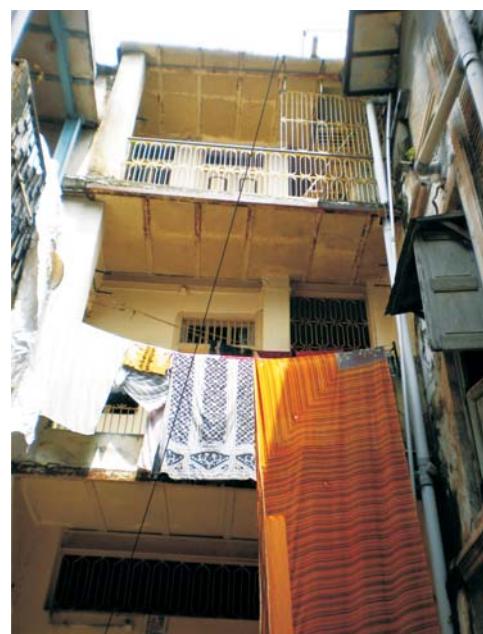
56

Survey no. - 874, 875 & 876A Residence

1. **Ownership** - Privately owned
2. **User Type**- Old (above 70)-2
Children (below10)-2
Youth (20-45)-4
3. **Income source** - Business
4. **Change** - No change
5. **New Material** -
6. **Total floors**- GF+2
7. **Tanka System** - No Tanka
8. **Any damage** - Earthquake damage
9. **Infrastructure** - Satisfied
10. **Vulnerability**- Very high
11. **Remarks** - limited access

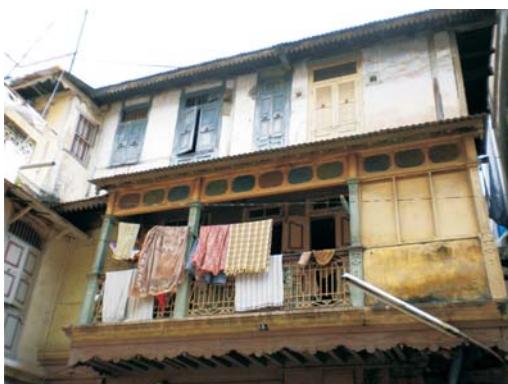
60

**Survey no. - 880 A, B, C & D
Residence**

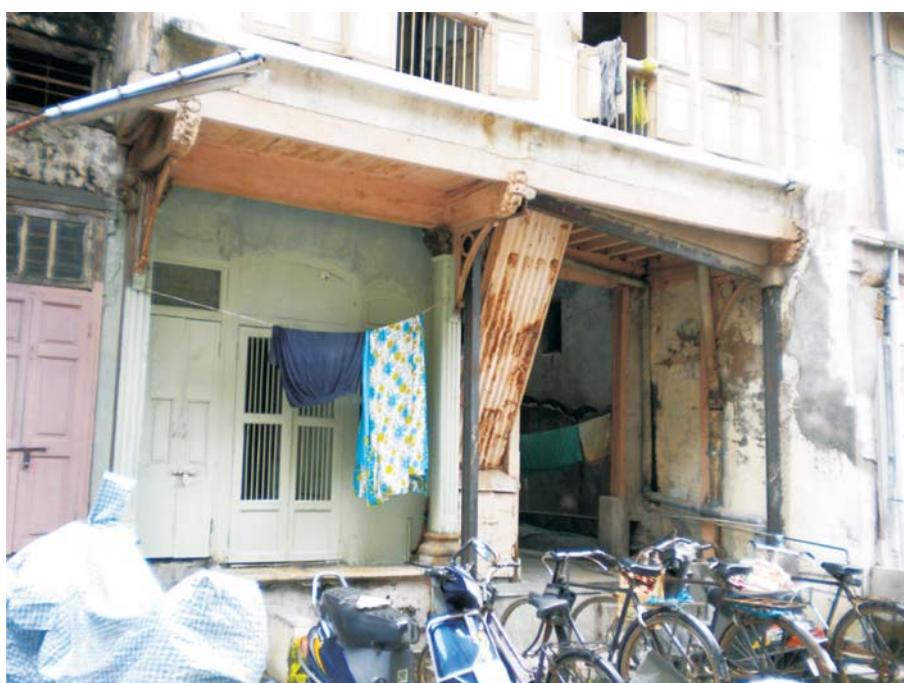
62A

**Survey no. - 882 (Second Floor)
Residence**

1. **Ownership** - Privately rented
 2. **User Type**- Youth (20-45)- 6
 3. **Income source** -
 4. **Change** - No Change
 5. **New Material** -
 6. **Total floors**-
 7. **Tanka System** - No Tanka
 8. **Any damage** - No damage
 9. **Infrastructure** - Satisfied
 10. **Vulnerability**-
 11. **Remarks** - House subdivided
-

**Survey no. - 882 (Third Floor)
Residence**

1. **Ownership** - Privately rented
2. **User Type-** Children (below10)-1
Youth (20-45)-2
3. **Income source** - Job
4. **Change** - No Change
5. **New Material** -
6. **Total floors**-
7. **Tanka System** - No Tanka
8. **Any damage** - No damage
9. **Infrastructure** - Satisfied
10. **Vulnerability**-
11. **Remarks** - House subdivided

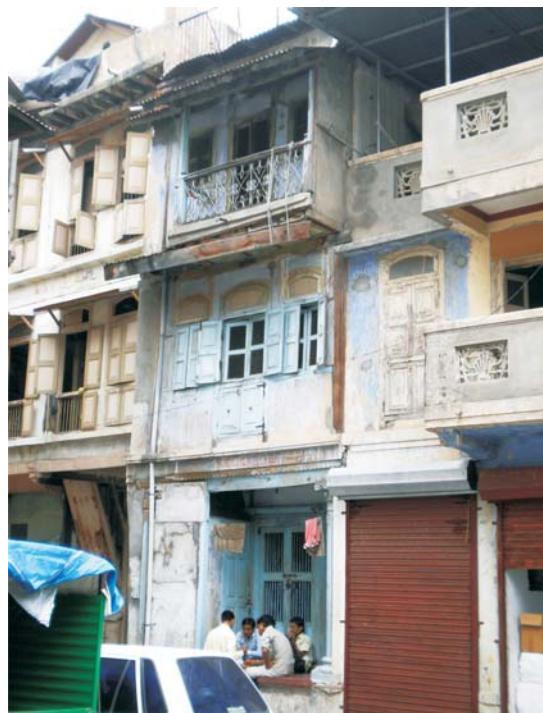
63

Survey no. - 883
Residence

1. **Ownership** - Privately rented
2. **User Type**- Youth (20-45)- 6
3. **Income source** -
4. **Change** - No Change
5. **New Material** -
6. **Total floors**-
7. **Tanka System** - No Tanka
8. **Any damage** - No damage
9. **Infrastructure** - Satisfied
10. **Vulnerability**-
11. **Remarks** - House subdivided
