# FIBER OPTIC SPLICE ENGINEERING SHEET

Zava Telecom -- Network Engineering Division

DOC-FSE-2026-04-28-0041

| Field | Value | Field | Value |
|---|---|---|---|
| Project | Tower Ridge Rehab | Engineer | K. Nakamura, PE |

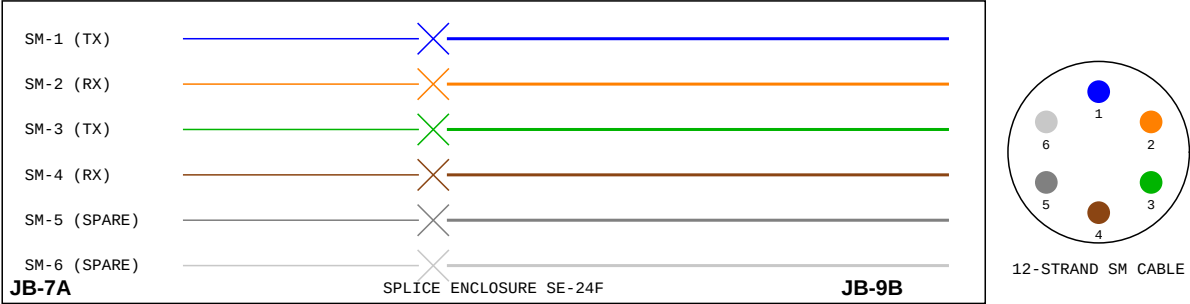
## FIBER ROUTING DIAGRAM -- SPLICE DETAIL

\* Elevated attenuation. Strands 5, 7, 11 showing stress-induced loss. See condition report CR-2026-04-10.

FIELD NOTE (P. Sharma, 04/28):  
Strand 11 re-spliced but loss unchanged.  
Micro-bend at TV-3 (confirmed VID-05, AUD-04-15).  
DO NOT re-splice. Conduit is root cause.  
Full conduit replacement required first.

Loss trend (SM-11): 0.42 dB/km (Jan) -> 0.47 (Feb) -> 0.55 (Apr 28)  
Progressive degradation confirms mechanical cause (not fusion quality).

CRITICAL FINDING: Route 2 shares conduit with Route 1 in Sections 3-5.  
Total customer exposure: 34 (Rt1) + 8 (Rt2) = 42 with NO redundancy.  
Conduit installed 2019 (pre-ZNS-2021-RED-004 redundancy standard).

RECOMMENDATION: Aerial bypass for Route 2 BEFORE conduit replacement.  
See FRD-2026-04-28 for routing analysis and reroute options.  
Materials ordered: PO-2026-0391 (Webb, 05/03). Budget: BUD-2026-TR-009.
