# SITE INSPECTION -- PHOTO DOCUMENTATION

Zava Telecom -- Field Operations

DOC-PHOTO-2026-05-02-TR9

Inspector: J. Alvarez | Date: 2026-05-02 | Site B, Segment 9

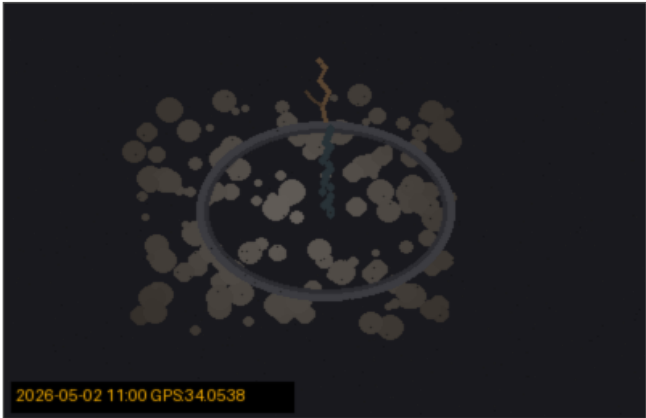
**PHOTO 1: Vault TV-3 Interior**  
Conduit crack visible at 12 o'clock.  
Water intrusion. Ref: FSE-2026-0041 SM-11.

*PRIORITY: Photos 1,2,4 critical -- 42 customers at risk (Rt1+Rt2 shared conduit Sec 3-5).*

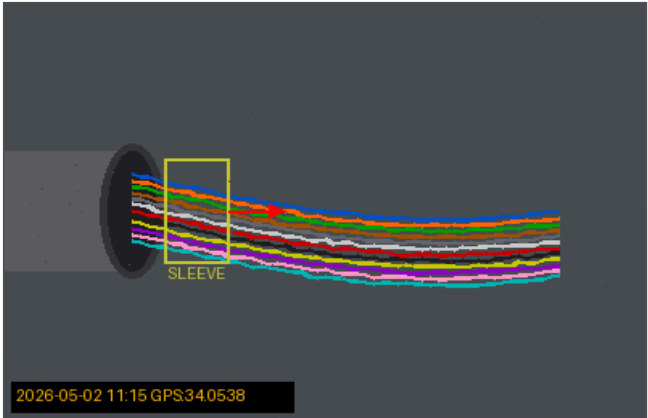
**PHOTO 2: Cable Stress Point**  
Micro-bend at conduit entry.  
Sleeve displaced 8cm. Micro-bend source.

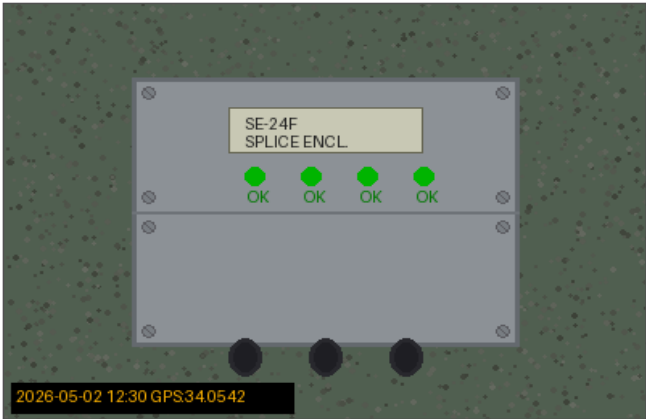
**PHOTO 3: Splice Enclosure**  
SE-24F housing intact.  
No moisture detected.

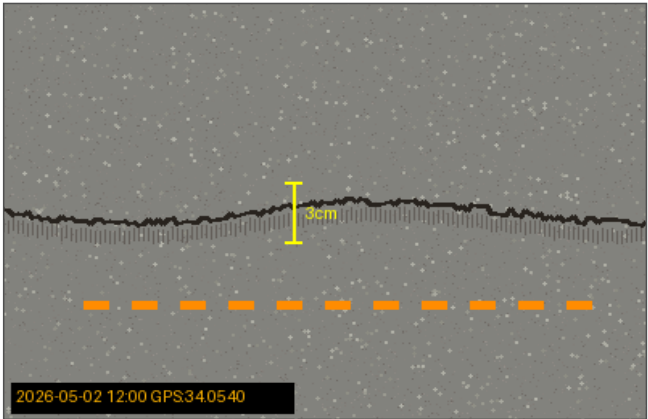
**PHOTO 4: Surface Damage**  
Pavement heave above conduit.  
3cm offset. Shared conduit (Rt1+Rt2).

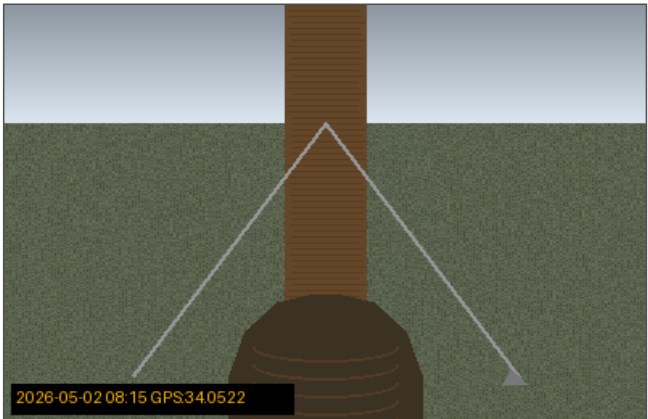
**PHOTO 6: Pole TR-38 Base**  
Ground erosion at base.  
Guy wire tension OK.
