# Daily Environmental & Cleanliness Incident Report: Camera 8

Project: Swachhta Prahari

Date of Report: September 8, 2025

Site: UPSIDA-Managed Sahibabad Industrial Site 4

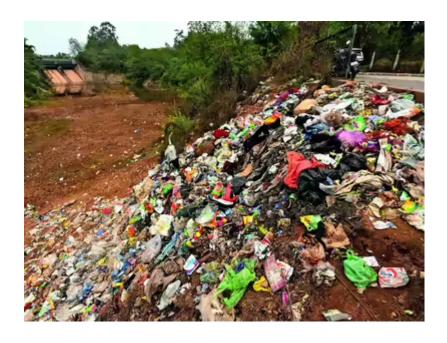
This report is an automated, camera-specific summary generated by the "Swachhta Prahari" Al surveillance system. It details all significant incidents detected by Camera 8 over the past 24 hours. The system uses the existing CCTV infrastructure to proactively monitor and identify environmental hazards in its field of view. During this period, the system flagged instances of waste spillage onto the road from the open dump site at around 5pm. Continuous monitoring of the waste level at this location indicates the Cleanliness is not proper as dumping sites weren't cleaned

INCIDENT ID	TIMESTAMP	CAMERA ID	EVENT TYPE	DETAILS	SEVERITY
SPILL- 0906-002	17:02:45	CAM-08	Waste Spillage	Waste from the open dump site has spilled onto the road, crossing the designated red-line boundary.	Medium
DUMP- 0906-001	06:00:45	CAM-08	Open Dump Site Monitoring	The waste level at this location indicates the cleanliness is not proper. Requires scheduling for clearance.	High

- The waste spillage event indicates that the open dump site is at capacity and poses a direct cleanliness risk.
- Continuous monitoring of the waste level at this location indicates the
  Cleanliness is not proper as dumping sites weren't cleaned

- 1. Immediate Action: Dispatch a cleanup crew to address the waste spillage on the road in the vicinity of Camera 8
- 2. Operational Planning: Schedule immediate clearance for the open dumping area monitored by Camera 8 to mitigate further spillage and address the high fill level.
- 3. Preventative Measure: The early morning dumping incident reinforces the need for installing cautionary signage in this specific area to deter future violations.
