Daily Environmental & Cleanliness Incident Report: Camera 8

Project: Swachhta Prahari

Date of Report: September 8, 2025

Site: UPSIDA-Managed Sahibabad Industrial Site 4

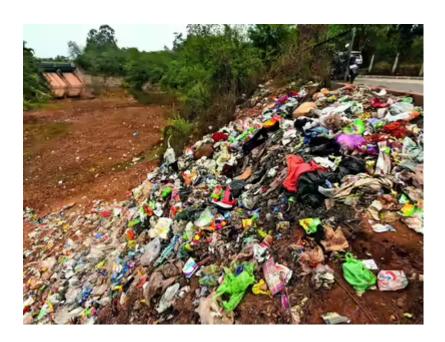
This report is an automated, camera-specific summary generated by the "Swachhta Prahari" Al surveillance system. It details all significant incidents detected by Camera 8 over the past 24 hours. The system uses the existing CCTV infrastructure to proactively monitor and identify environmental hazards in its field of view. During this period, the system flagged instances of waste spillage onto the road from the open dump site at

around 5pm. Continuous monitoring of the waste level at this location indicates the Cleanliness is not proper as dumping sites weren't cleaned

INCIDENT ID	TIMESTAMP	CAMERA ID	EVENT TYPE	DETAILS	SEVERITY
SPILL- 0906-002	17:02:45	CAM-08	Waste Spillage	Waste from the open dump site has spilled onto the road, crossing the designated red-line boundary.	Medium
DUMP- 0906-001	06:00:45	CAM-08	Open Dump Site Monitoring	The waste level at this location indicates the cleanliness is not proper. Requires scheduling for clearance.	High

- The waste spillage event indicates that the open dump site is at capacity and poses a direct cleanliness risk.
- Continuous monitoring of the waste level at this location indicates the
 Cleanliness is not proper as dumping sites weren't cleaned

1. Immediate Action: Dispatch a cleanup crew to address the waste spillage on the road in the vicinity of Camera 8

- 2. Operational Planning: Schedule immediate clearance for the open dumping area monitored by Camera 8 to mitigate further spillage and address the high fill level.
- 3. Preventative Measure: The early morning dumping incident reinforces the need for installing cautionary signage in this specific area to deter future violations.
