# Daily Environmental & Cleanliness Incident Report: Camera 8

**Project:** Swachhta Prahari

Date of Report: September 8, 2025

Site: UPSIDA-Managed Sahibabad Industrial Site 4

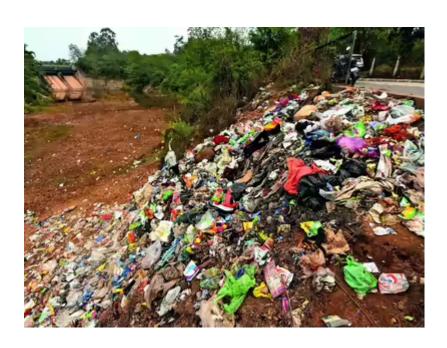
around 5pm. Continuous monitoring of the waste level at this location indicates the Cleanliness is not proper as dumping sites weren't cleaned

INCIDENT ID	TIMESTAMP	CAMERA ID	EVENT TYPE	DETAILS	SEVERITY
SPILL- 0906-002	17:02:45	CAM-08	Waste Spillage	Waste from the open dump site has spilled onto the road, crossing the designated red-line boundary.	Medium
DUMP- 0906-001	06:00:45	CAM-08	Open Dump Site Monitoring	The waste level at this location indicates the cleanliness is not proper. Requires scheduling for clearance.	High

- The waste spillage event indicates that the open dump site is at capacity and poses a direct cleanliness risk.
- Continuous monitoring of the waste level at this location indicates the
  Cleanliness is not proper as dumping sites weren't cleaned

1. Immediate Action: Dispatch a cleanup crew to address the waste spillage on the road in the vicinity of Camera 8

- 2. Operational Planning: Schedule immediate clearance for the open dumping area monitored by Camera 8 to mitigate further spillage and address the high fill level.
- 3. Preventative Measure: The early morning dumping incident reinforces the need for installing cautionary signage in this specific area to deter future violations.
