# UAS Tracking Document

September 2021

The purpose of this document is to help record changes made to the OpenUAS so that the design can be traced back and optimized as needed.

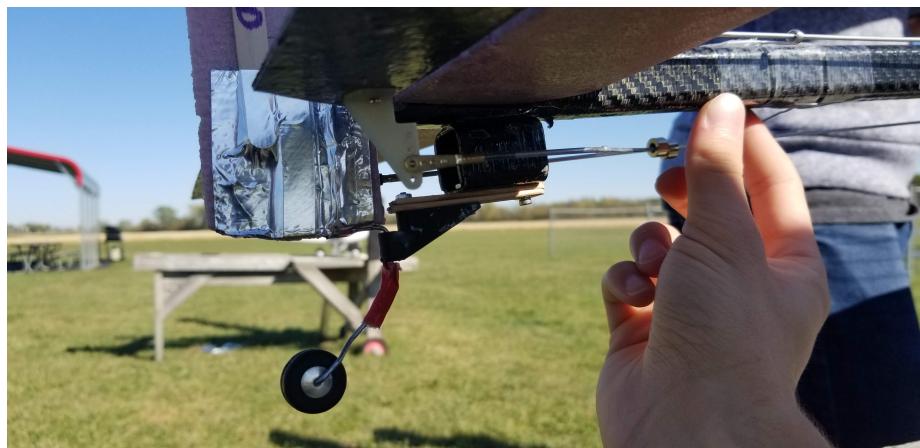
Figure 6: UAS 1.4 Tailwheel Mounting

The mounting of the tail wheel was changed to try and make sure it does not break off like it did after the flight test for UAS 1.3. The figure below shows how the wheel was specifically attached:

1. Mounted tail wheel to tail boom
2. Added a thin strip of wood to the rudder

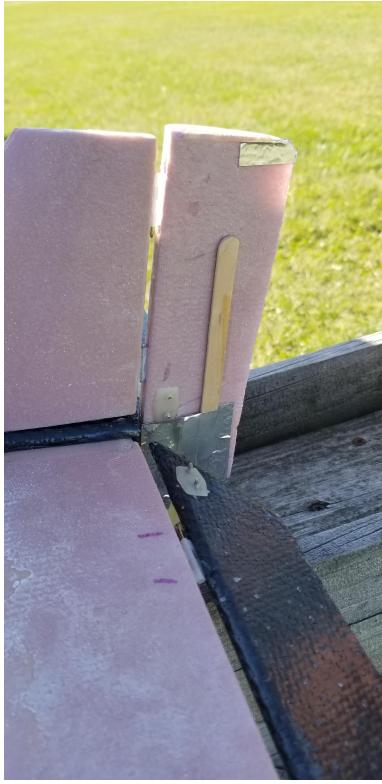
Figure 7: UAS 1.4 Rudder Stiffener

The thin strip of wood was added to the rudder in order to stiffen the foam so that it does not break as happened in the UAS 1.3 test flight. The construction of this stiffener is shown below:

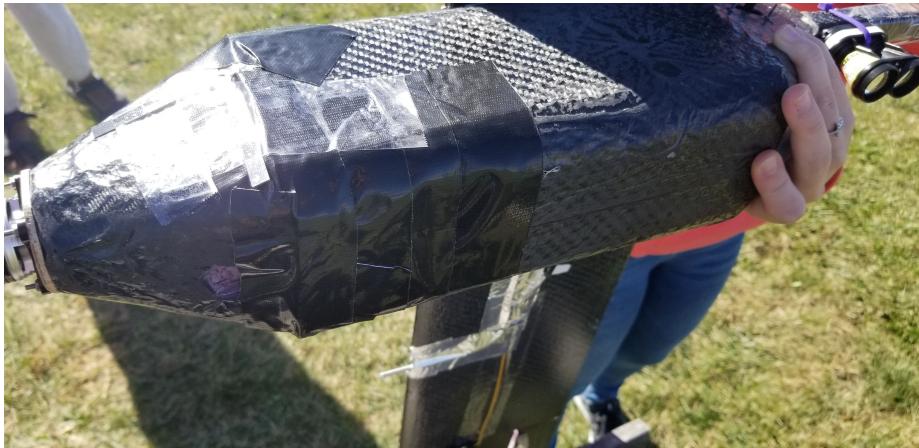
Figure 8: UAS 1.4 Fuselage Repairs

In this test, we wanted to confirm the left yawing that we saw in the previous test. Because the landing gear broke off on impact of the previous test, the craft was repaired as best possible in the field and an autonomous hand launch was used. The repairs done are shown in the figure below.

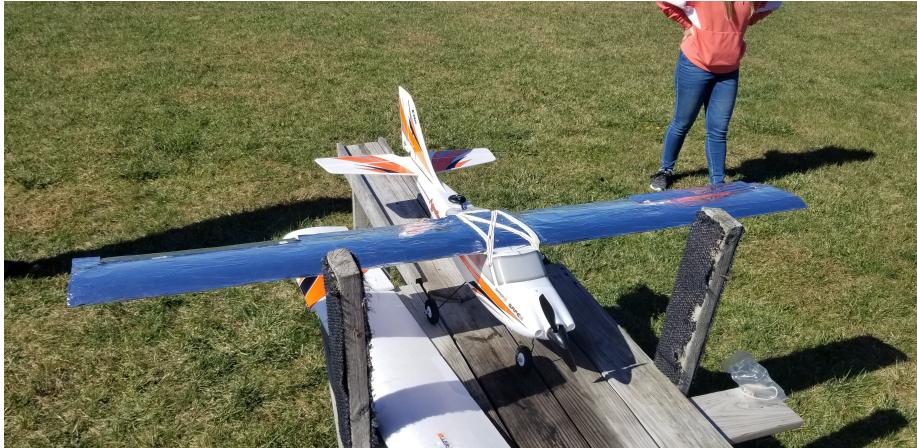
Figure 9: E-Flight Apprentice with Monokote Wing attached

In this test, the monokote wing with carbon fiber stiffener rods was tested. Since the OpenUAS was broken beyond repair after the previous test, the wing was attached to the Apprentice fuselage as shown below:

The purpose of this test was to check if adding the stiffener rods and the monokote helps to prevent flexing and failure of the mainly foam wing. This test did a manual runway takeoff and then tested the responses of the Apprentice when flying, the flexing of the wing during rapid elevator deflections, and stall characteristics of the wing.
