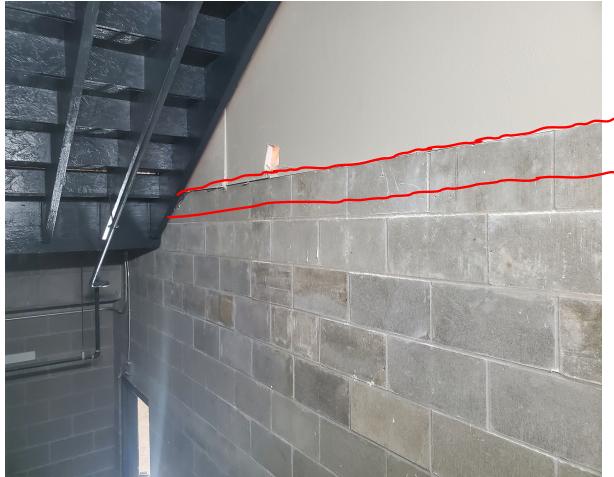
- At all stairs: suggest adding painted 1x6 trim to 'hide' misalignment of drywall and CMU.

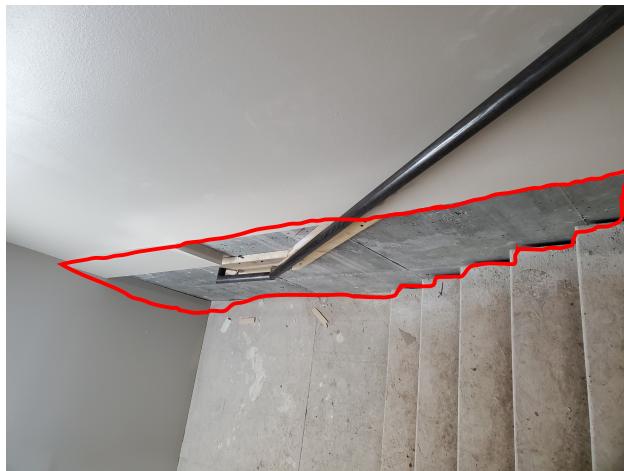
- Fill in with drywall to make less chunky and hodgepodge.

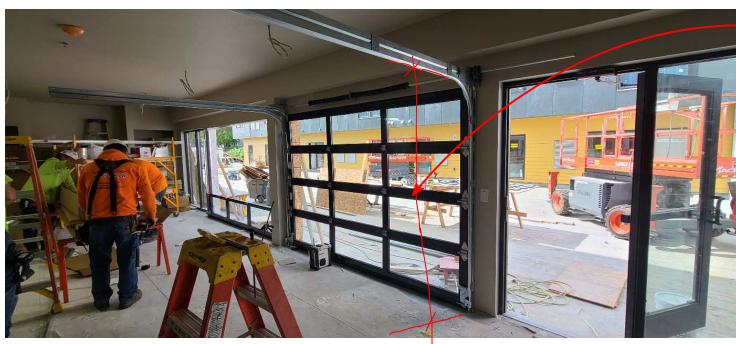
- Inspector might flag this. Codewise, this dimension has to be at least 7'-6".

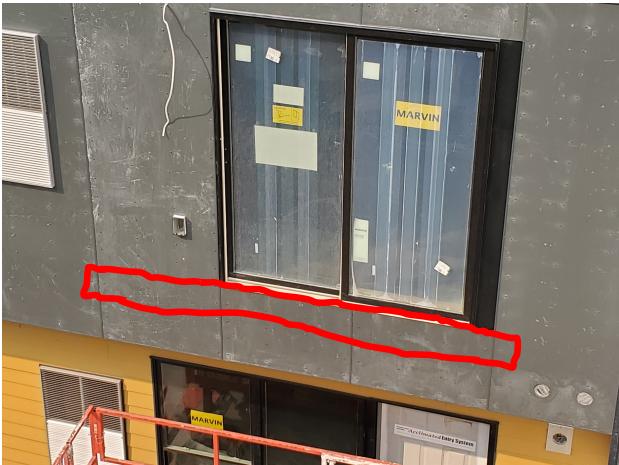
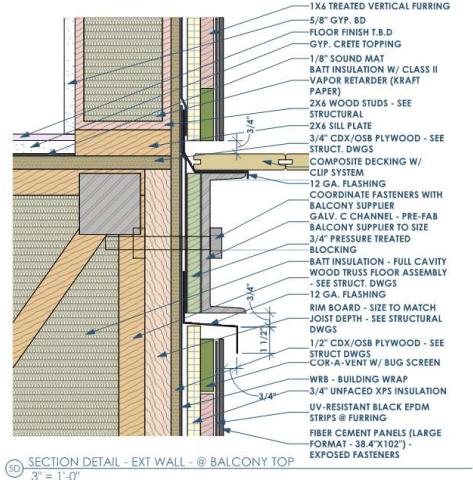
- Concerned that if the ledger of the balcony is lagged tightly against the fiber cement, that the fiber cement will crack. Recommend providing a detail like 5D/A501 to assure horizontal loads from the balcony bypass the fiber cement and rigid insulation.

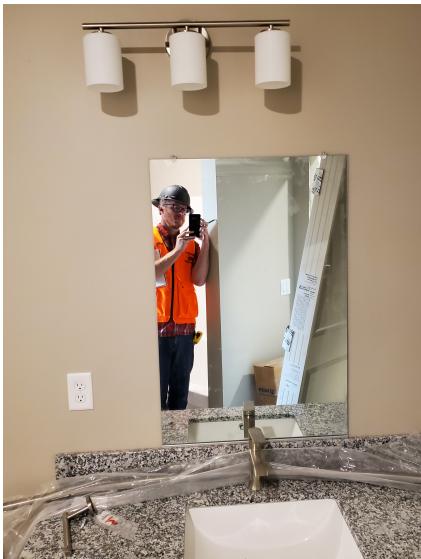
Recommend centering the light fixture on the vanity and mirror. Occurs in multiple rooms.

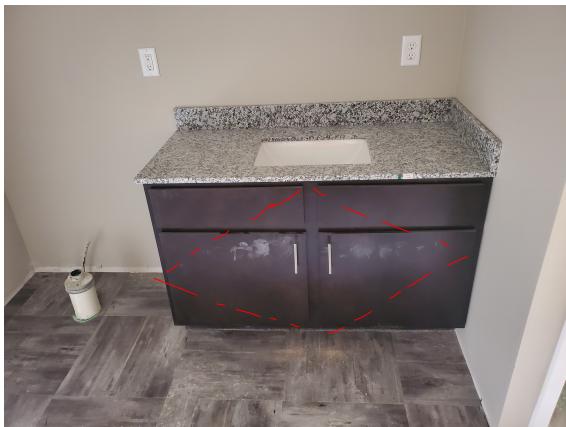
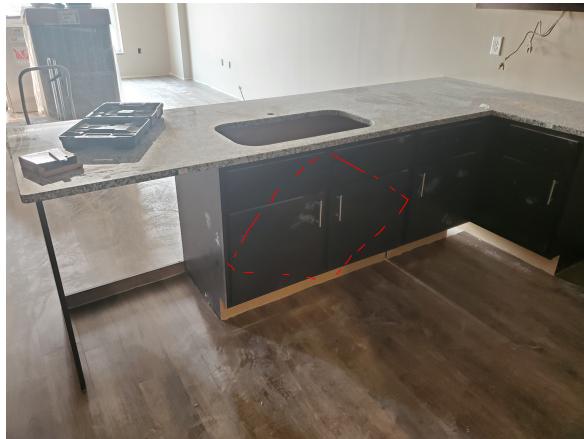
- In Room 208 (a Type A unit), the cabinets below both the kitchen sink and vanity sink need to be removeable per detail 6D and 5D/A480
- The kitchen in room 208 needs a work area with a min. clearances as outlined in 6D and 5D/A480

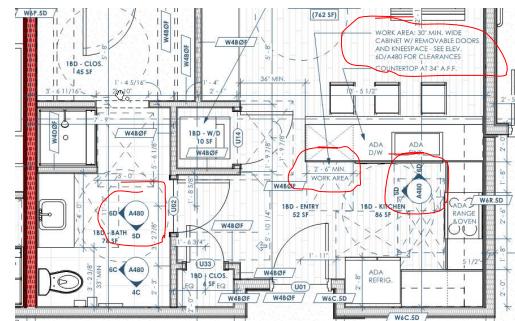
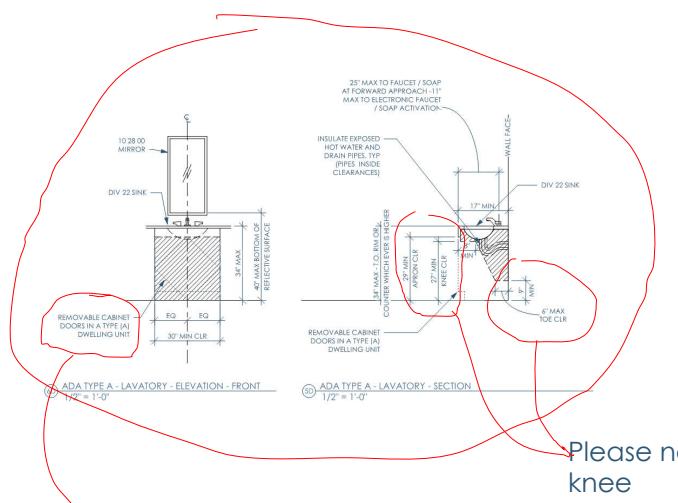
Please note  
knee  
clearances

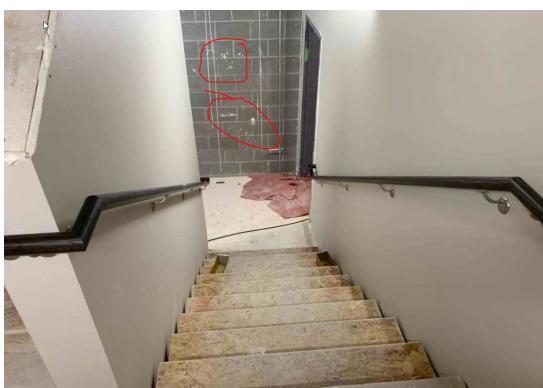
- Clean all paint/drywall from exposed CMU at all stairs and elevator
