The Current: Site Report: 07.24.2020

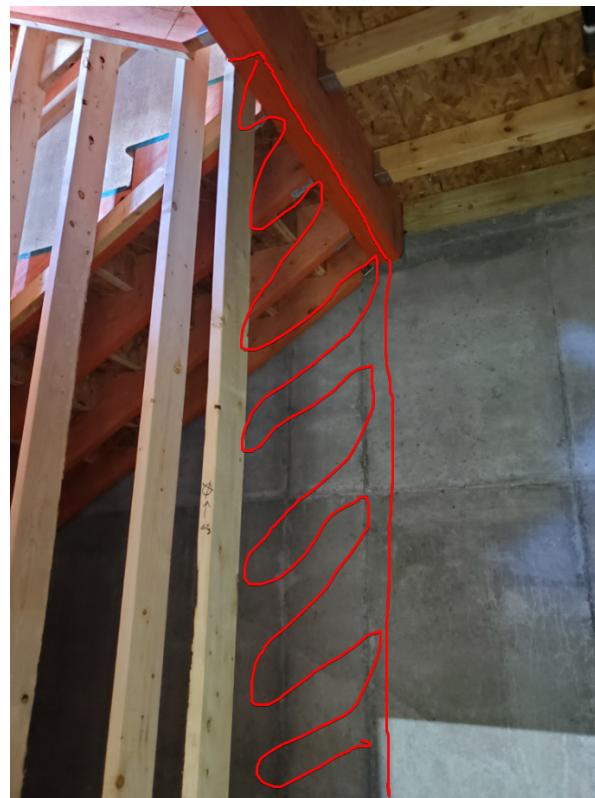
- Holddowns at the 2nd and 3rd floors, for both the east and west stair need to be installed.
- The inspector, will most likely require that this 'dead space' under the stairs be closed off with drywall. Will most likely require a sprinkler as well. Confirm with Fire Protection engineer.

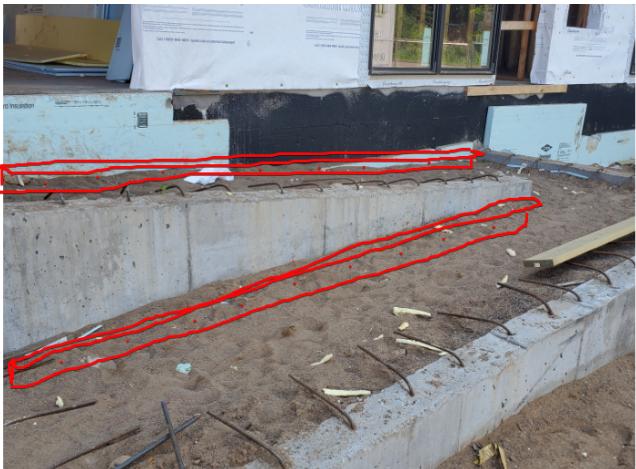
- Bear concrete slab on 3"x3"x1/4" galv angle attached with 5/8"x5" galv. anchor bolts at 24" o.c."

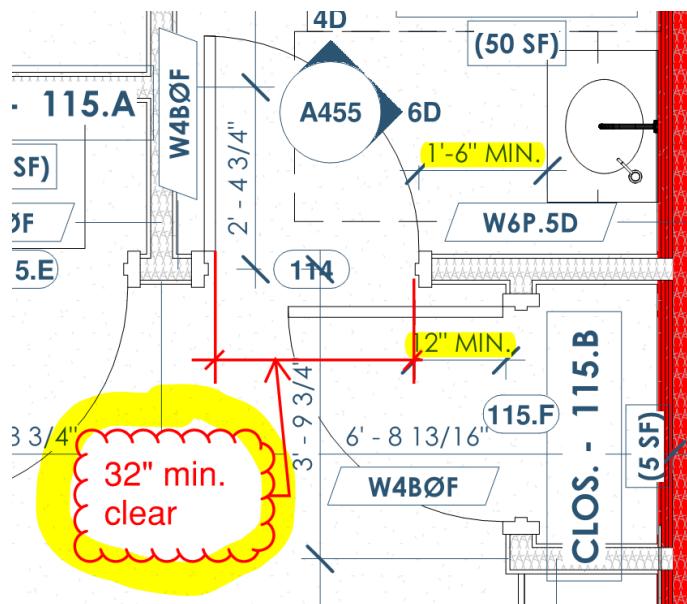
- Assure the following clearances at Restroom 114

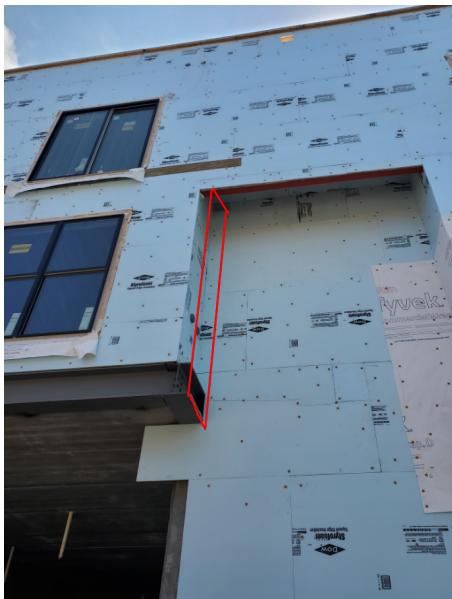
- Furr out wall to hide steel on the north elevation

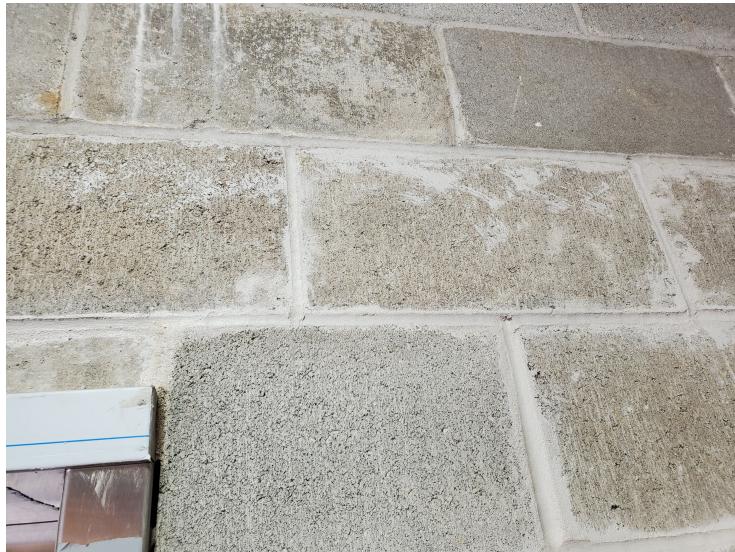
- Clean all the exposed CMU with wire brush to remove smears of surface mortar.

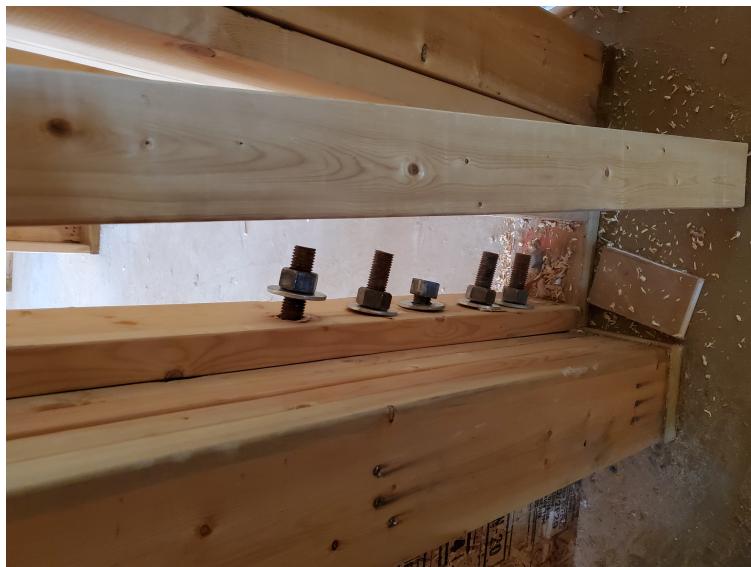
- tighten bolts at all hold downs

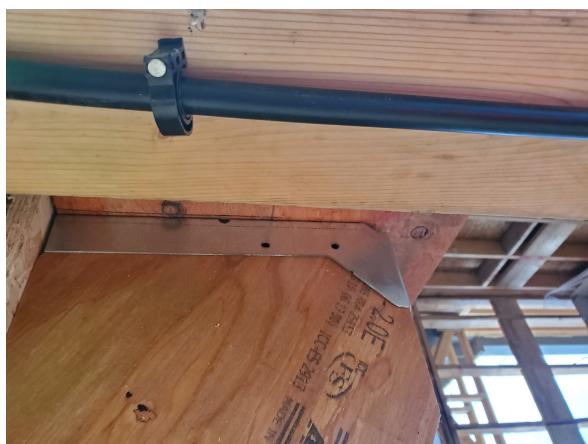
- Missing fasteners at a few hanger locations throughout the various stair well stringers.

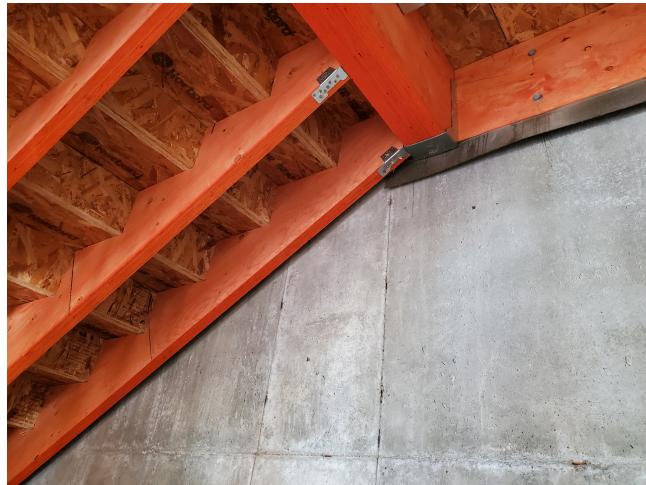
- Please take care to cover exposed concrete and/or CMU from over spray of stair paint.

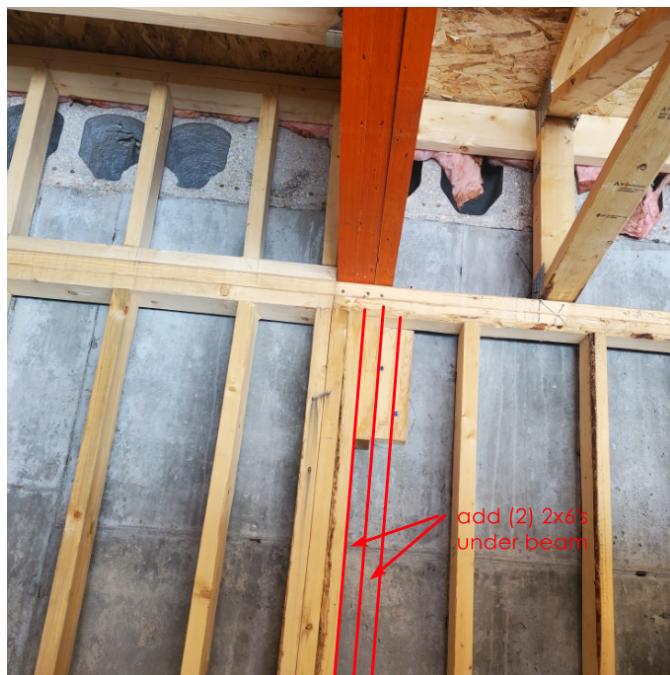
- Add additional sistered studs at column near LVL at elevator on 1st floor

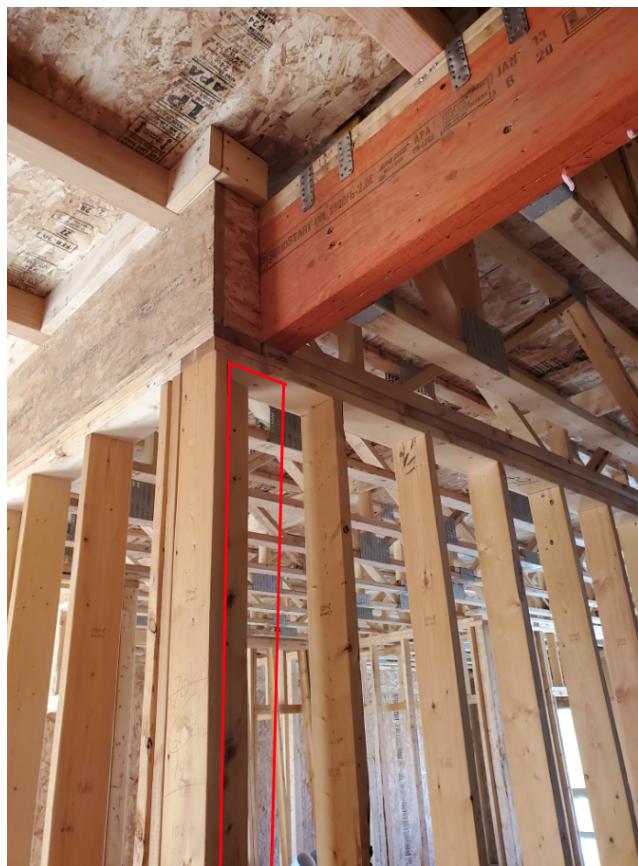
- Add (2) additional 2x10 at the following corner (near elevator) at both the 2nd and 3rd floors to transfer load down to 2nd floor steel beam

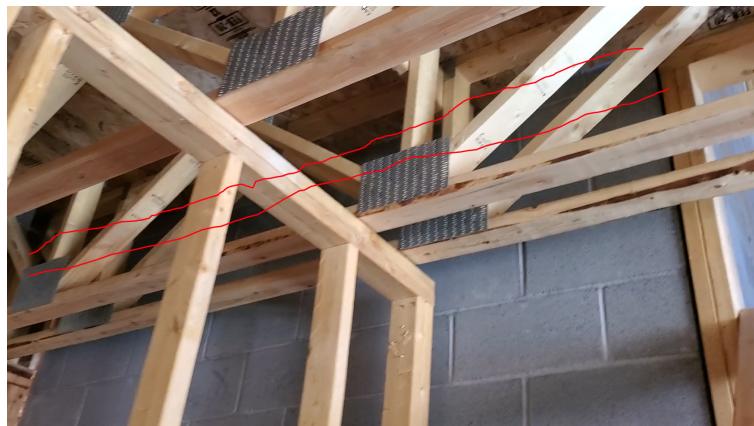
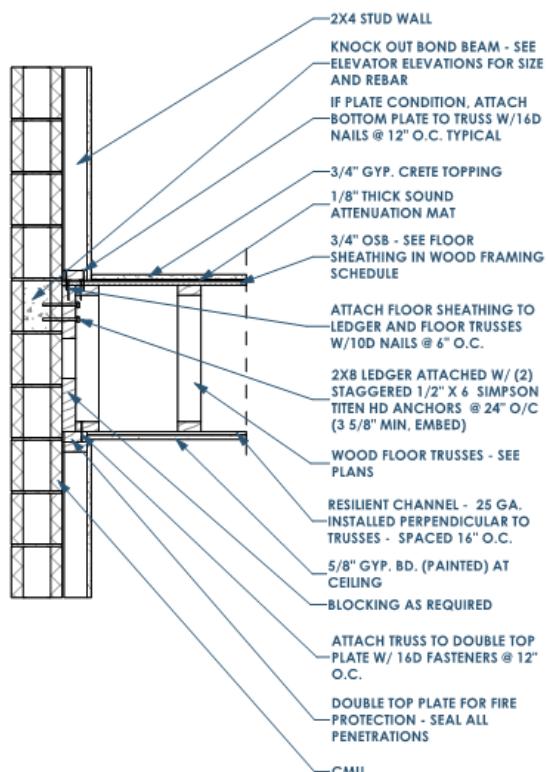
6
S211

- Add 2x ledger at elevator CMU to support floor sheathing
