## Report of Findings

**Belle Realty of Lafayette  
Claim No: 23595506**

**RCG File No: 100018452**

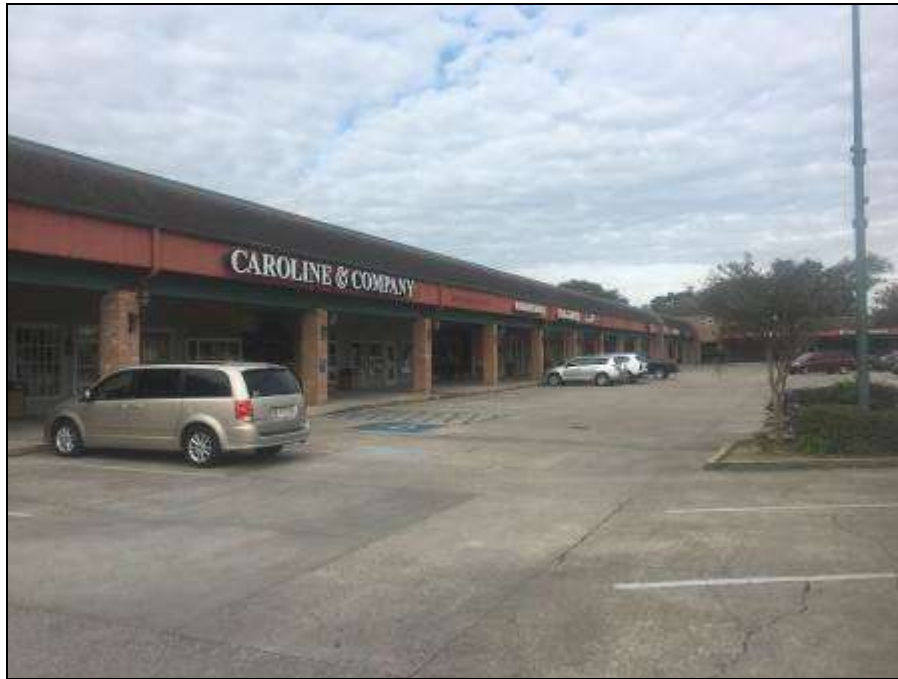
**Photograph 1**

View of the east (front) elevation of the Belle Realty of Lafayette building.

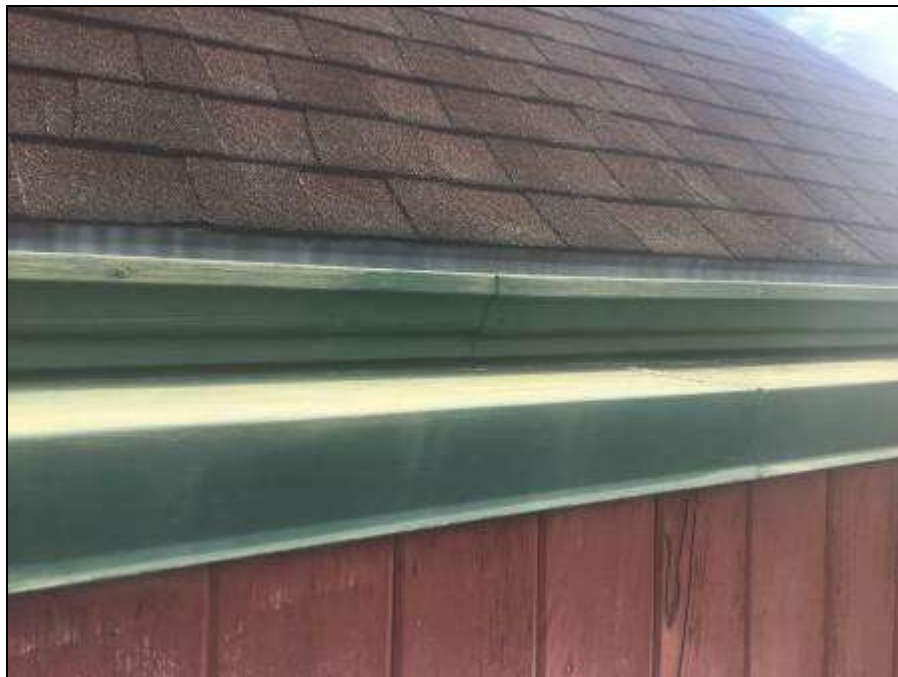
**Photograph 2**

View of a light-gauge metal gutter on the east side of the building. Notice no spatter marks or indentations in the gutter.

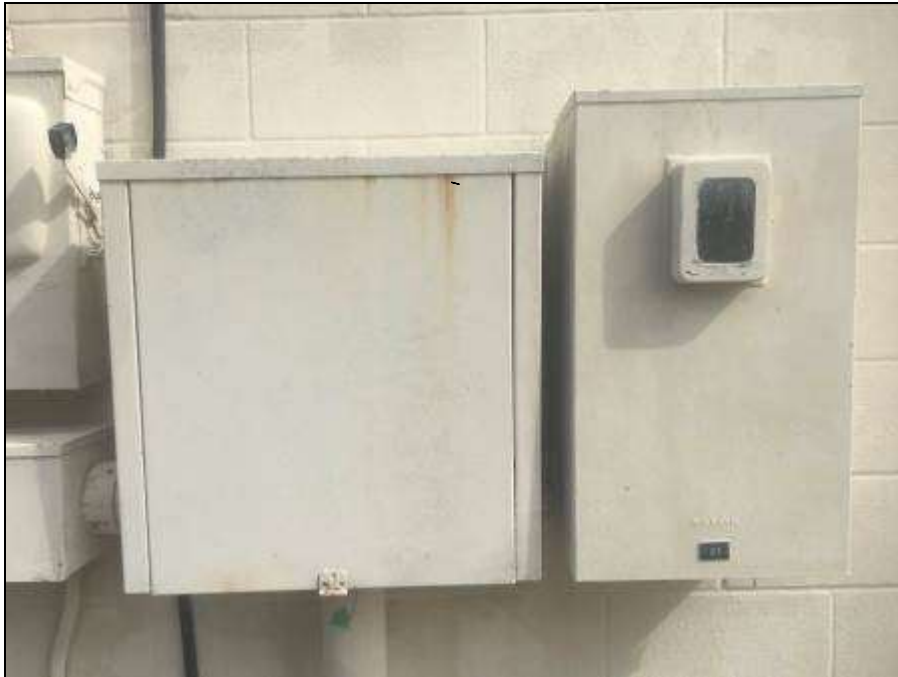
**Photograph 3**

View of an electrical panel on the west side of the building. Notice no spatter marks or indentations on the surface of the electrical panel.

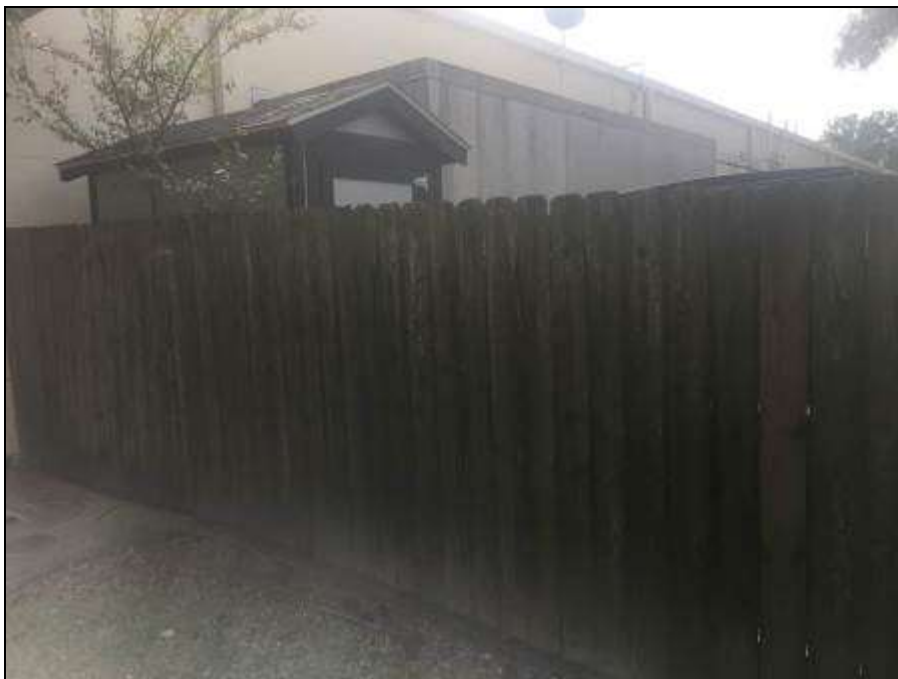
**Photograph 4**

- There were no spatter marks or small rounded areas of displaced wood fibers on the wood siding on the various sides of the building.
- There were no broken glass panes in any of the windows on the various sides of the building.
- There were no indentations in the light-gauge metal gutters and downspouts on the various sides of the building (**Photograph 2**).
- There were no spatter marks or indentations on the heavy-gauge electrical boxes, which were located on the west side of the building (**Photograph 3**).
- There were no spatter marks or small rounded areas of displaced wood fibers on the wood fencing at the site (**Photograph 4**).

View of a section of wood fencing, which faced toward the north, on the west side of the building. Notice no small rounded areas of displaced wood fibers on the fencing.

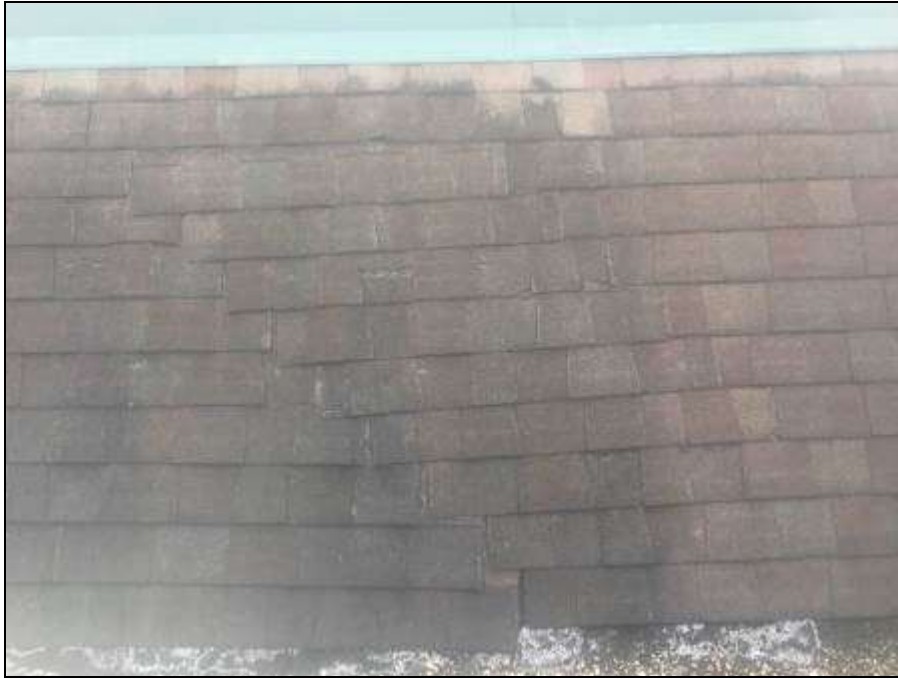
**Photograph 5**

- There were four roof slopes that faced toward the north.
- There were no missing or torn three-tab asphalt-composition shingles on the surfaces of these roof slopes.
- There were slipped shingle tabs on one of these roof slopes (**Photograph 5**).
- There was evidence, mastic, of prior repairs to the shingle tabs on one of these roof slopes (**Photograph 6**).
- The tar seals for the three-tab asphalt-composition shingles on the surfaces of these roof slopes were not easily broken with hand pressure. You could not break the tar seal without tearing the shingle.

View of the slipped shingles on one of the north-facing roof slopes over the building.

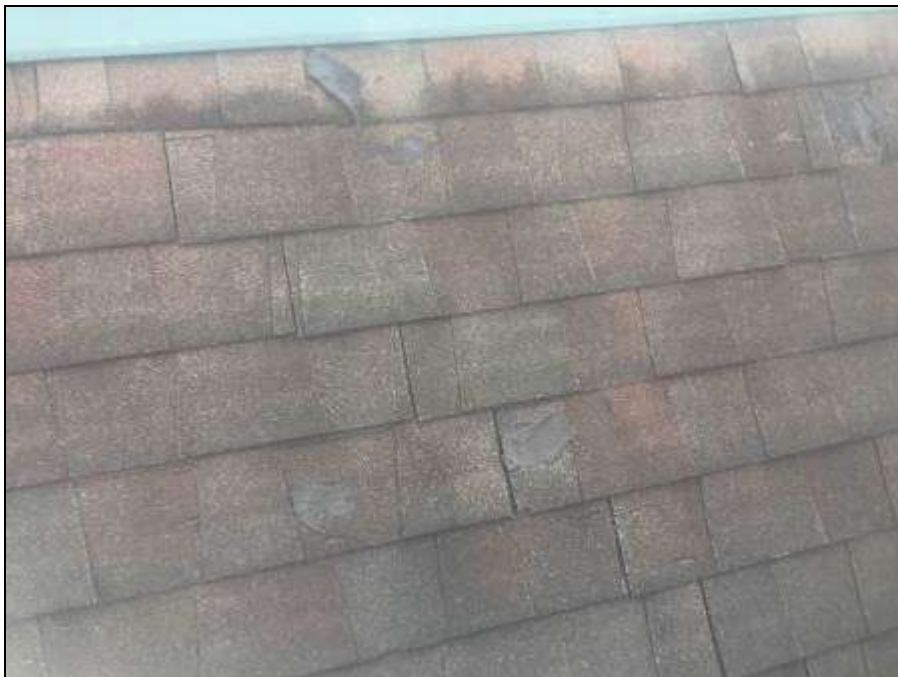
**Photograph 6**

View of evidence, mastic, of prior repairs to the shingle tabs on one of the north-facing roof slopes over the building.

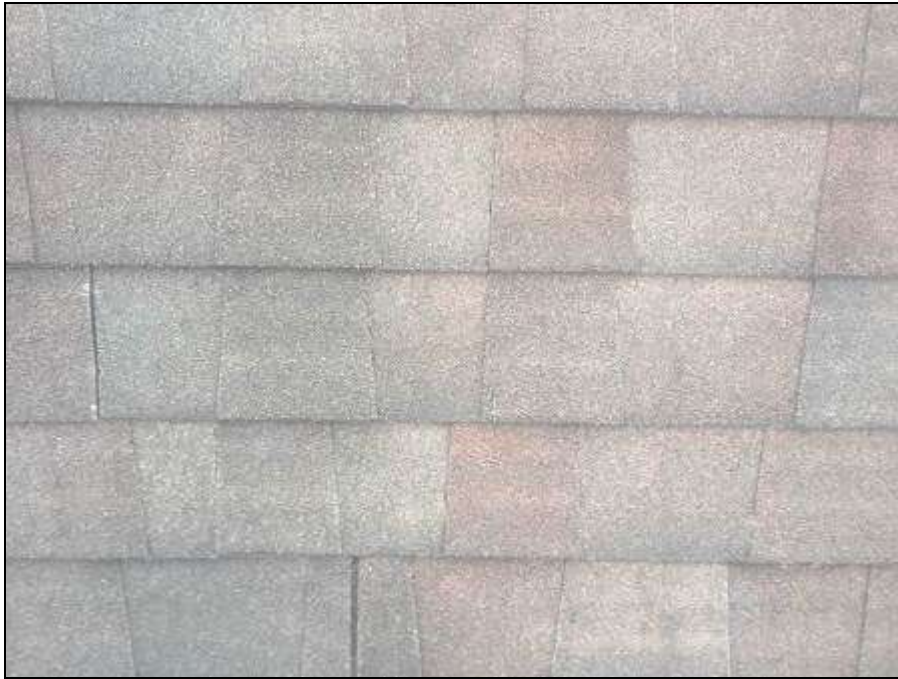
**Photograph 7**

- There was minor granule loss from the three-tab asphalt-composition shingles on the surfaces of these roof slopes.
- There was minor pitting and deterioration in the three-tab asphalt-composition shingles on the surfaces of these roof slopes.
- A detailed visual inspection of one test square (100 square feet) of roofing on these roof slopes revealed spatter marks but no small, rounded areas of granule loss consistent with hail impacts on the three-tab asphalt-composition shingles on the surfaces of these roof slopes (**Photograph 7**).

View of the shingles on the surface of a north-facing roof slope over the building. Notice no spatter marks or small, rounded area of granule loss on the shingles.

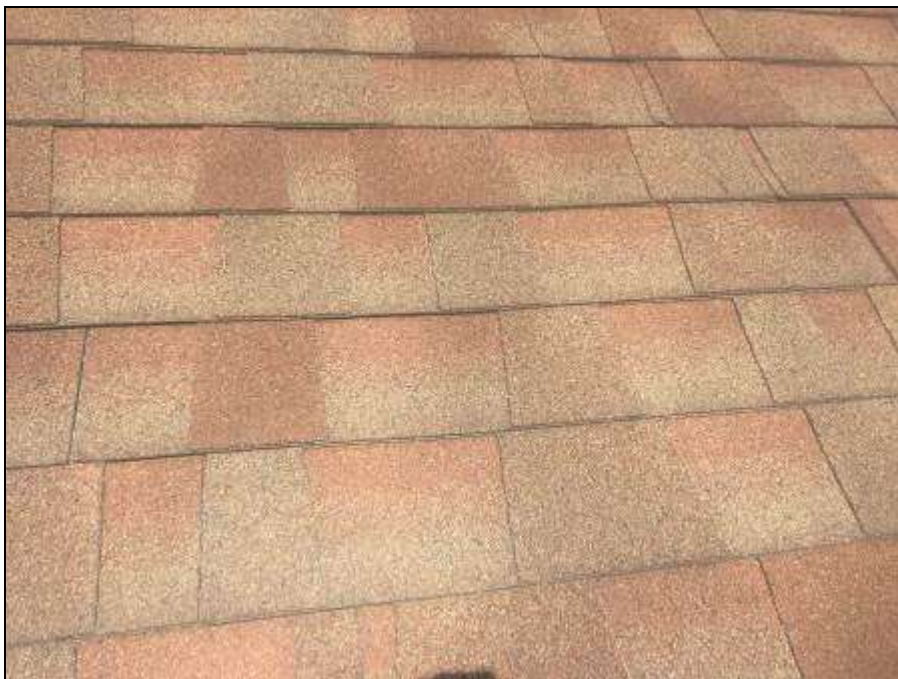
**Photograph 8**

- A detailed visual inspection of one test square (100 square feet) of roofing on these roof slopes revealed spatter marks but no small, rounded areas of granule loss consistent with hail impacts on the three-tab asphalt-composition shingles on the surfaces of these roof slopes (**Photograph 8**).

View of the shingles on the surface of a south-facing roof slope over the building. Notice no spatter marks or small, rounded area of granule loss on the shingles.

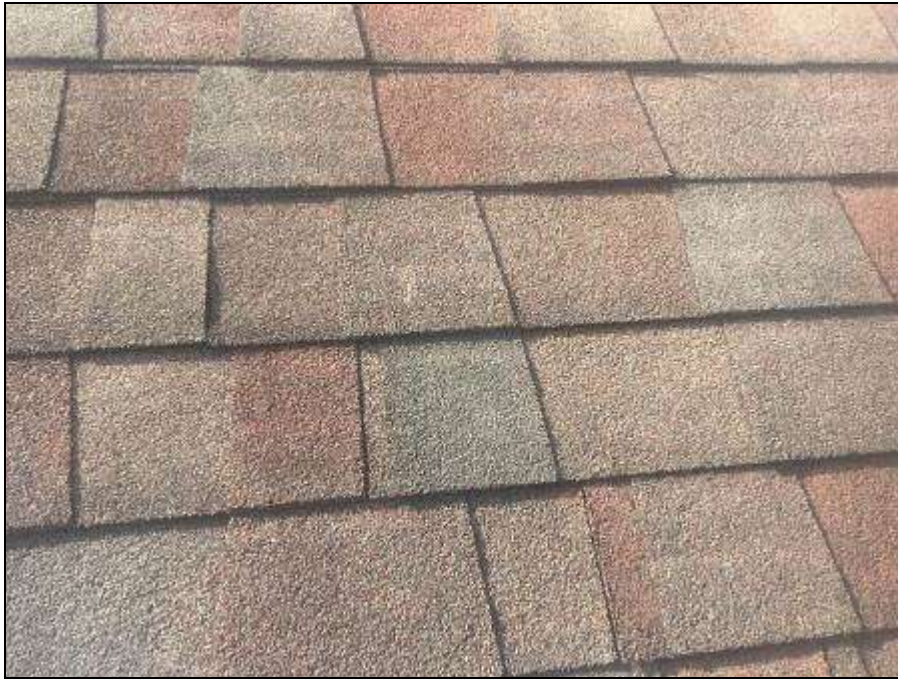
**Photograph 9**

- A detailed visual inspection of one test square (100 square feet) of roofing on these roof slopes revealed spatter marks but no small, rounded areas of granule loss consistent with hail impacts on the three-tab asphalt-composition shingles on the surfaces of these roof slopes (**Photograph 9**).

View of the shingles on the surface of an east-facing roof slope over the building. Notice no spatter marks or small, rounded area of granule loss on the shingles.

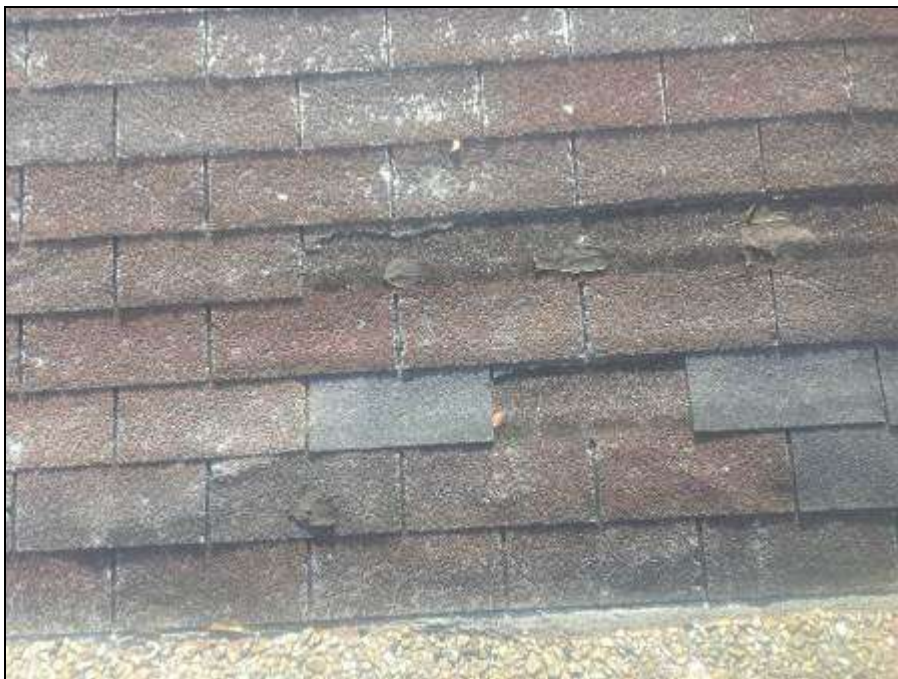
**Photograph 10**

- There were three roof slopes that faced toward the west.
- There were isolated locations where there were missing and torn three-tab asphalt-composition shingles on the surfaces of these roof slopes (**Photograph 10**).
- There were isolated locations where there was evidence, different-colored shingles, of prior repairs to the three-tab asphalt-composition shingles on the surfaces of these roof slopes (**Photograph 11**).

View of the torn and missing shingle tabs on one of the west-facing roof slopes over the building.

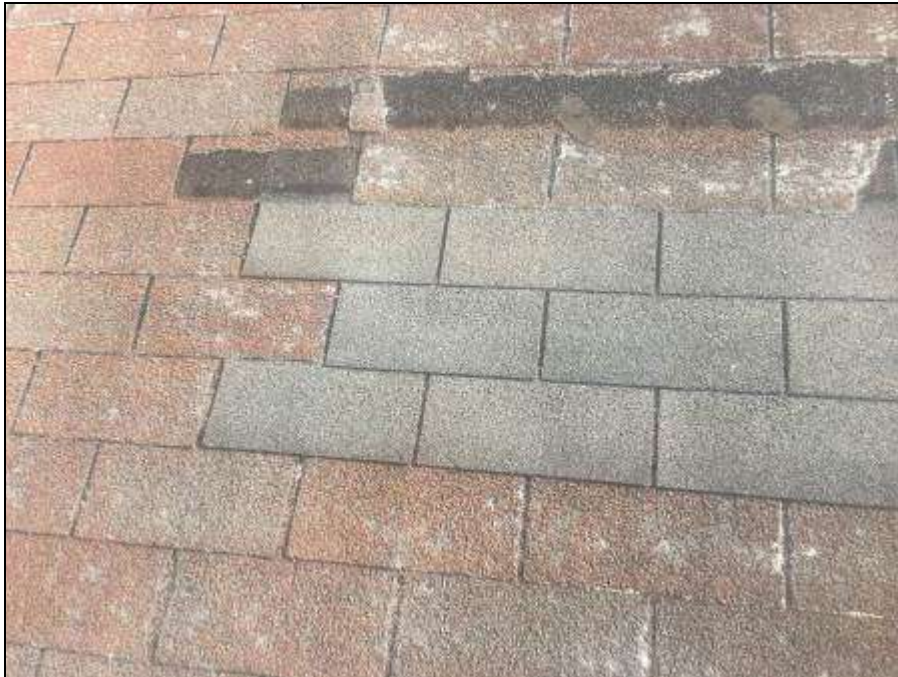
**Photograph 11**

View of the evidence, different-colored shingles, of prior repairs to the three-tab asphalt-composition shingles on a west-facing roof slope over the building.

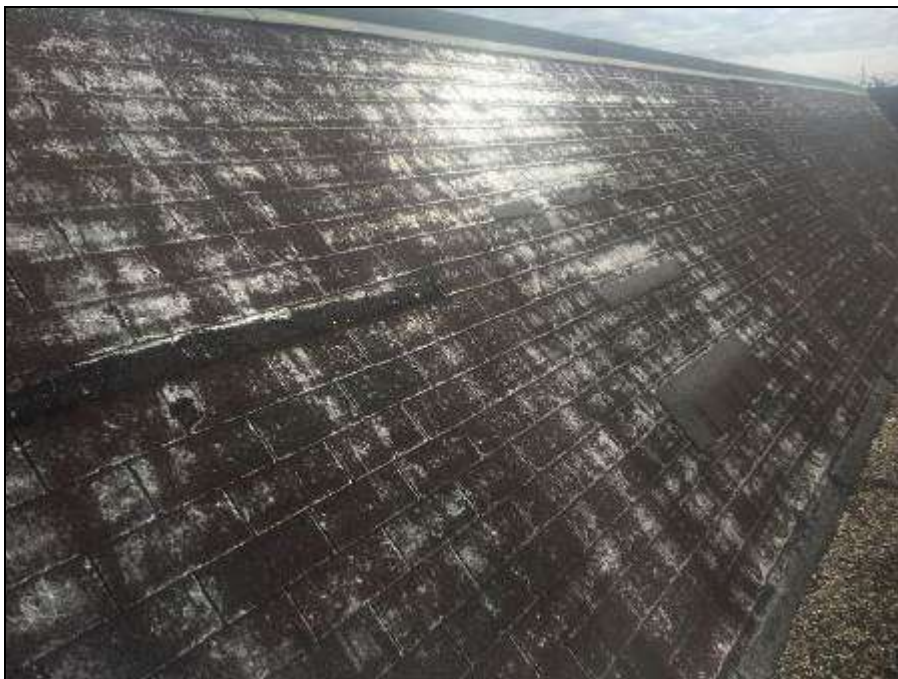
**Photograph 12**

- There was minor to substantial granule loss from the three-tab asphalt-composition shingles on the surfaces of these roof slopes. In some instances, the fibers of the shingles were exposed (**Photograph 12**).

View of the granule loss from the shingle tabs on one of the west-facing roof slopes over the building. Notice the fibers in the shingles are exposed.

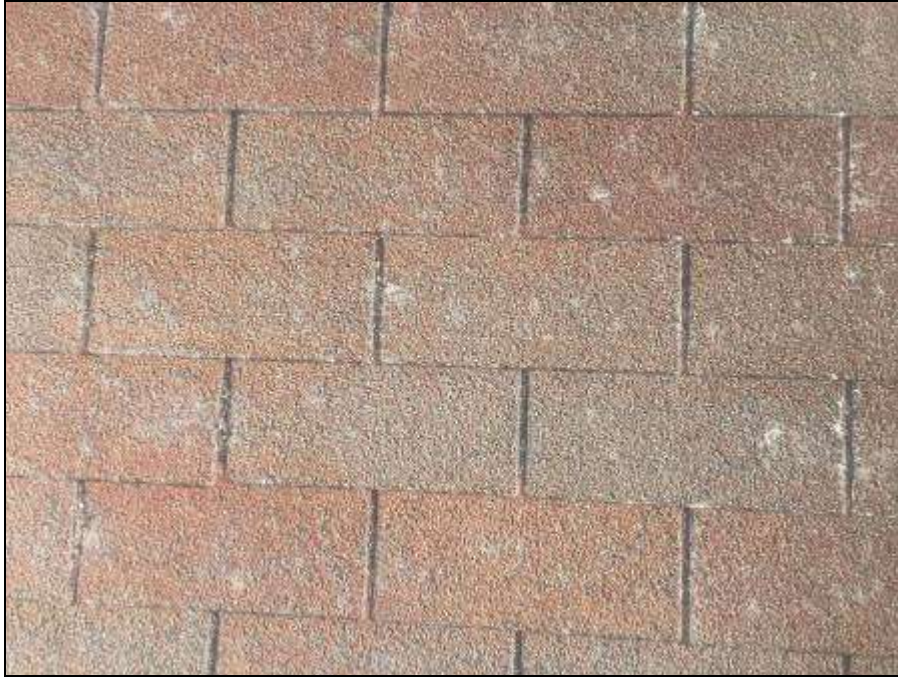
**Photograph 13**

- There was minor to moderate pitting and deterioration in the three-tab asphalt-composition shingles on the surfaces of these roof slopes.
- A detailed visual inspection of one test square (100 square feet) of roofing on these roof slopes revealed numerous spatter marks and small, rounded areas of granule loss consistent with hail impacts on the three-tab asphalt-composition shingles on the surfaces of these roof slopes (**Photograph 13**).

There were numerous small, rounded areas of granule loss consistent with hail impacts, on the three-tab asphalt-composition shingles on the surfaces of the west-facing roof slopes over the building. The hail damage appeared old and prior to the reported 2019 storm event. Composition shingle roofs damaged by hail are characterized by random-sized bruises to the shingles distributed fairly evenly over the areas of all the roof slopes exposed to the hail. When it occurs, hail damage will be found throughout areas of the roof system that are exposed to hail, and will not occur in grouped clusters. Damage will be found on the edges of the shingles, as well as in the fields of the mats. Shingles that make up the roof ridges, or unsupported shingles, such as those at ridge vents and roof edges are particularly vulnerable to hail damage. A detailed visual inspection of

one test square of roofing (100 square feet), which was made on all of the various roof slopes over the building, revealed spatter marks and small, rounded areas of granule loss consistent with hail impacts on the west-facing roof slopes over the building. A Hail Verification Report (Report 8137944) from CoreLogic indicated that there was one recorded hail event with maximum-sized hailstones of 1.1 inches at the location of the Belle Realty of Lafayette building between January 1, 2009, and November 12, 2019. This event occurred on April 2, 2017. There were two recorded hail events with maximum-sized hailstones of 0.75 inch and 1.1 inches within one mile of the Belle Realty of Lafayette building between January 1, 2009, and November 12, 2019. These events occurred on March 18, 2016 and April 2, 2017. The hail size was determined by radar signature and was not field verified. This was consistent with the observations, which as mentioned above, indicated that there were spatter marks and small, rounded areas of granule loss consistent with hail impacts on the west-facing roof slopes over the building.

View of the shingles on the surface of the west-facing roof slope over the building. Notice the spatter marks and small, rounded areas of granule loss on the shingles.

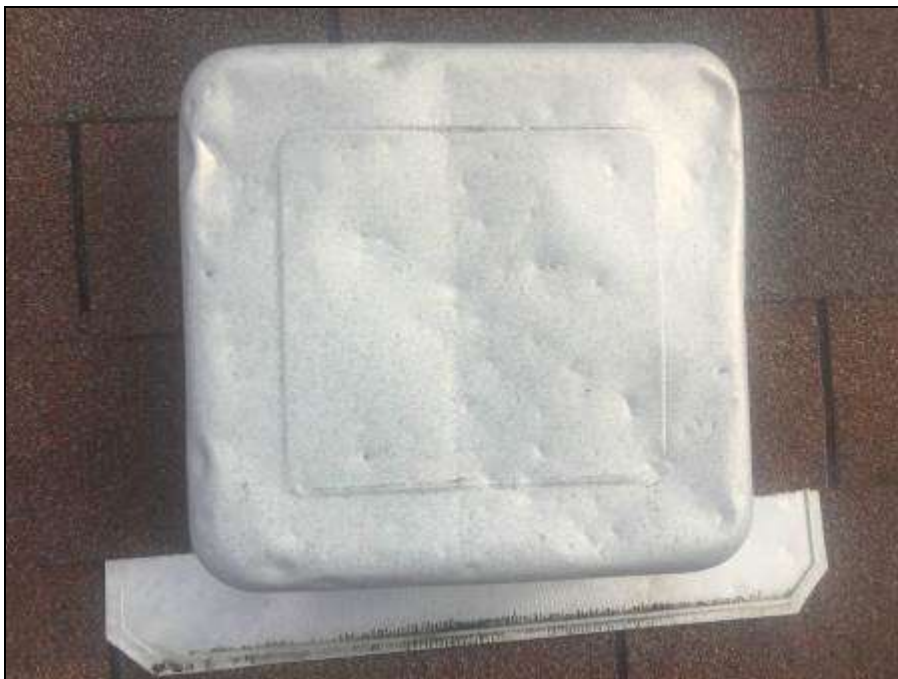
**Photograph 14**

- There were indentations in the light-gauge metal roof vents within these roof slopes. The indentations were estimated to be pea-sized in diameter (**Photograph 14**).

View of the pea-sized indentations in a light-gauge metal vent within a west-facing roof slope over the building.

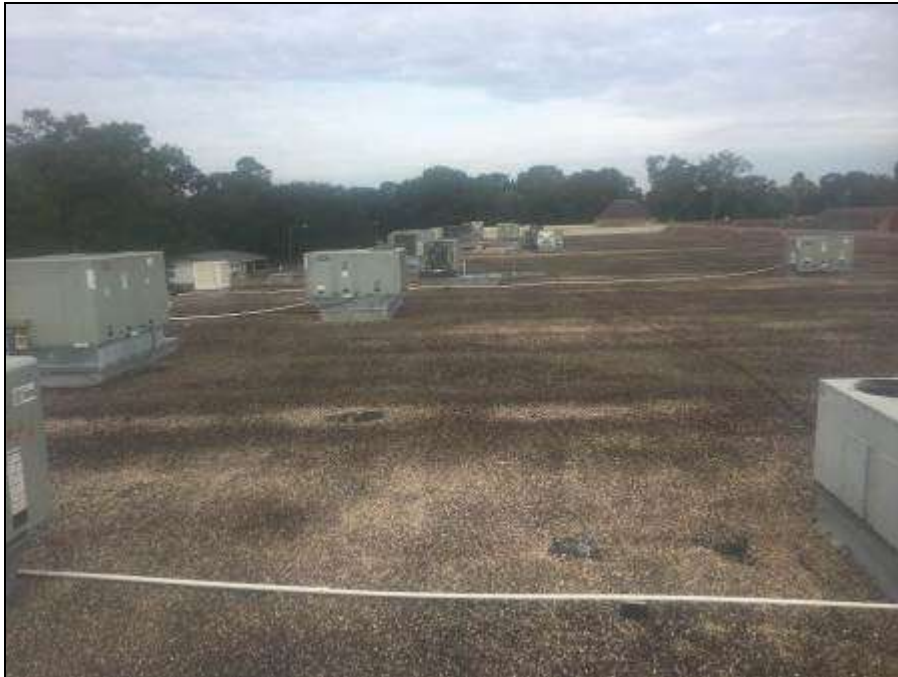
**Photograph 15**

- The majority of the low-sloped roof over the building consisted of a gravel ballasted built-up system (**Photograph 15**). There were no crushed or displaced sections of gravel ballast on the built-up system over the building.
- There were no visible punctures in the gravel ballasted built-up system on the low-sloped roof surface over the building.
- There was a TPO membrane on a portion of the low-sloped roof over the building.

There was no physical evidence to suggest that the gravel ballasted built-up roof system was damaged from hail impacts. From viewing the roof surface over the building, our observations indicated that there were no crushed or displaced sections of gravel ballast on the built-up system over the building. There were no visible punctures in the gravel ballasted built-up system on the low-sloped roof surface over the building. This supports our conclusion that there was no physical evidence to suggest that the gravel ballasted built-up roof system was damaged from hail impacts.

View of the built-up system with a gravel ballast on the low-sloped roof over the building.

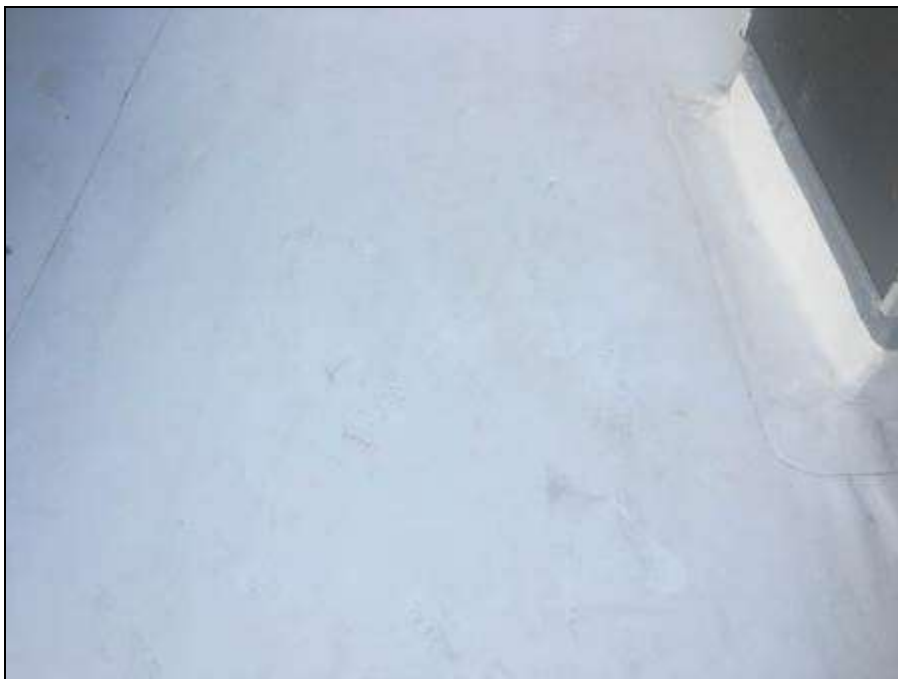
**Photograph 16**

- There were no punctures in the TPO membrane on the low-sloped roof over the building (**Photograph 16**).
- There were indentations in the cooling fins of the air-conditioning compressors on the surface of the low-sloped roof over the building (**Photographs 17**).
- There were indentations in the light-gauge metal turbines within the low-sloped roof over the building. The indentations were estimated to be pea-sized in diameter (**Photograph 18**).

There was no physical evidence to suggest that the TPO membrane on a portion of the low-sloped roof over the building was damaged from hail impacts. From viewing the roof surface over the building, our observations indicated that there was a TPO membrane on a portion of the low-sloped roof surface over the building. There were no punctures in the TPO membrane on the low-sloped roof over the building. This supports our conclusion that there was no physical evidence to suggest that the TPO membrane on a portion of the low-sloped roof over the building was damaged from hail impacts.

View of the TPO membrane on a portion of the low-sloped roof over the building. Notice no punctures in the TPO membrane.

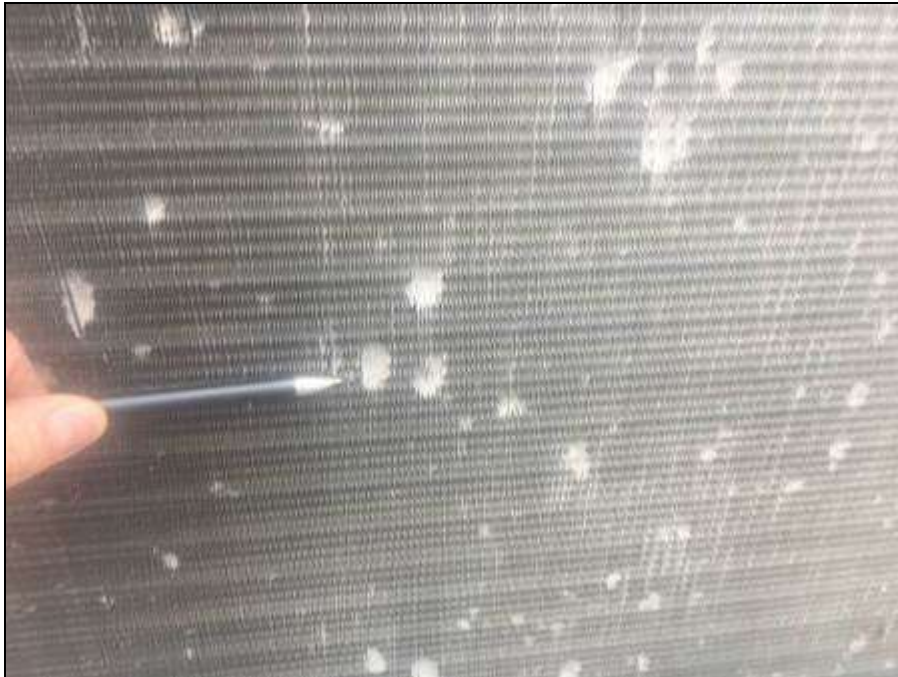
**Photograph 17**

View of the indentations in the cooling fins of the air-conditioning compressors on the surface of the low-sloped roof over the building.

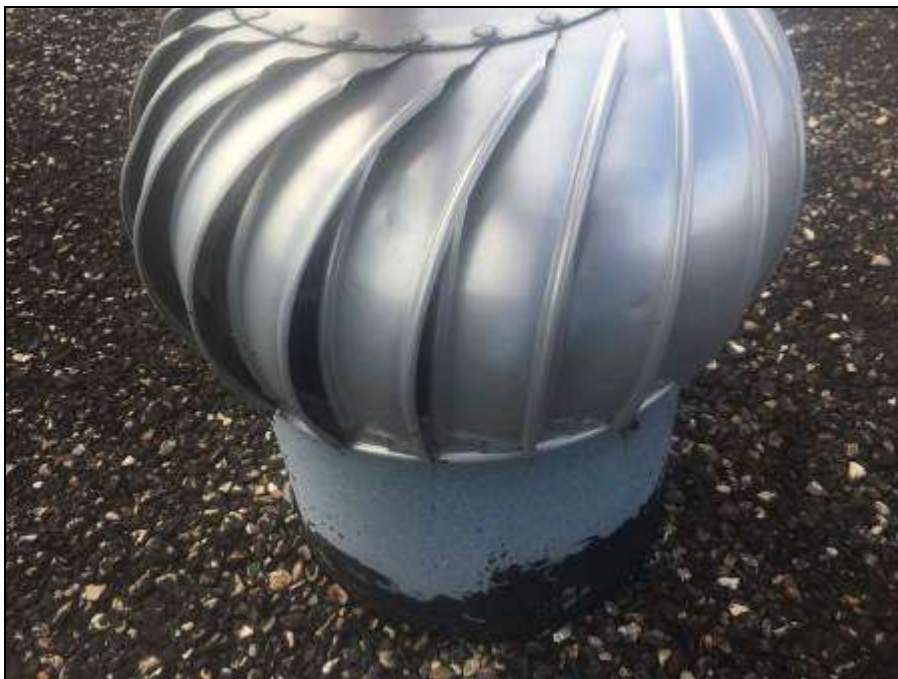
**Photograph 18**

In addition, other objects, such as gutters, downspouts, metal vent caps, and air-conditioner coil fins, will also be struck by hail and will exhibit evidence of such in the form of indentations or spatter marks. In most instances, the impact energy required to damage these objects is less than that required to damage typical roof shingles. This is due to the lack of rigid support to these objects and their ductility. Consequently, indentations in these objects from hailstones do not necessarily indicate damage to the shingles. However, indentations may be used to evaluate the size of the hail that struck a particular roof system. Our observations revealed that there were no indentations in the light-gauge metal gutters and downspouts on the various sides of the building. There were no spatter marks or indentations on the heavy-gauge electrical boxes, which were located on the west side of the building. There were no spatter marks or small rounded areas of displaced wood fibers on the wood fencing at the site. There were indentations in the light-gauge metal roof vents within the west-facing roof slopes over the building. The indentations were estimated to be pea-sized in diameter. There were indentations in the cooling fins of the air-conditioning compressors on the surface of the low-sloped roof over the building. There were indentations in the light-gauge

metal turbines within the low-sloped roof over the building. The indentations were estimated to be pea-sized in diameter.

View of the pea-sized indentations in a light-gauge metal turbine within the low-sloped roof surface over the building.
