Floor Condition Survey Report

Address: 29 Genista Close, Brizlincote Valley, Burton on Trent

Survey Date: June 2025

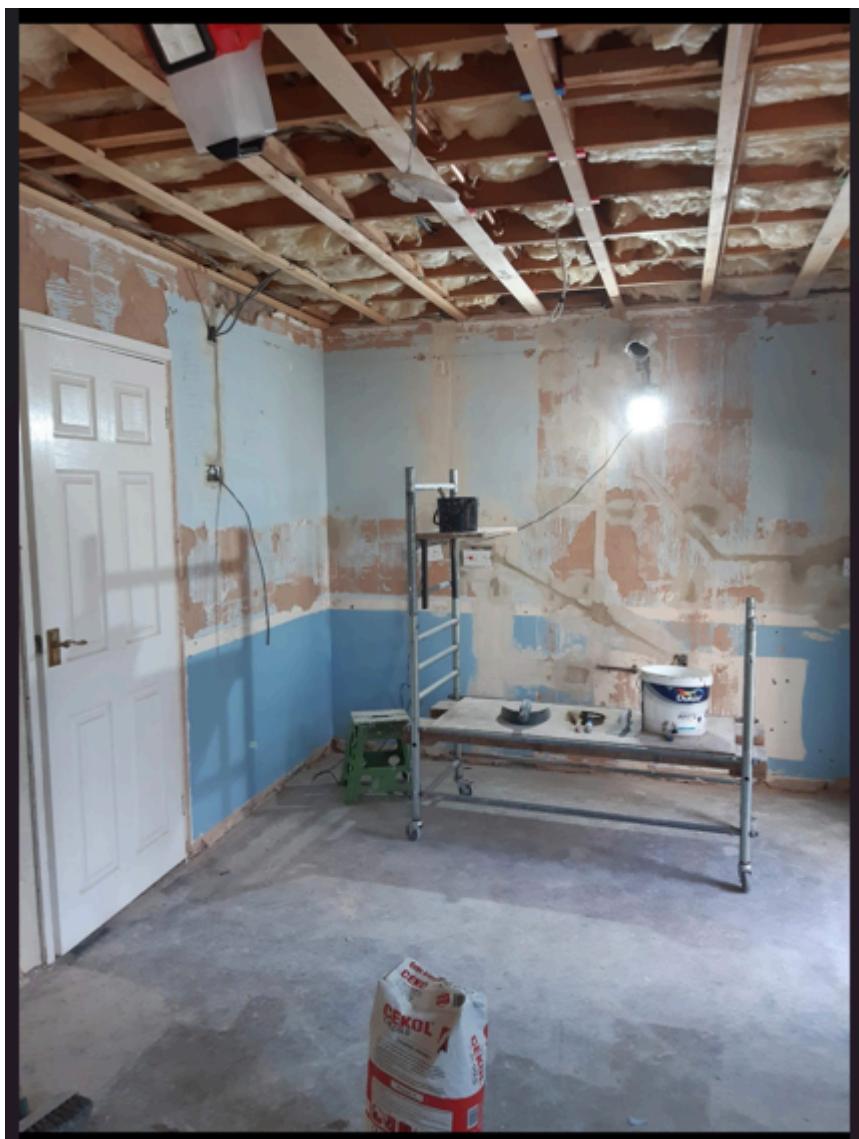
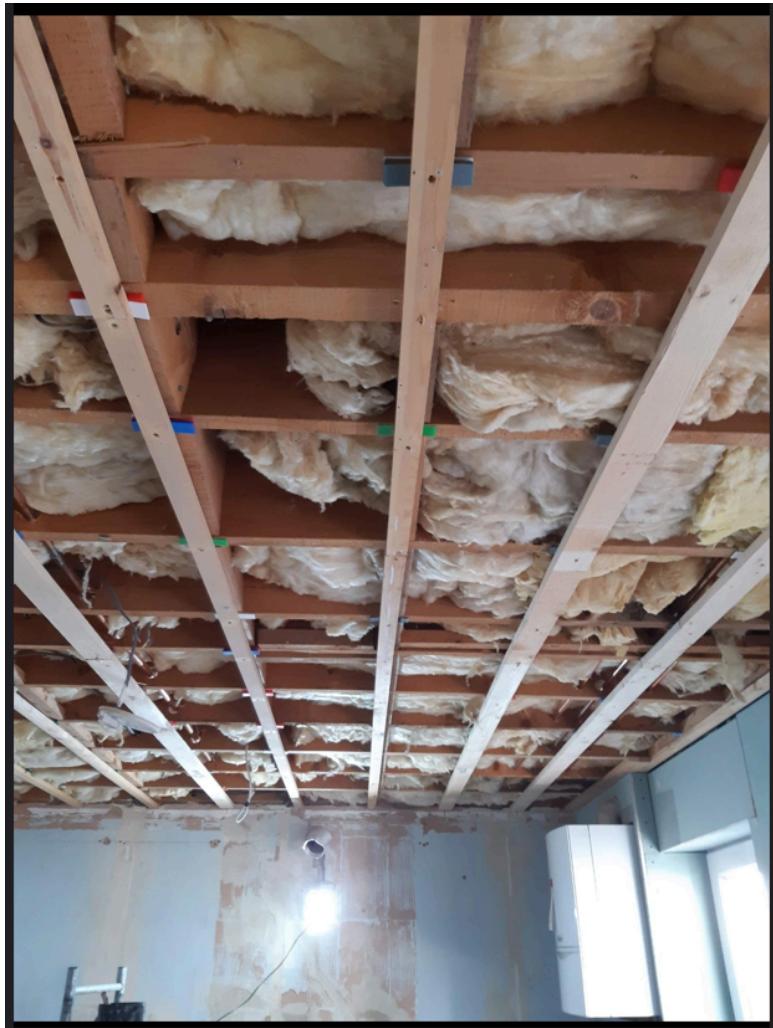
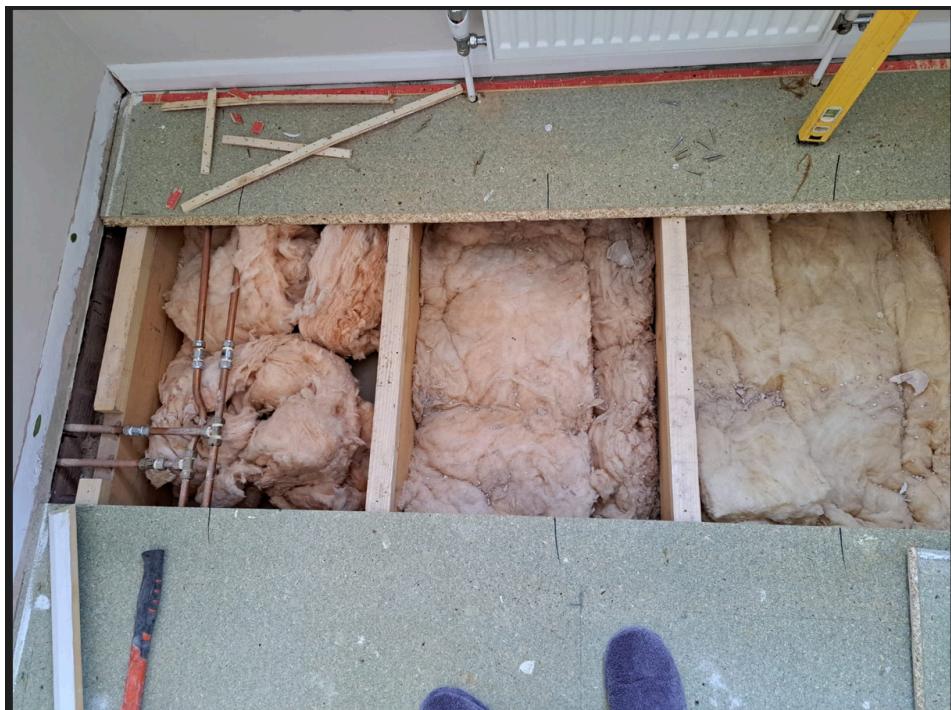
- Underside view shows joists bearing on wall plate; evidence of historic ceiling levelling consistent with previous movement.
- Joist notched at top edge to accommodate pipework. Notching may exceed the permitted one-eighth depth.

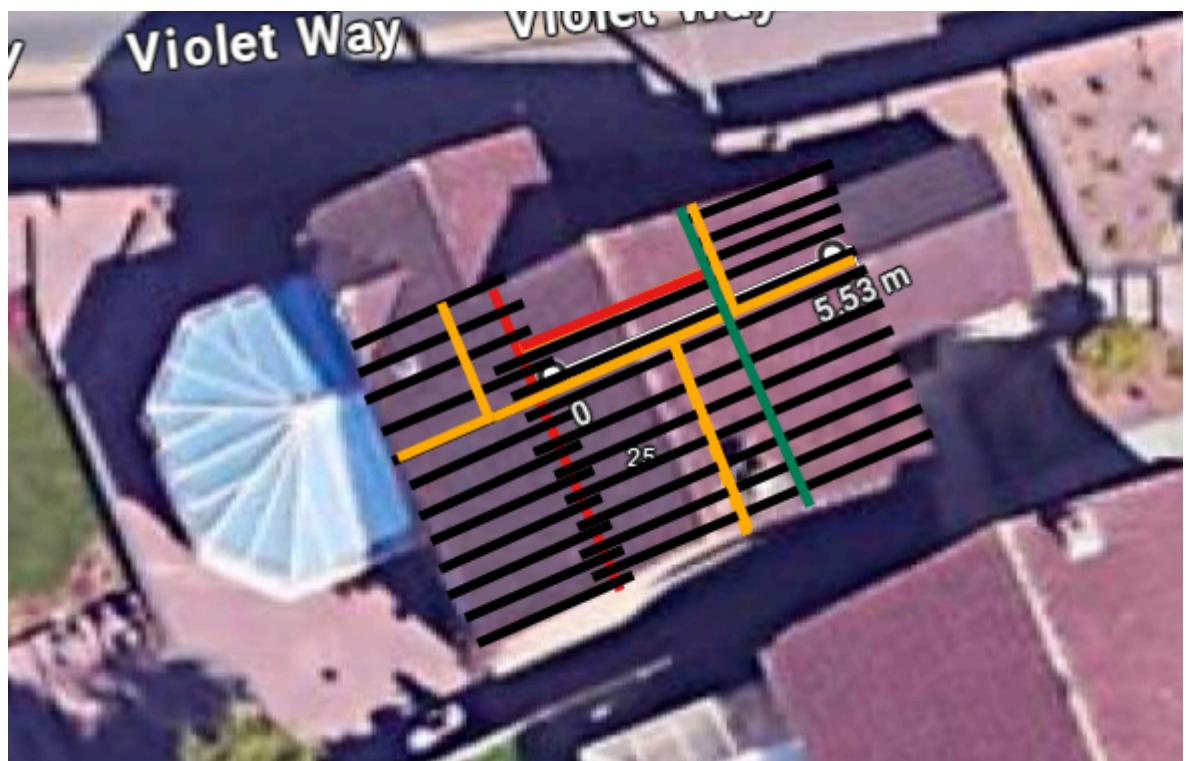
- Illustration of joist spans relative to structural walls. Spans between red-marked supports are approximately 5.0–5.2 m, near or exceeding the safe span limit for 47 × 195 mm joists at the specified spacing.

Rough not to scale current joist layout based on site visit and photos provided by the customer.

Green = suggested beam position
