ELEVATOR INSPECTION REPORT

Project Name: ONE PARAMOUNT CAMPUS 10

Report ID: 556/4

Date of Inspection: 28/10/2024

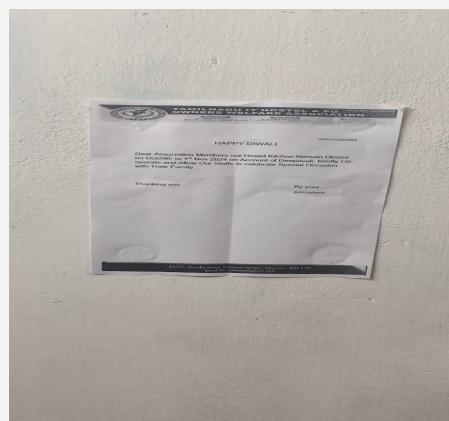
p2
11	CONDITION OF MACHINE MOUNTING & ISOLATION	Y	N	Y - Complied, N - Not Complied

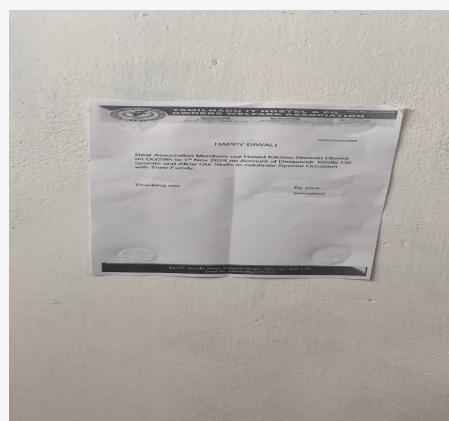
<p style="text-align: center;">p2</p>
23	MANUAL BRAKE RELEASE INSTRUCTIONS	Y	N	Y - Complied, N - Not Complied
