ELEVATOR INSPECTION REPORT

Project Name: ONE PARAMOUNT CAMPUS 10

Report ID: 556/4

Date of Inspection: 28/10/2024

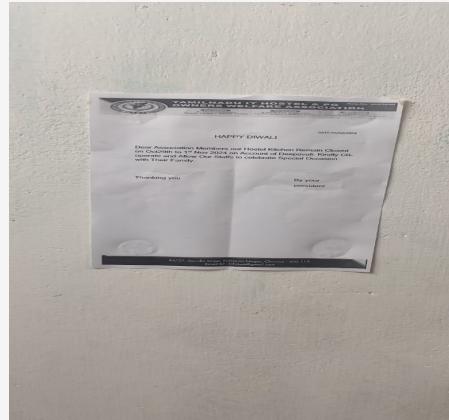
p2
10	CWT RUN BY	Y	N	Y - Complied, N - Not Complied

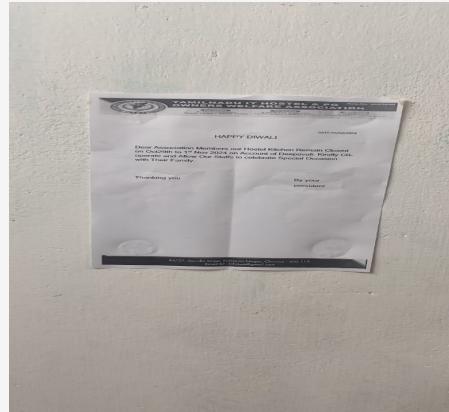
p1		p2
12	CWT OIL DRAIN TRAY CONDITION	Y	N	Y - Complied, N - Not Complied

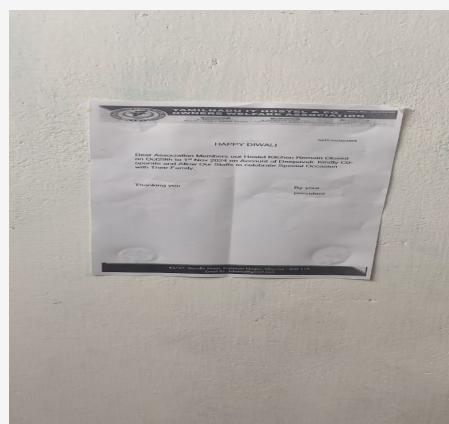
p2
14	TENSION PULLEY CONDITION	Y	N	Y - Complied, N - Not Complied

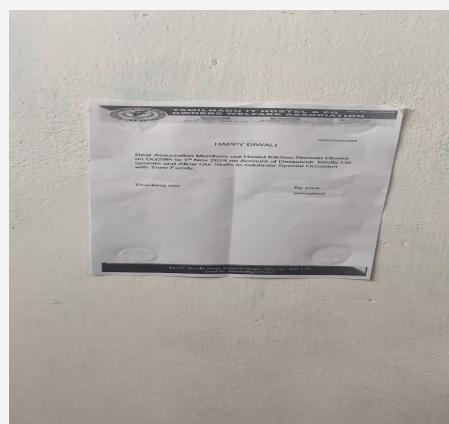
p2
16	SCREEN GUARD CONDITION	Y	N	Y - Complied, N - Not Complied
