ELEVATOR INSPECTION REPORT

Project Name: SKCL

Building No: DESIGN SQUARE

Report ID: 5/1

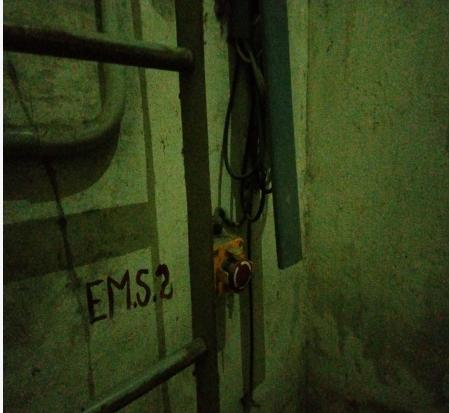
S.No.	L1	L2
1	PIT CONDITION - Hanging pit wires/cables is not routed and secured	PIT CONDITION - Oil spill in the pit
2	PIT LIGHT & CONTROL - Pit light is not working	PIT LIGHT & CONTROL - Pit light is not working
3	CWT OIL DRAIN TRAY CONDITION - CWT Oil drain trays are missing	CWT RUN BY - CWT run by 135 mm is inadequate to the minimum of 150 mm
4	TENSION PULLEY CONDITION - Tension pulley is not clean	CAR OIL DRAIN TRAY CONDITION - Oil Drain trays are not clean
5	CONDITION OF CAR BOTTOM - Car bottom bulb is missing/ not working.	CWT OIL DRAIN TRAY CONDITION - Oil Drain trays are not clean
6	CONDITION OF SAFETY GEAR - Safety gear assembly is not clean	TENSION PULLEY CONDITION - Tension pulley is not clean
7	CONDITION OF SLIDING GUIDE SHOE/ GUIDE ROLLERS - Guide shoe play is more	CONDITION OF CAR BOTTOM - Car bottom bulb is missing/ not working.
8		CONDITION OF SLIDING GUIDE SHOE/ GUIDE ROLLERS - Guide shoe play is more

S.No.	DESCRIPTION	L1	L2	OBSERVATION
1	PIT IDENTIFICATION	Y	Y	Complied
No Image Captured				
2	PIT CONDITION	N	N	Y - Complied, N - Not Complied

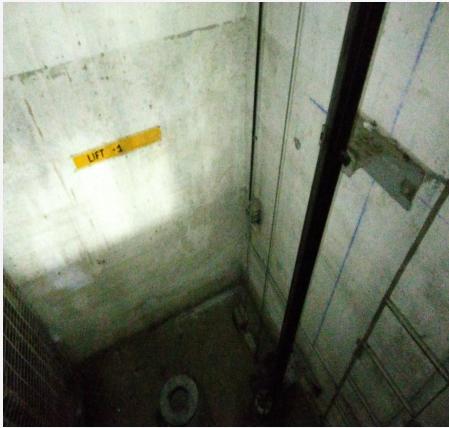
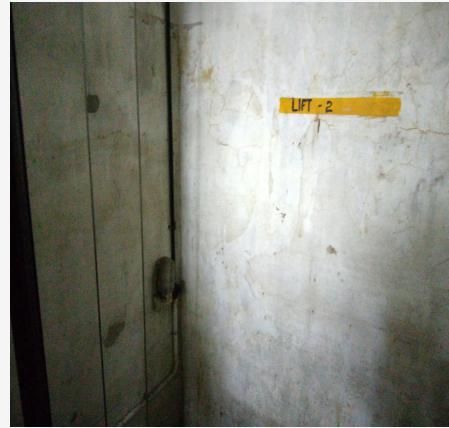
S.No.	DESCRIPTION	L1	L2	OBSERVATION
3	PIT LIGHT & CONTROL	N	N	Y - Complied, N - Not Complied

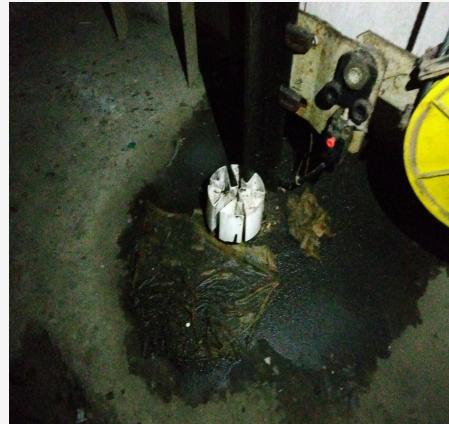
S.No.	DESCRIPTION	L1	L2	OBSERVATION
11	CAR OIL DRAIN TRAY CONDITION	Y	N	Y - Complied, N - Not Complied

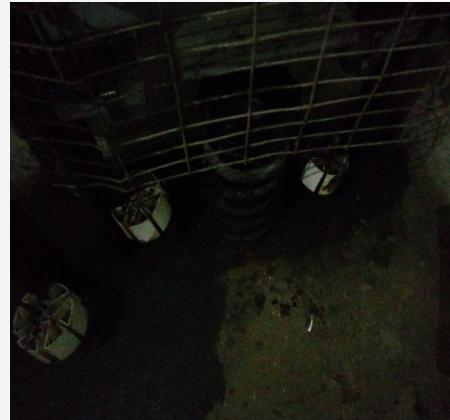
L1

L2
12	CWT OIL DRAIN TRAY CONDITION	N	N	Y - Complied, N - Not Complied

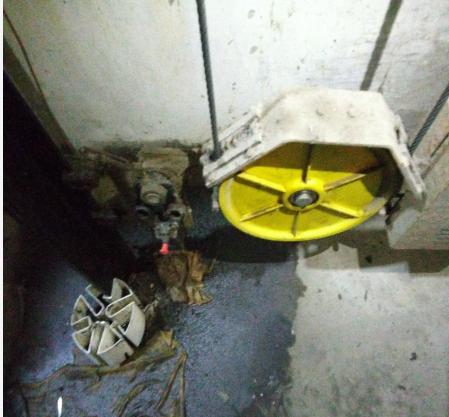
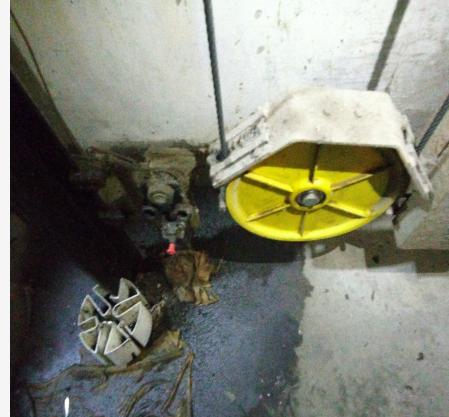
S.No.	DESCRIPTION	L1	L2	OBSERVATION
13	DOWN FINAL LIMIT SWITCH CONDITION /OPERATION	Y	Y	Complied
				No Image Captured
14	TENSION PULLEY CONDITION	N	N	Y - Complied, N - Not Complied

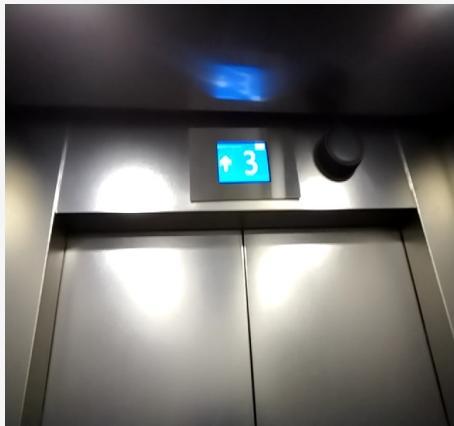
S.No.	L1	L2
1	CABIN IDENTIFICATION - Cabin ID is missing	CABIN IDENTIFICATION - Cabin ID is missing
2	CAPACITY PLATE - Capacity plate is missing	CAPACITY PLATE - Capacity plate is missing
3	CABIN SAFETY INSTRUCTIONS - Instruction plate is missing	CABIN SAFETY INSTRUCTIONS - Instruction plate is missing
4	PROVISION OF ARD - ARD audio is not working,recommended	START, ROLL BACK & STOP JERKS - Starting jerk
5	RIDING PERFORMANCE - Cabin sway /play is observed	RIDING PERFORMANCE - Cabin Riding is noisy
6	FAN WORKING CONDITION - Fan switch is not working	LIFT LICENSE DISPLAY IN ELEVATOR CABIN - License available and not displayed in cabin
7	LIFT LICENSE DISPLAY IN ELEVATOR CABIN - License available and not displayed in cabin

S.No.	DESCRIPTION	L1	L2	OBSERVATION
1	CABIN IDENTIFICATION	N	N	Y - Complied, N - Not Complied

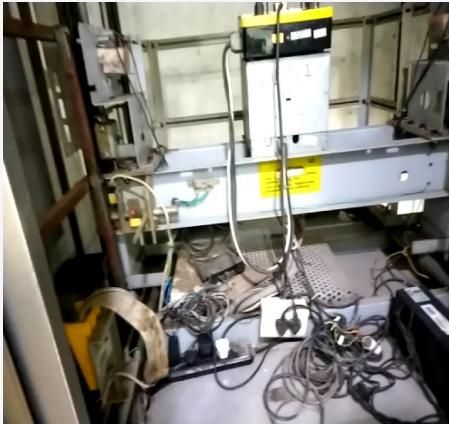
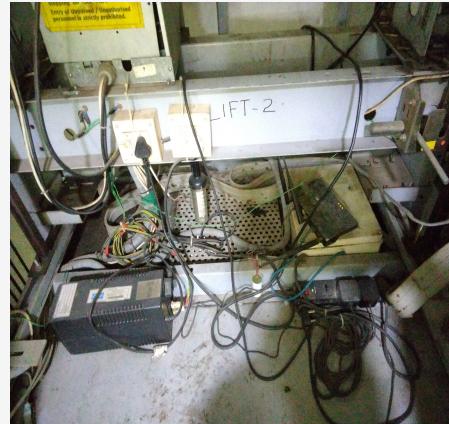
S.No.	L1	L2
1	CAR TOP WIRING PIPES SADDLING - Car top wires/ cables are not secured/not routed	CAR TOP WIRING PIPES SADDLING - Car top wires/ cables are not secured/not routed
2	CAR GUIDE SHOE & LINERS - Guide shoe play is excess	CAR GUIDE SHOE & LINERS - Guide shoe play is excess

S.No.	DESCRIPTION	L1	L2	OBSERVATION
16	CAR TOP WIRING PIPES SADDLING	N	N	Y - Complied, N - Not Complied

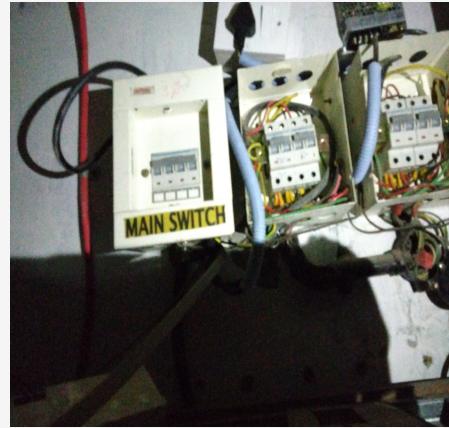
S.No.	L1	L2
1	POWER MAIN SWITCH CONDITION - Missing identification on 3 Phase / 1 Phase power mains	POWER MAIN SWITCH CONDITION - Missing identification on 3 Phase / 1 Phase power mains
2	ACCESSIBILITY OF POWER MAIN SWITCHES - Not accessible. Provided above false ceiling	ACCESSIBILITY OF POWER MAIN SWITCHES - Not accessible. Provided above false ceiling
3	LOG CARD ENTRY & HISTORY - Log book is not provided	LOG CARD ENTRY & HISTORY - Log book is not provided
4	GOVERNOR & ROPE CONDITION - Governor remote access is not working (MRL)	GOVERNOR & ROPE CONDITION - Governor remote access is not provided (MRL)
5	BRAKE OPERATION & CONDITION - Brake operation is noisy.	BRAKE OPERATION & CONDITION - Brake operation is noisy.
6	SMOKE DETECTOR / FIRE EXTINGUISHER - Fire extinguisher is not provided	SMOKE DETECTOR / FIRE EXTINGUISHER - Fire extinguisher is not provided

S.No.	DESCRIPTION	L1	L2	OBSERVATION
6	POWER MAIN SWITCH CONDITION	N	N	Y - Complied, N - Not Complied

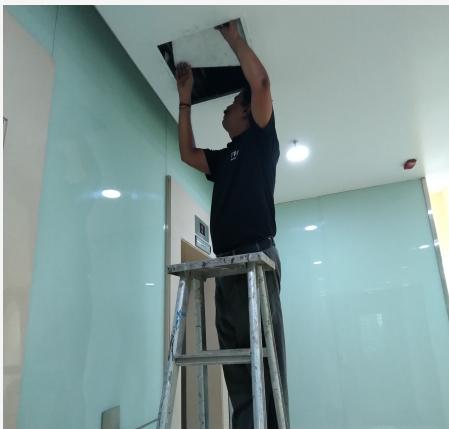
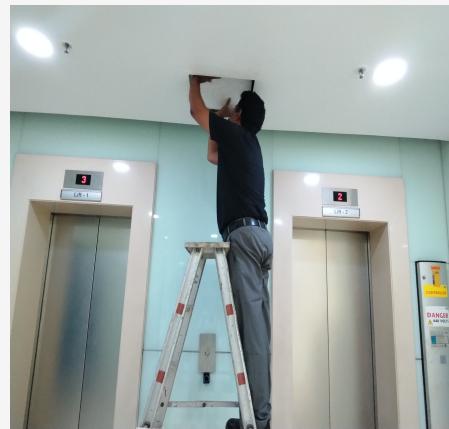
L1		L2
7	ACCESSIBILITY OF POWER MAIN SWITCHES	N	N	Y - Complied, N - Not Complied
