Footscray Hospital Construction

Daily Construction Site Report

PROJECT	REPORT DATE	REPORT ID	STATUS
Footscray Hospital	11/11/2025	0af50f68	PROCESSING

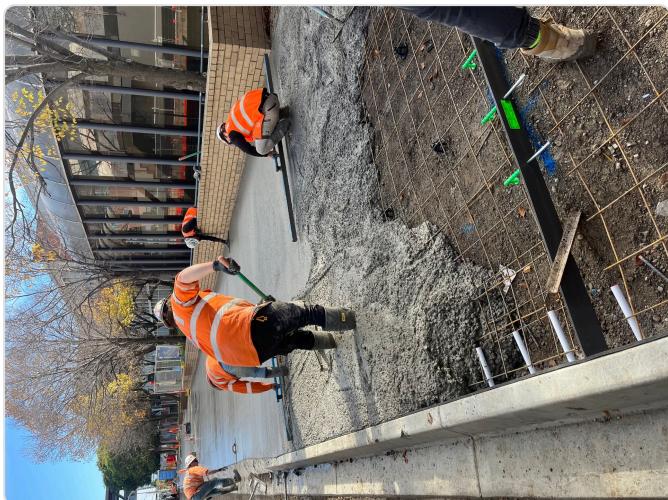
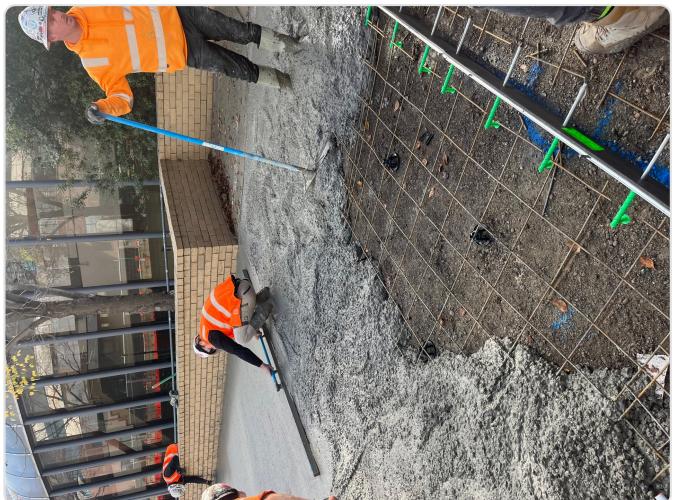
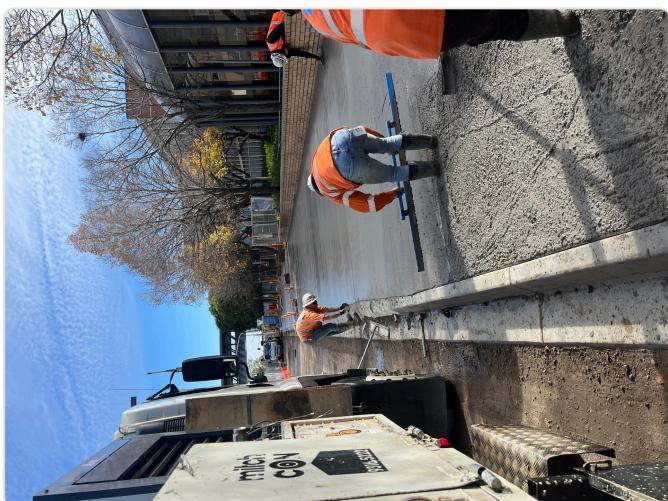
Site Photos

Concrete infill pour near western retaining wall

Verified reinforcement and formwork, placed 32 MPa concrete via boom pump, vibrated and screeded to level, finished surface and applied curing compound. Final levels checked with laser and confirmed within ± 5 mm tolerance. Area cleaned and equipment washed down post-pour.
