Losmandy Titan Reassembly

Ed Wiley and Daniel Maloney, Stellar Skies Observatories

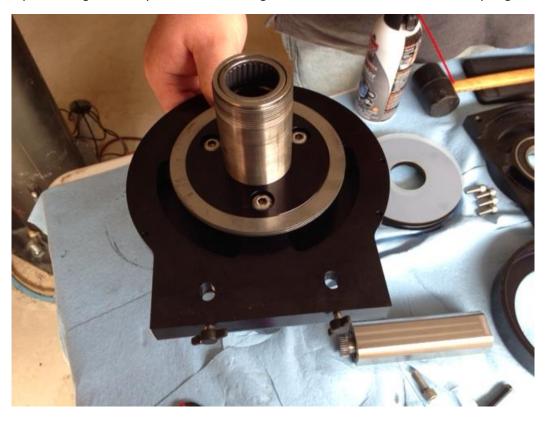
Photo 1. Race bearing placed on the Dec housing. Note that bearing has been degreased as much as possible and lubricated.

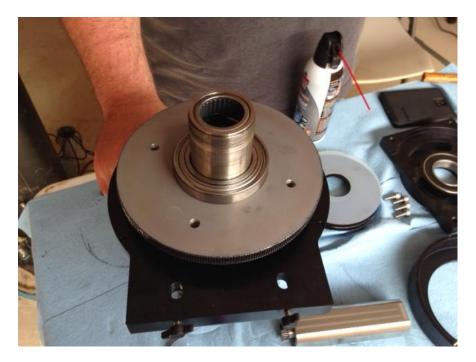
Photo 2. Dec gear placed on top of race bearing (again after clearing and lubricating).

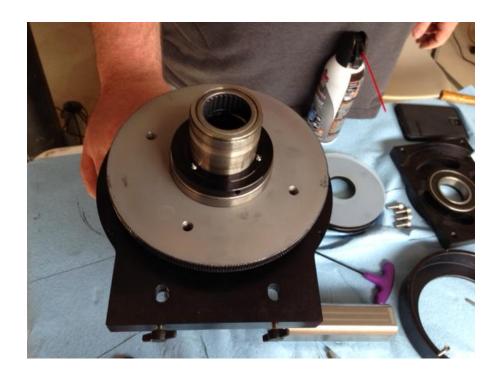
Photo 3 Gear "keeper" installed. It's important to insure that the Dec gear is properly seated with gentle pressure during tightening of the "keeper."

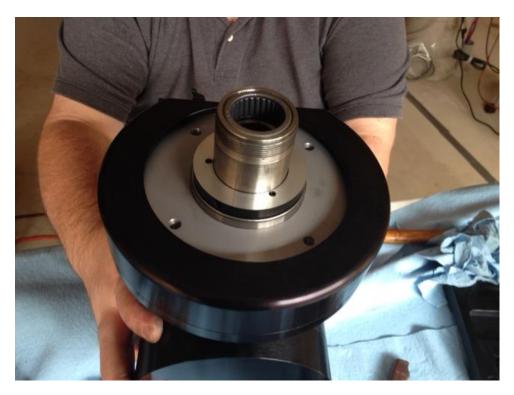
Photo 4. Gear housing fitted. Make sure that during installation you do not bump the gears.

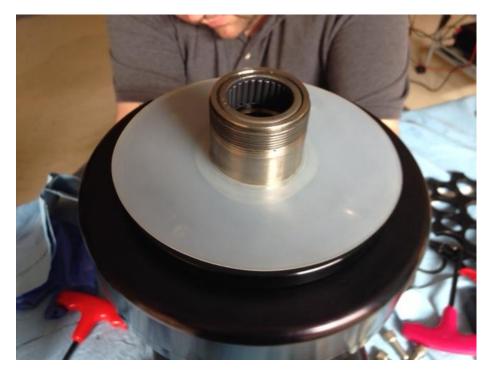
Photo 7. The clutch pad is installed directly over the wavy washer.

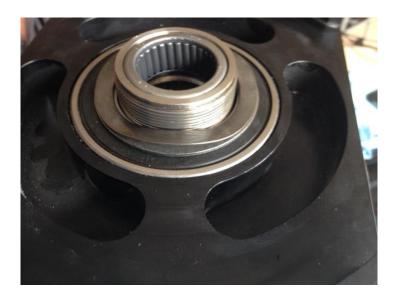
Photo 9. Detail of Photo 8. Again, ONLY the flat washer is installed, NOT the wavy washer and not two wavy washers. More explanation: If you try to install as in this photo, the pressure wheel does not work properly, it binds because there is not enough clearance once the snap ring is installed.

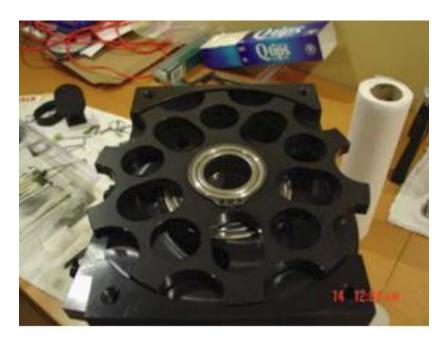
Photo 10. The pressure wheel is mounted. Screw it down far enough to permit the snap ring to be installed. Photo from Titan Tips.

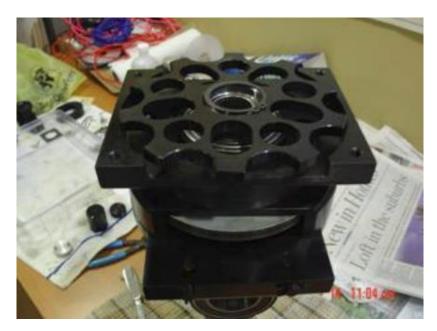
Photo 11. Snap ring shown before the pressure wheel is screwed down to permit installation. Photo from Titan Tips.
