Leveraging Performance Evaluation Through Special Maintenance of Photo Voltaic Power Plant in Nusa Tenggara Region to Achieve Photovoltaic Reliability Excellence

6 - 1 0 A u g u s t 2 0 2 3 Prama Sanur Beach, Denpasar, Bali, Indonesia oleh

Specification of PV Module Gili Terawangan Solar Power Plant

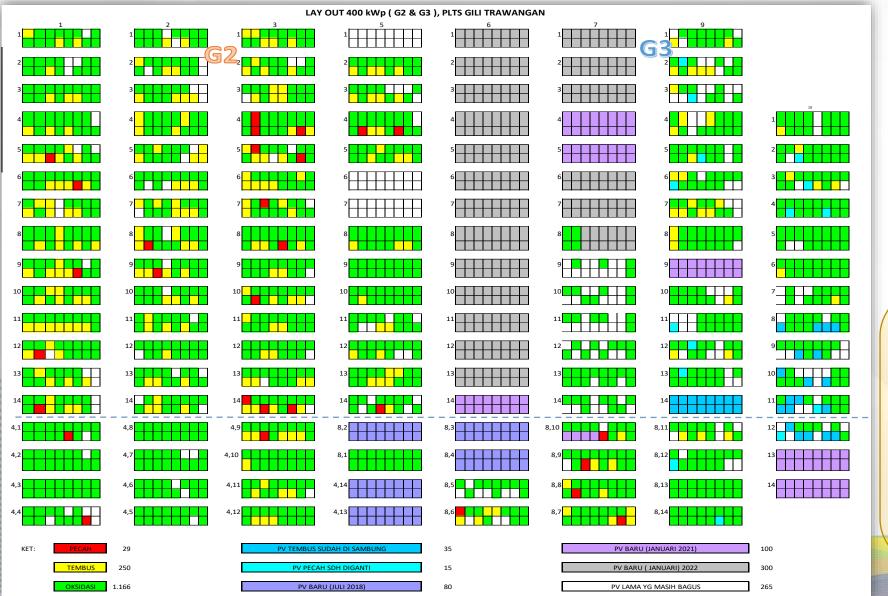
Layout of the PV Module Conditions for PLTS Gili Trawangan (G2 and G3 Inverter)

G2 Data	Number	Percentage	G3 Data	Number	Percentage
NORMAL	125	11%	NORMAL	140	13%
OXIDATION	736	66%	OXIDATION	430	38%
CRACKING	24	2%	CRACKING	5	0%
BREAKDOWN	203	18%	BREAKDOWN	47	4%
NEW PV PANELS (JULY 2018)	32	3%	NEW PV PANELS (JULY 2018)	48	4%
NEW PV PANELS (JANUARY	_	0%	NEW PV PANELS (JANUARY	100	9%
2021)	0		2021)		
NEW PV PANELS (JANUARY	_	0%	NEW PV PANELS (JANUARY	300	27%
2022)	0		2022)		
BREAKDOWN PV PANEL THAT	0	0%	BREAKDOWN PV PANEL THAT	35	3%
HAD BEEN REPAIRED	0		HAD BEEN REPAIRED		
CRACKING PV PANELS THAT	0	00/	CRACKING PV PANELS THAT	15	1%
HAD BEEN REPLACED	U	0%	HAD BEEN REPLACED	15	
Total	1120	100%	Total	1120	100%

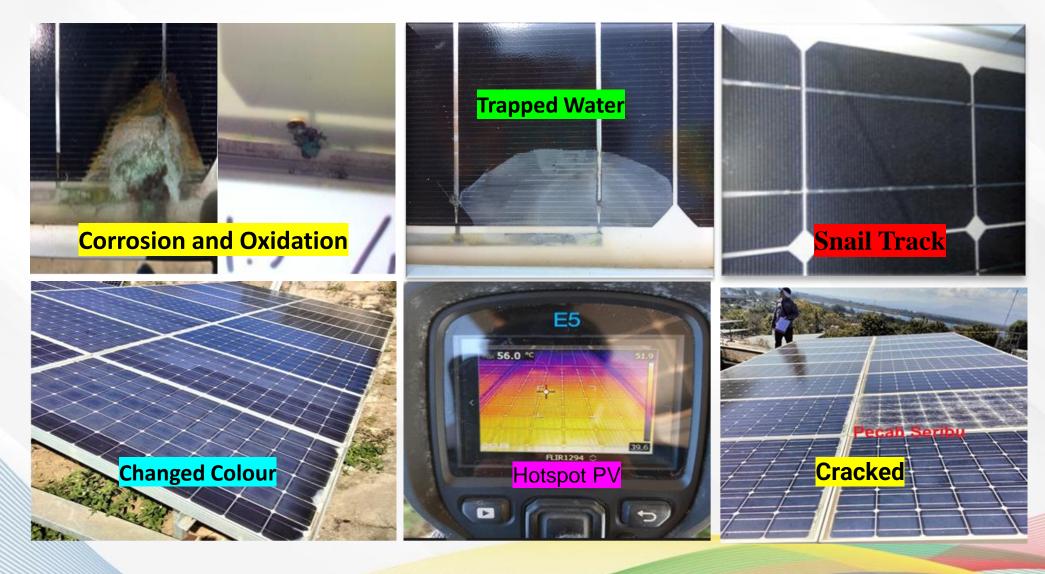
TYPES OF PV MODULE DAMAGED

- 1. The declining of Gili Trawangan Solar Power Plant's reliability is due to the PV Module cracking, oxidation (corrosion), snail track, short circuit, breakdown, damaged lamination (air bubbles), and discolored cells, resulting decreasing in kWh production of PV module from year to year, approximately from 17% to 19% per year.
