Photo Sheet

Eberl Claims Service

Insured: NEW ZION HILL MISSIONARY BAPTIST CHURCH INCORPORATED

Claim #: AA190825

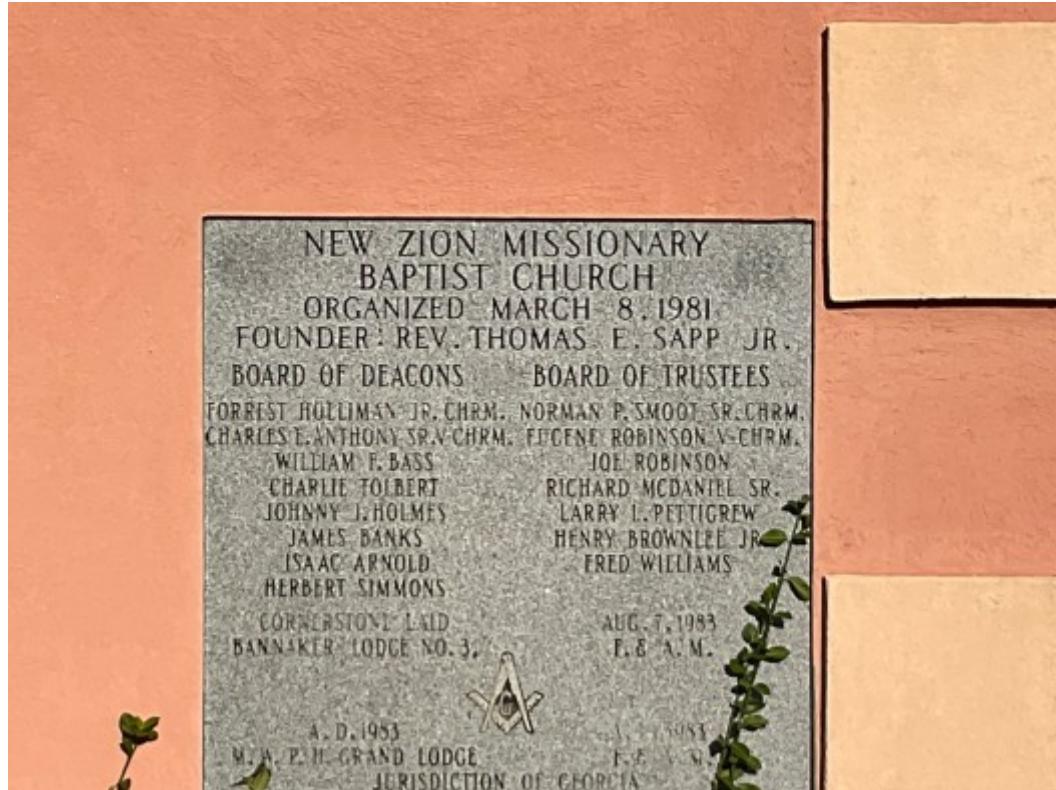
3-Risk

It appears as though this church building was built in 1983.

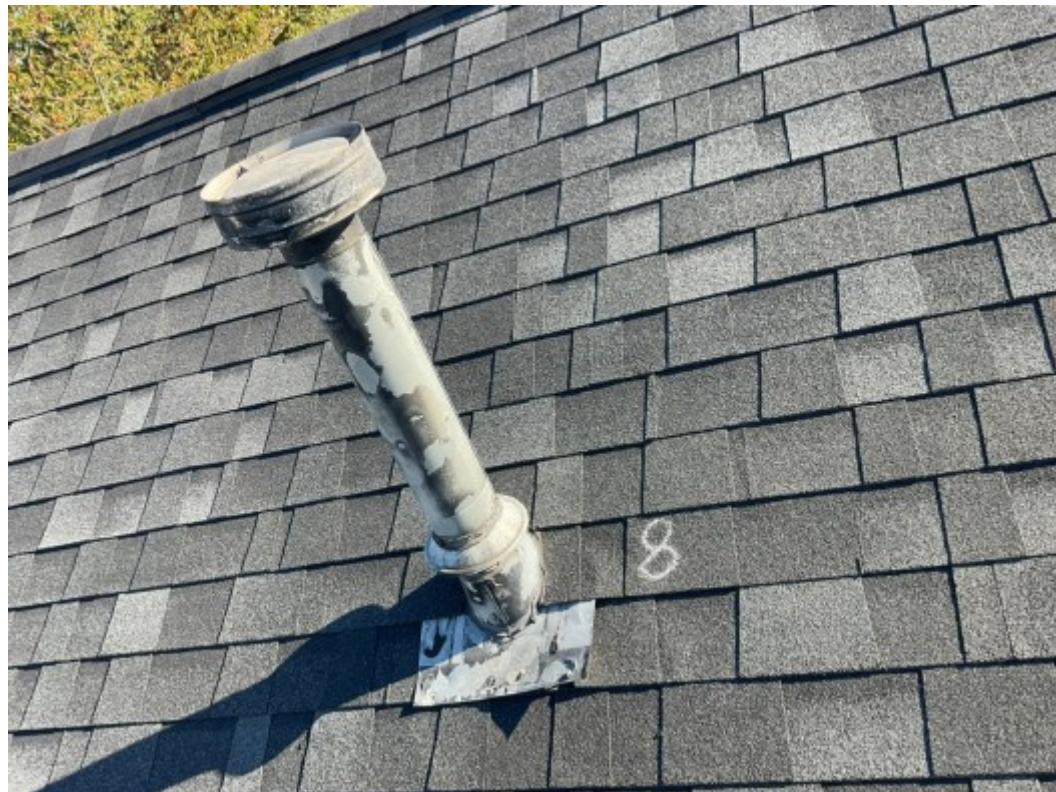
4-Building Roof

Eight cap and collar sets are present on the church building roof.

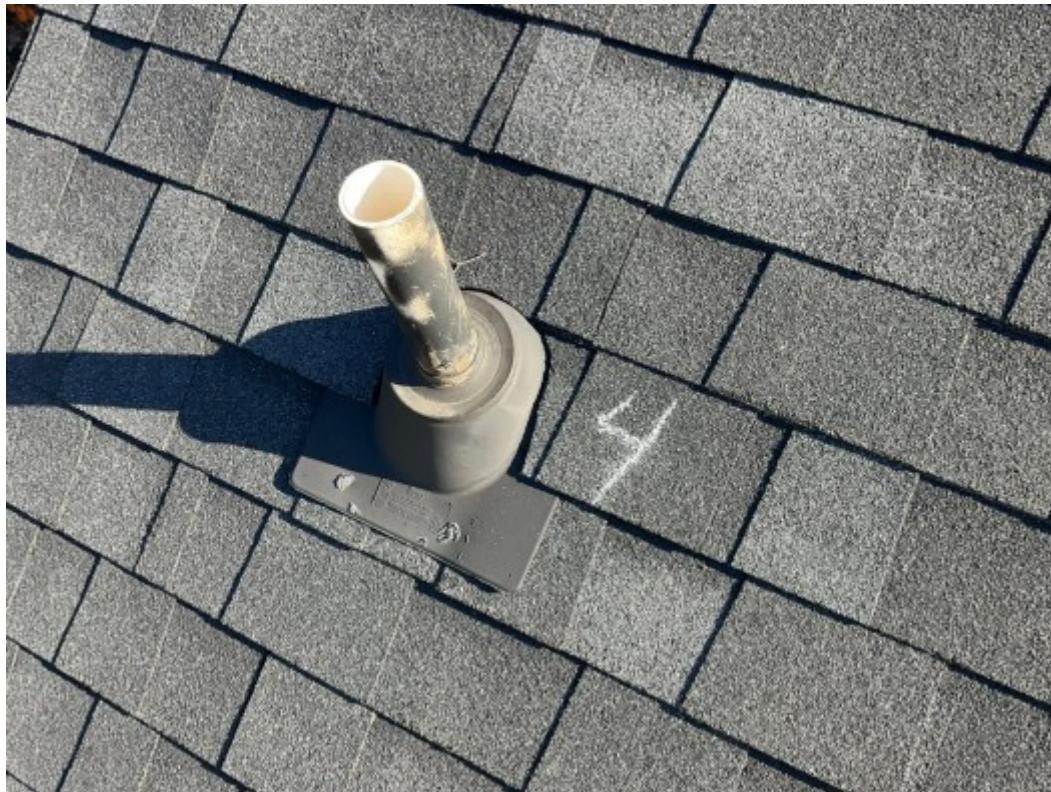
5-Building Roof

Four pipe jacks are present on the roof surface.

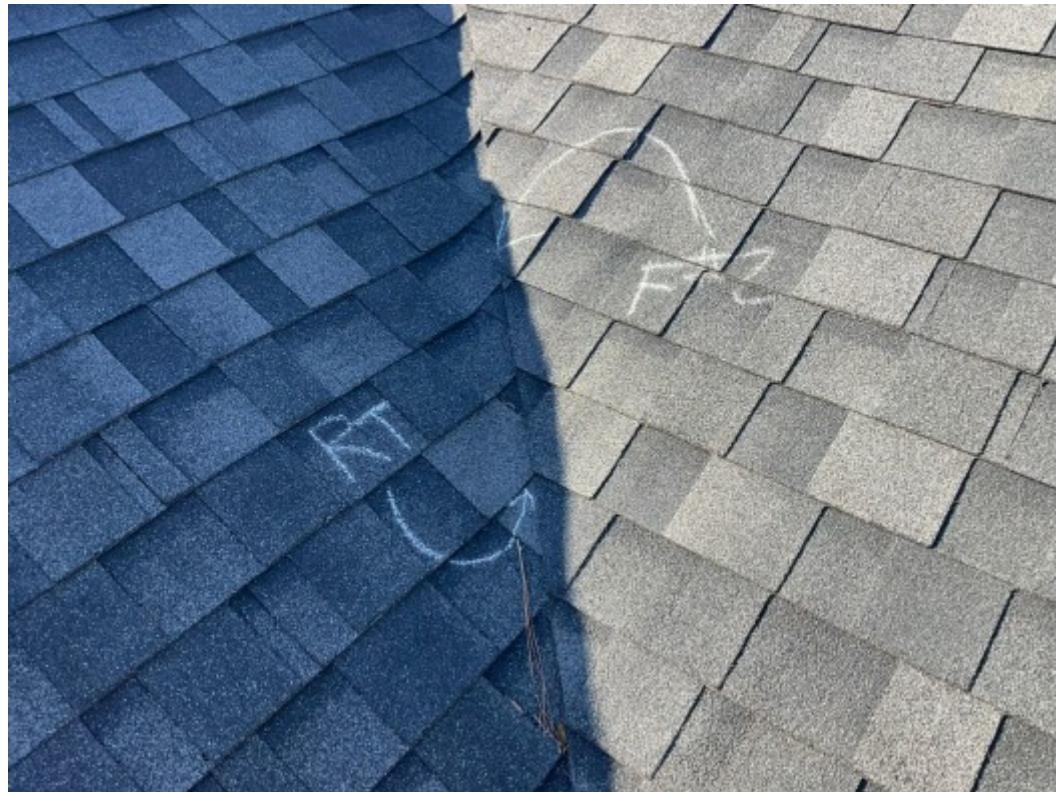
7-Building Roof

The right slope underlays the front slope at the valley.

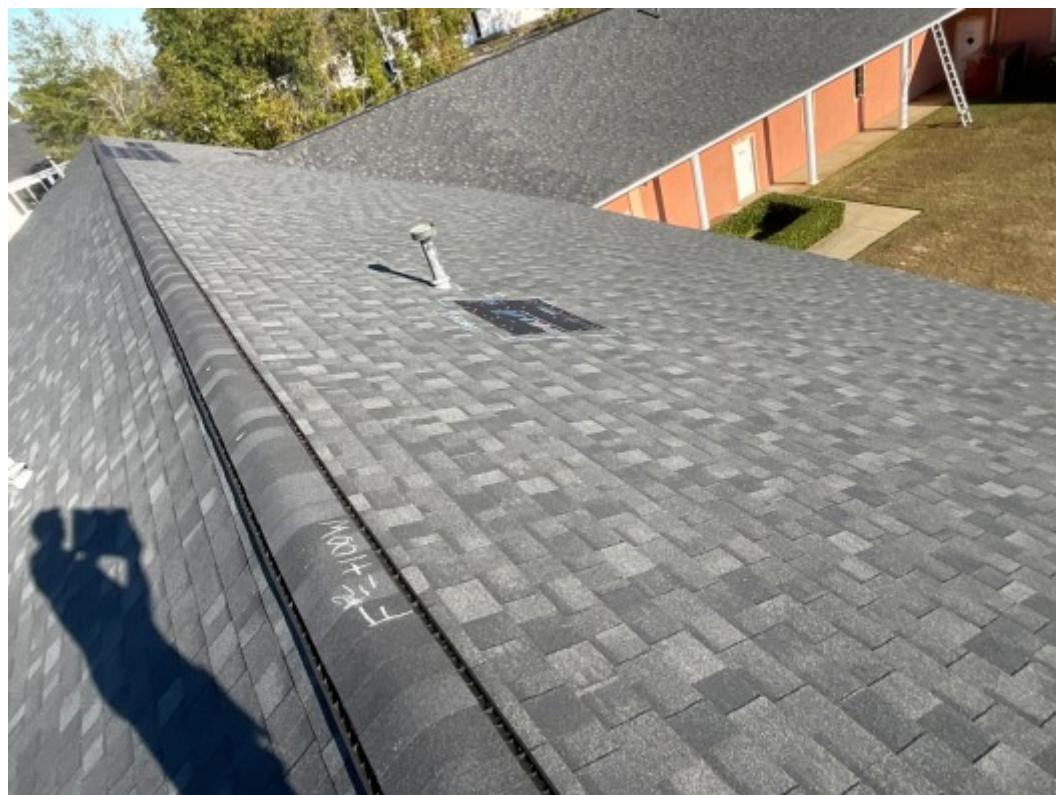
8-Building Roof

It appears as the wind has damaged over 100 shingles on the front facing slope of the church building roof.

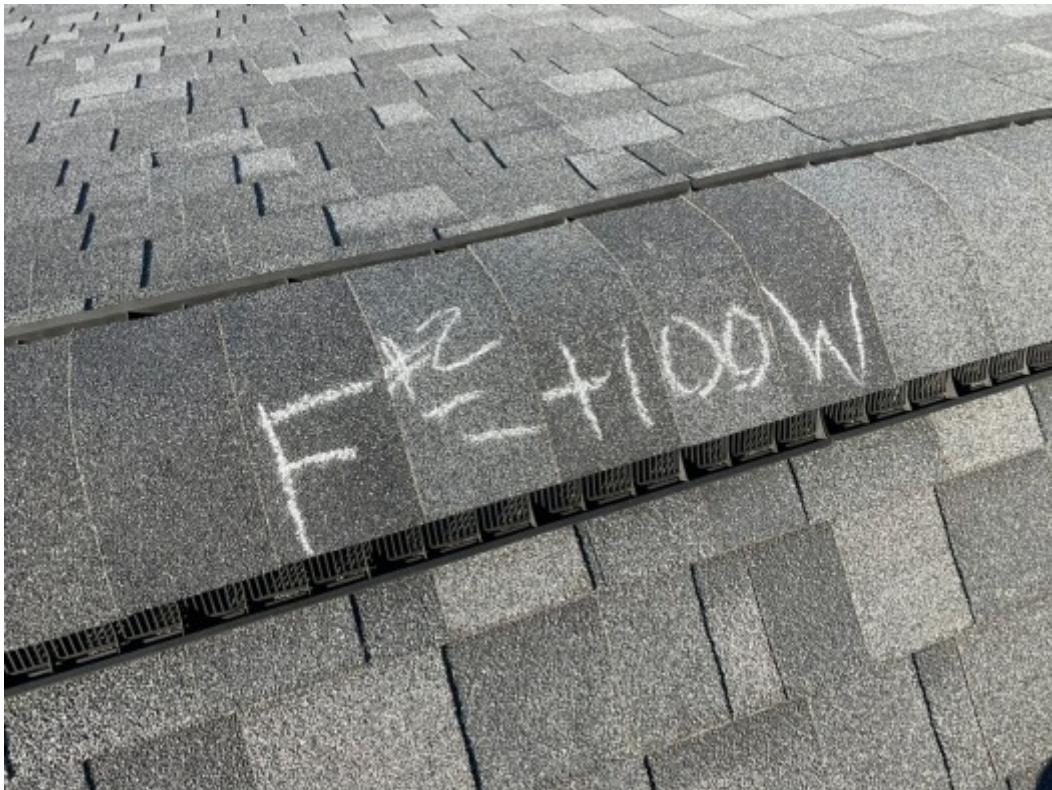
9-Building Roof

It appears as the wind has damaged over 100 shingles on the front facing slope of the church building roof.

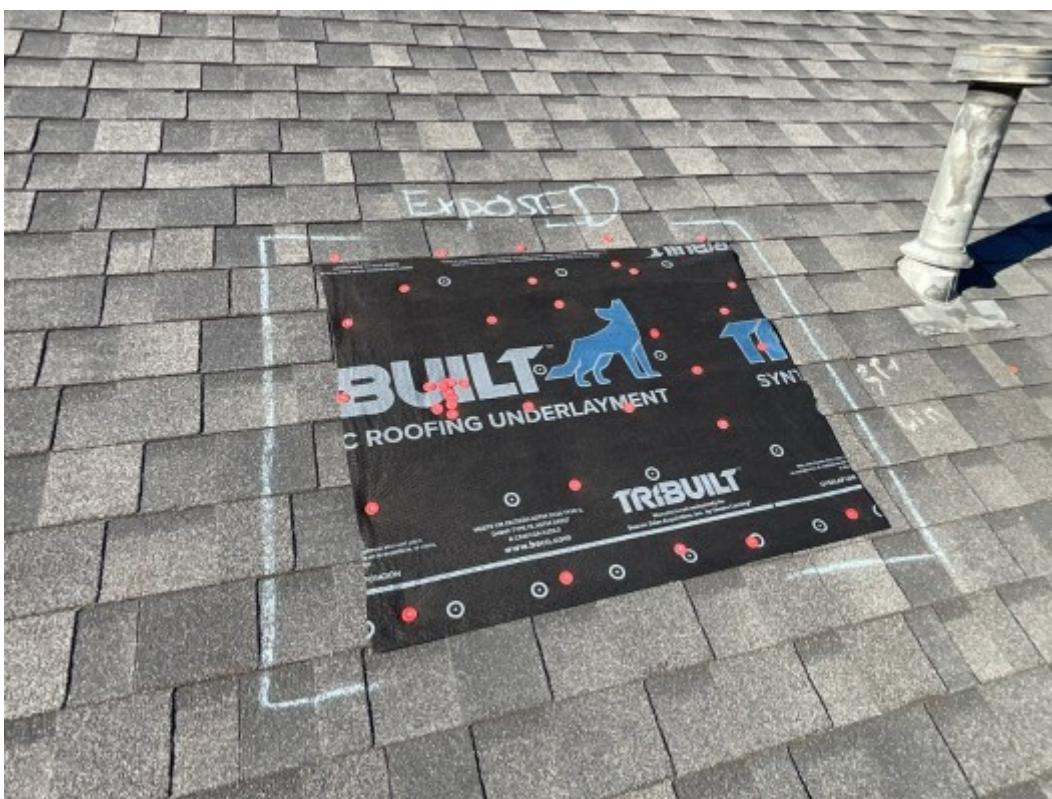
10-Building Roof

It appears as the wind has damaged over 100 shingles on the front facing slope of the church building roof.

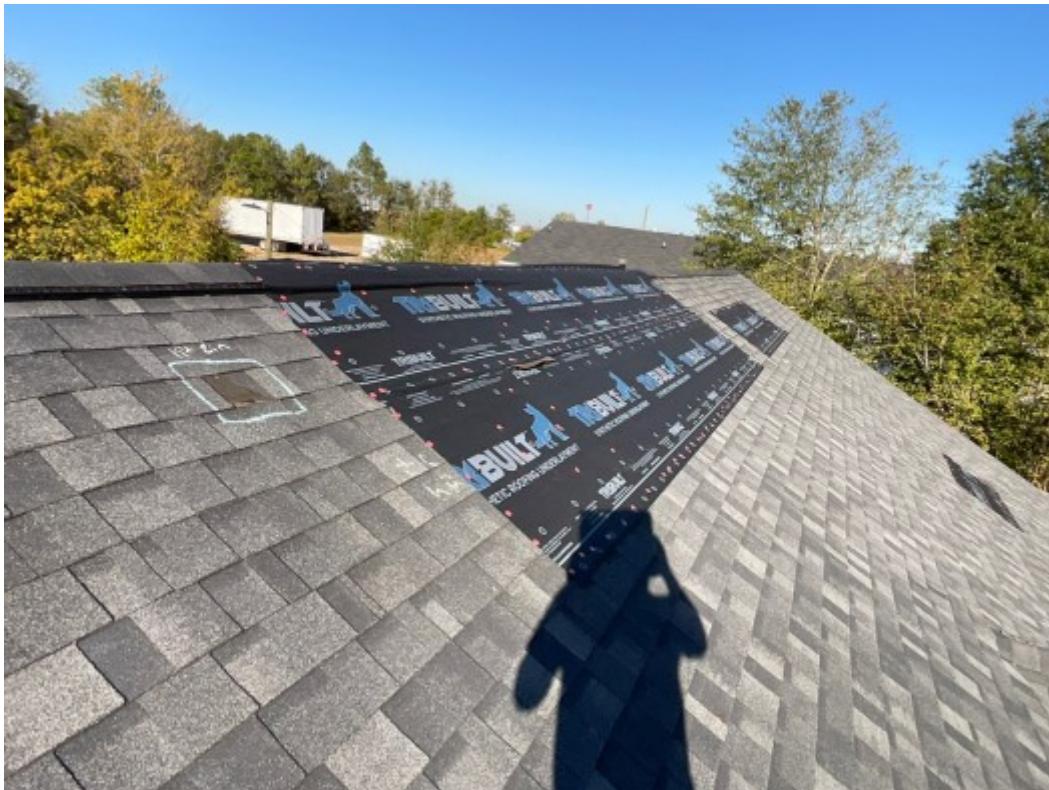
11-Building Roof

It appears as the wind has damaged over 100 shingles on the front facing slope of the church building roof.

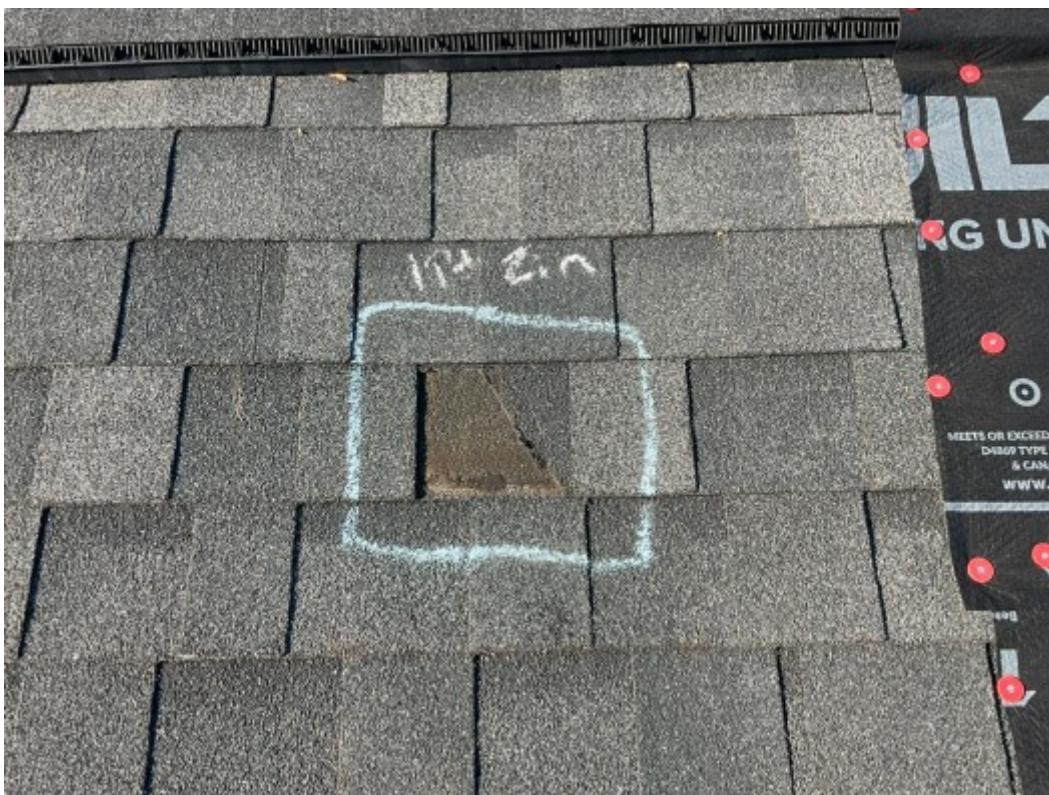
12-Building Roof

It appears as the wind has damaged over 100 shingles on the front facing slope of the church building roof.

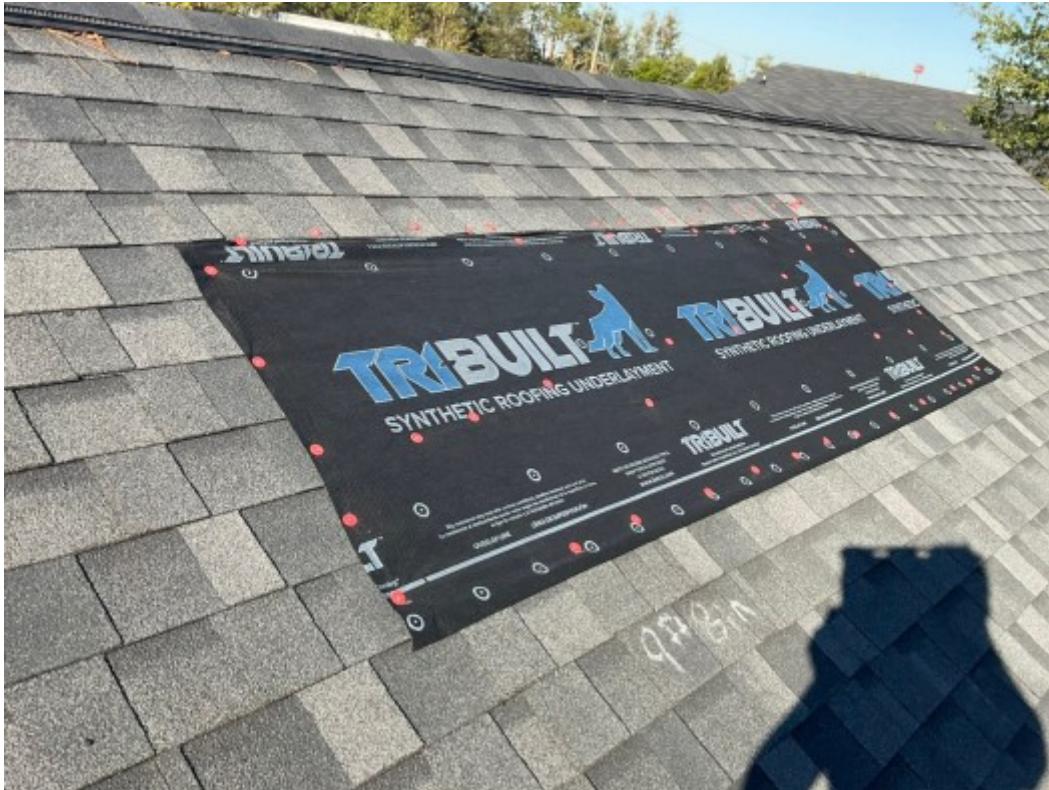
13-Building Roof

It appears as the wind has damaged over 100 shingles on the front facing slope of the church building roof.

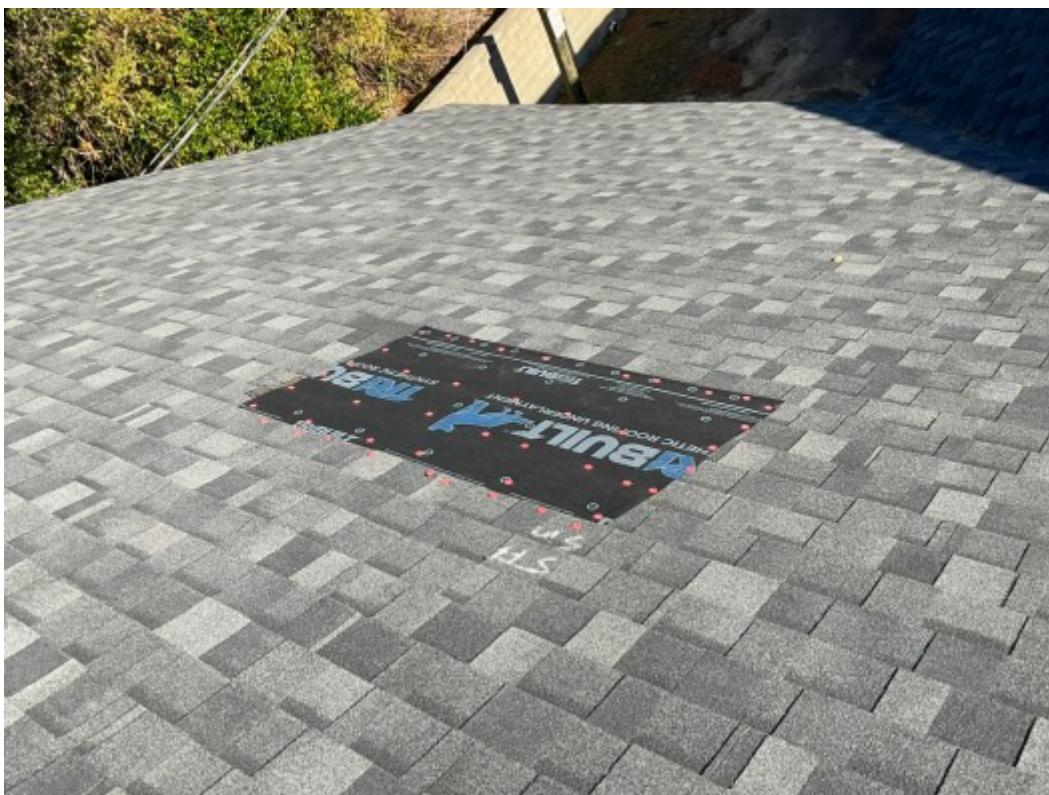
14-Building Roof

It appears as the wind has damaged over 100 shingles on the front facing slope of the church building roof.

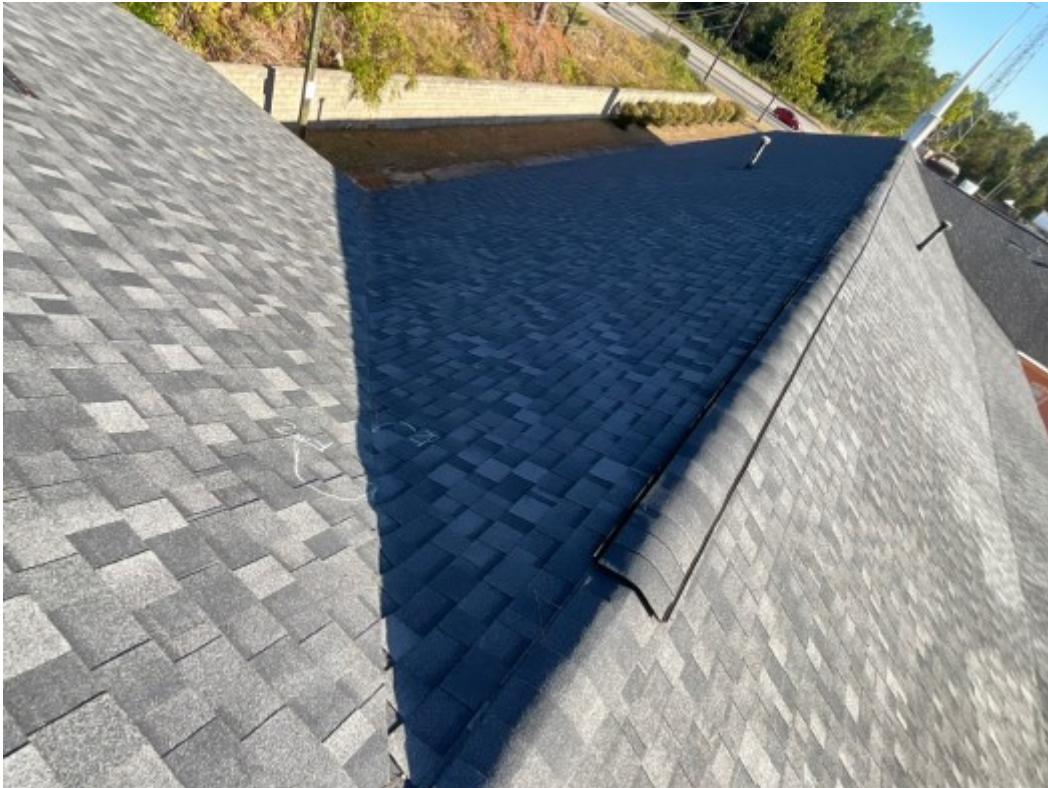
15-Building Roof

The right facing slope has been inspected and found to be free from storm related damage. Please note, the slope is tucked under the damaged front facing slope at the valley.

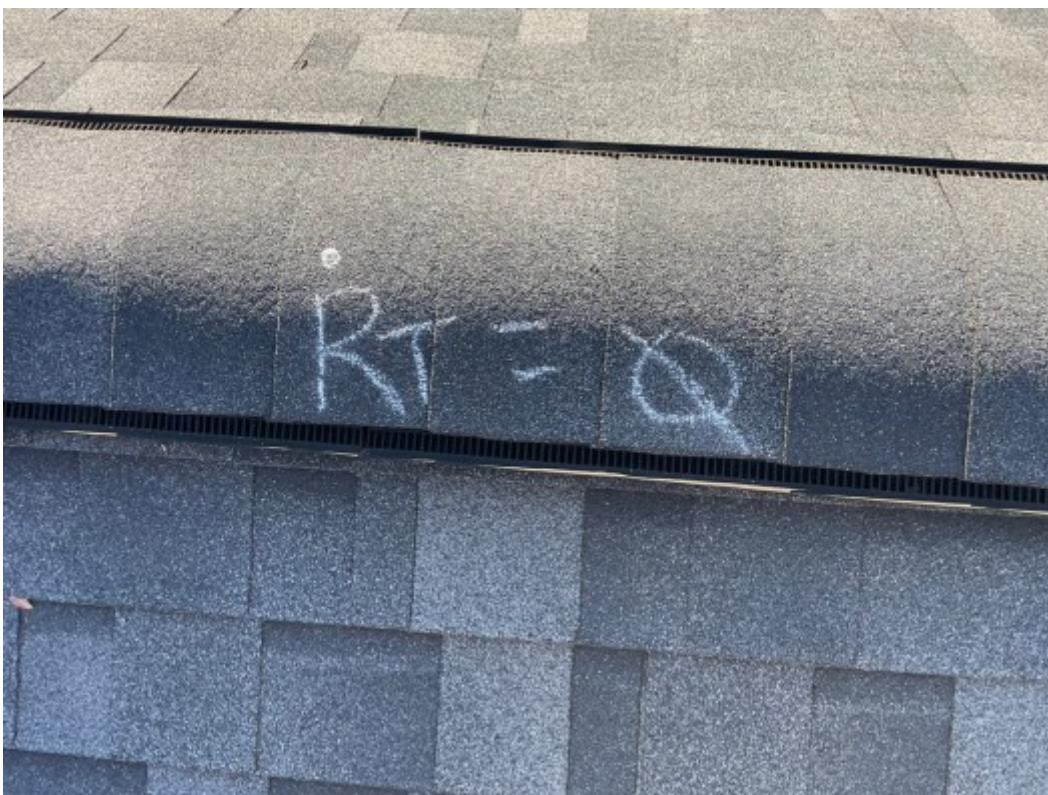
16-Building Roof

The right facing slope has been inspected and found to be free from storm related damage. Please note, the slope is tucked under the damaged front facing slope at the valley.

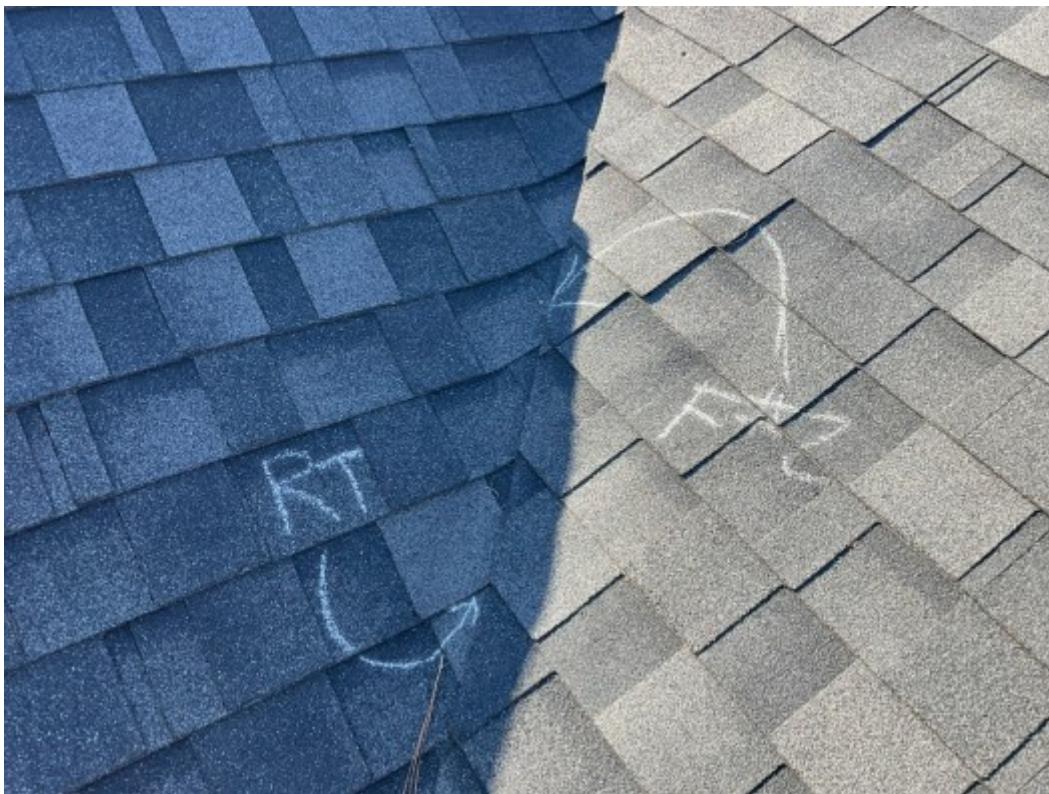
17-Building Roof

The right facing slope has been inspected and found to be free from storm related damage. Please note, the slope is tucked under the damaged front facing slope at the valley.

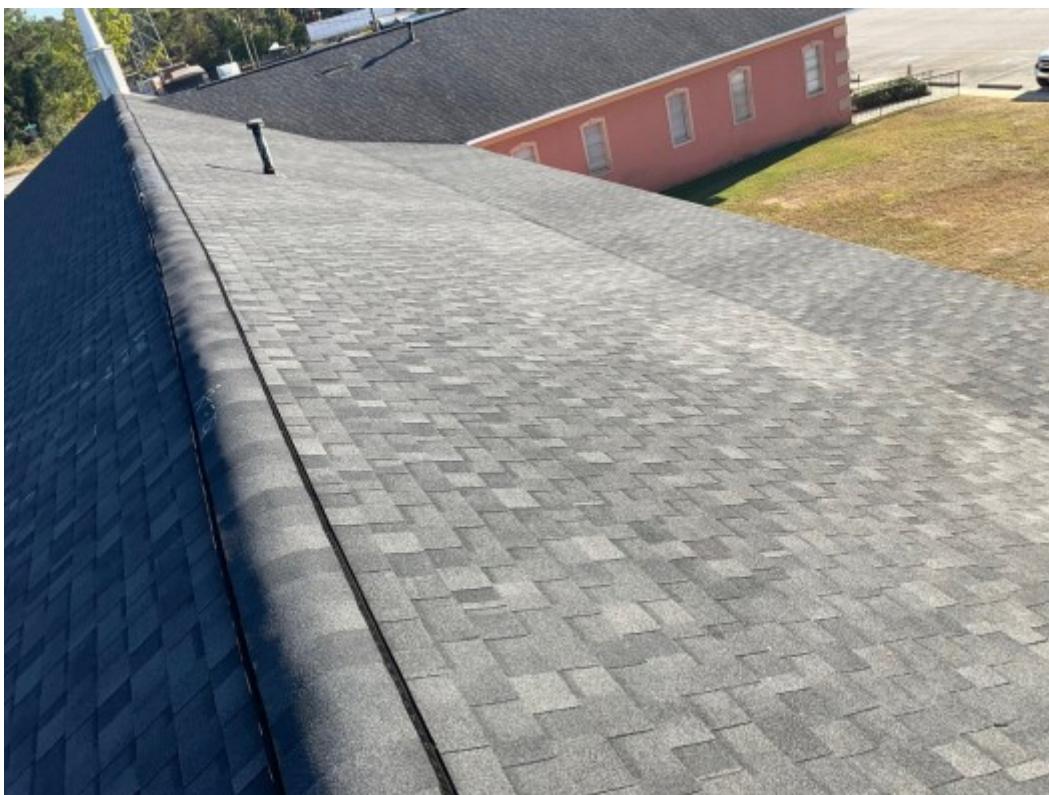
18-Building Roof

It appears as the wind has damaged five shingles on the left facing slope of the church building roof.

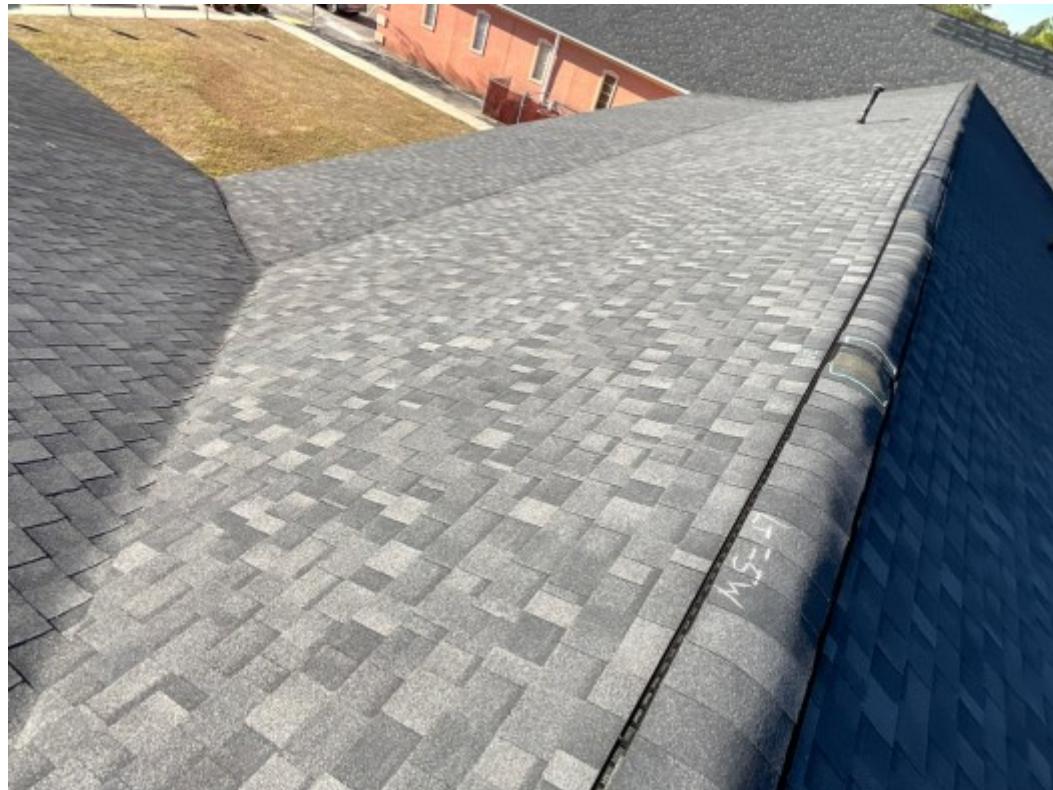
19-Building Roof

It appears as the wind has damaged five shingles on the left facing slope of the church building roof.

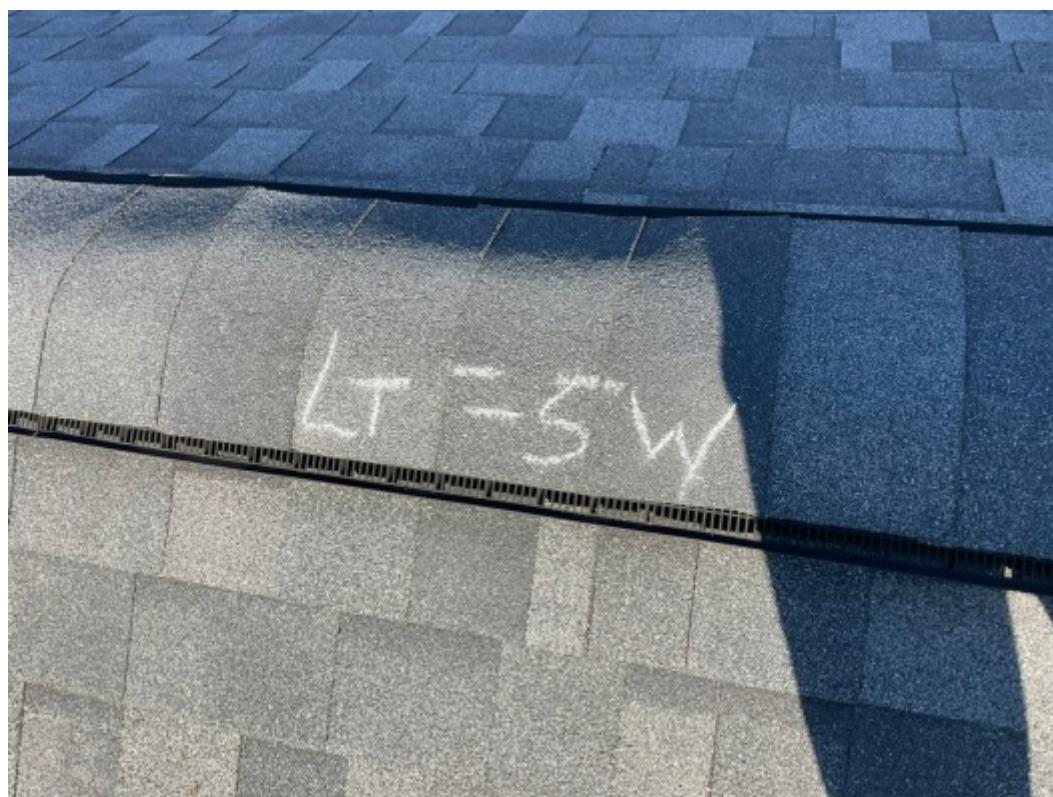
20-Building Roof

It appears as the wind has damaged five shingles on the left facing slope of the church building roof.

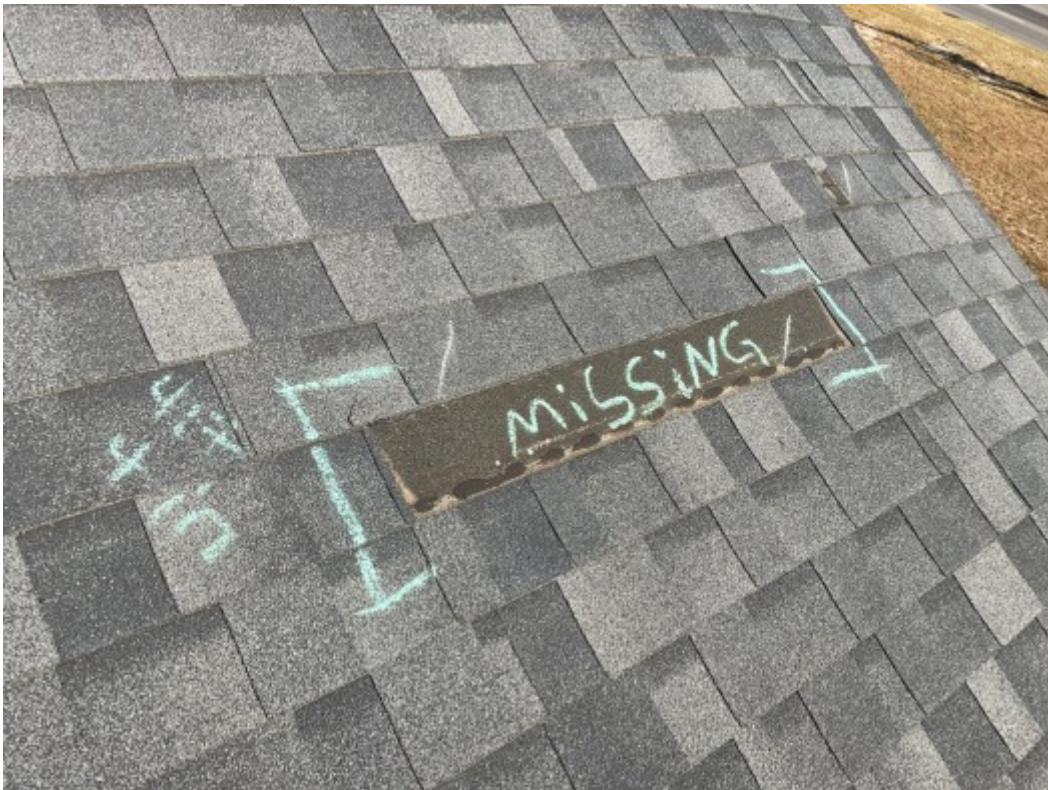
21-Building Roof

It appears as the wind has damaged five shingles on the left facing slope of the church building roof.

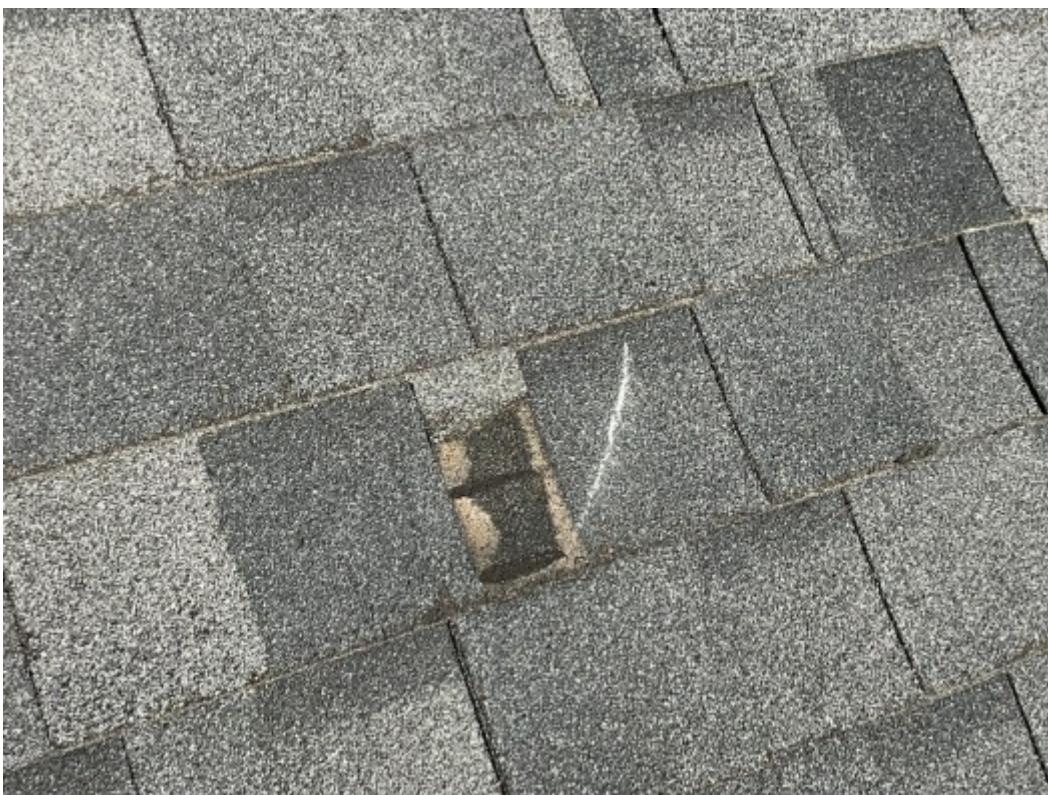
22-Building Roof

It appears as the wind has damaged five shingles on the left facing slope of the church building roof.

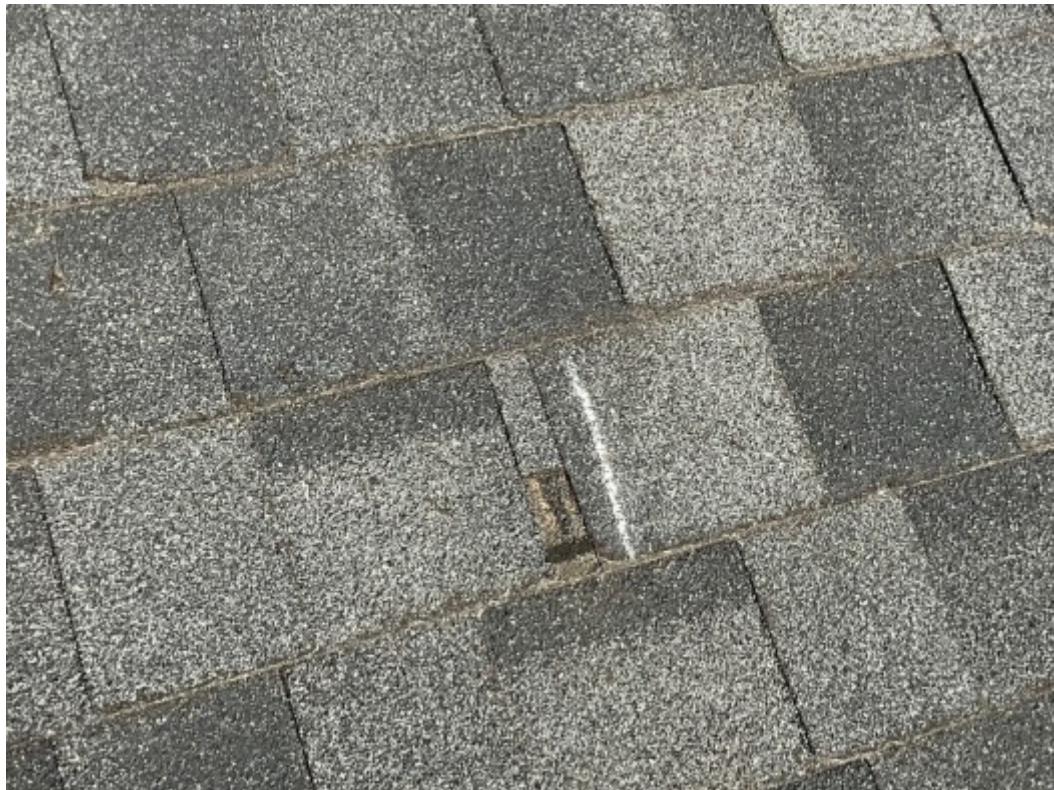
23-Building Roof

It appears as the wind has damaged five shingles on the left facing slope of the church building roof.

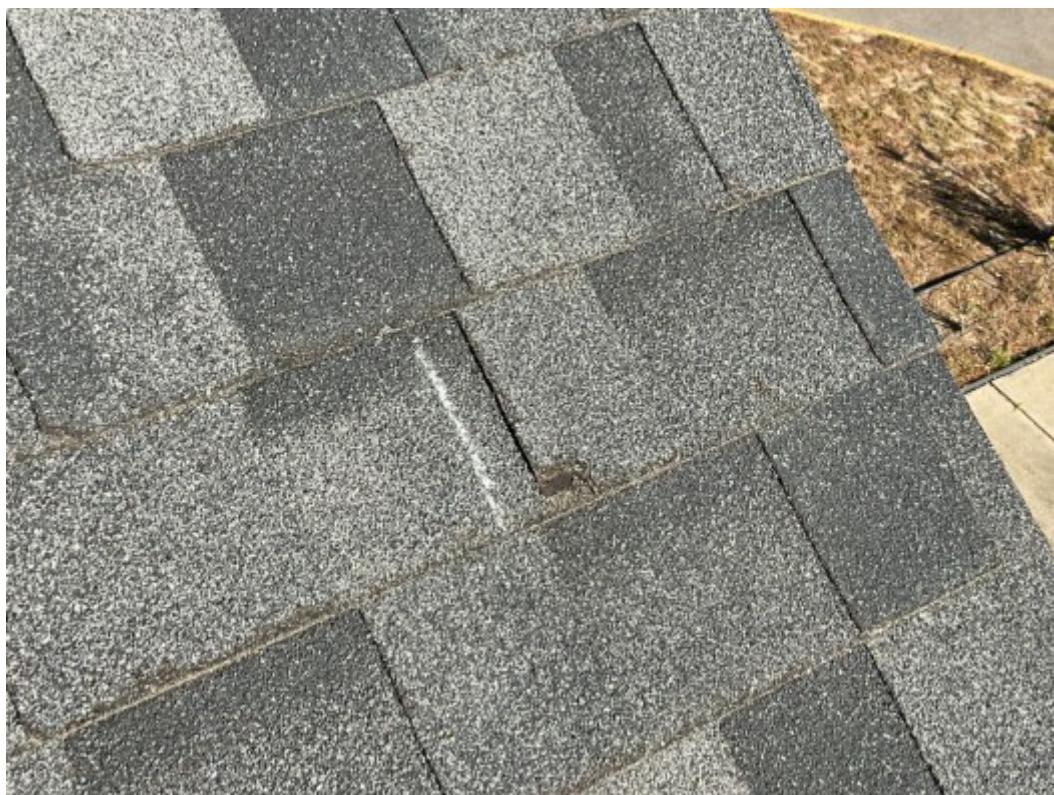
24-Building Roof

It appears as the wind has damaged five shingles on the left facing slope of the church building roof.

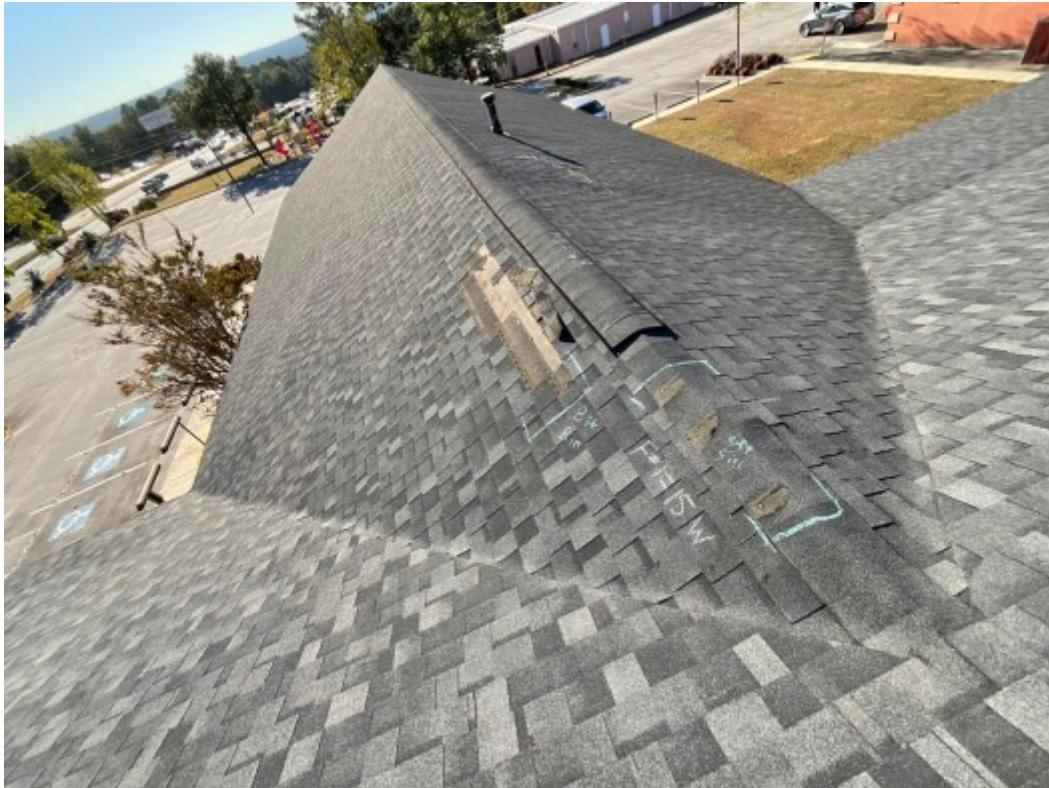
25-Building Roof

It appears as the wind has damaged 15 shingles on the front facing slope of the church building roof.

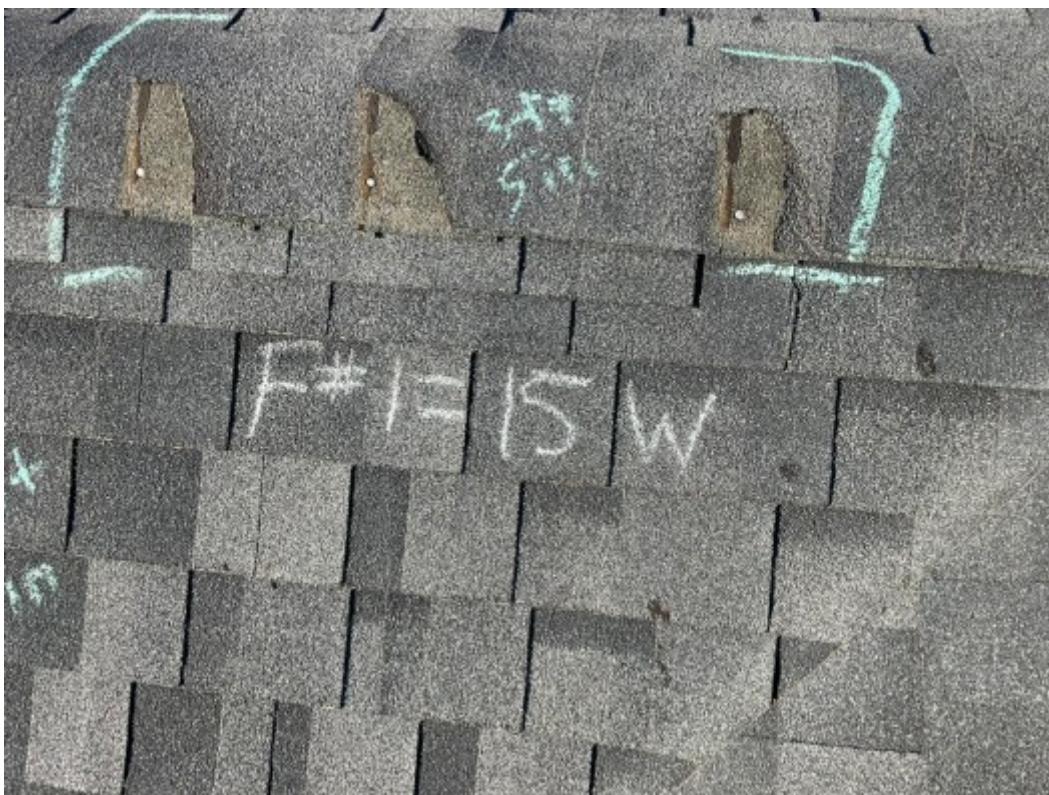
26-Building Roof

It appears as the wind has damaged 15 shingles on the front facing slope of the church building roof.

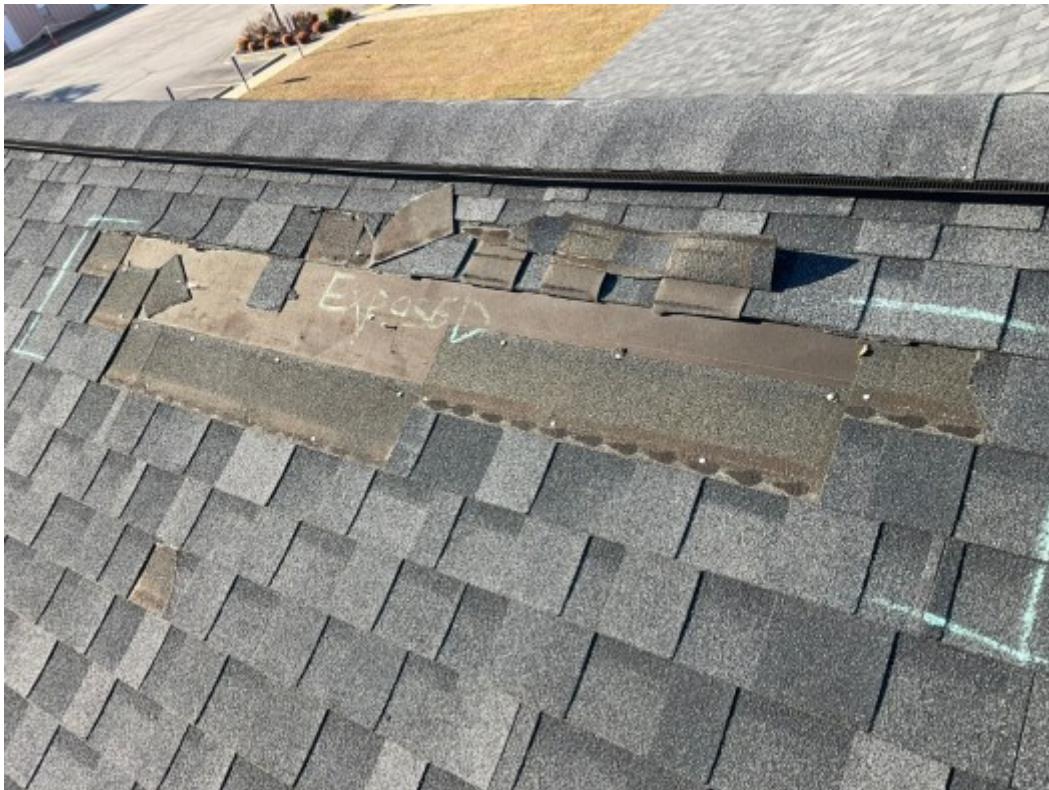
27-Building Roof

It appears as the wind has damaged 15 shingles on the front facing slope of the church building roof.

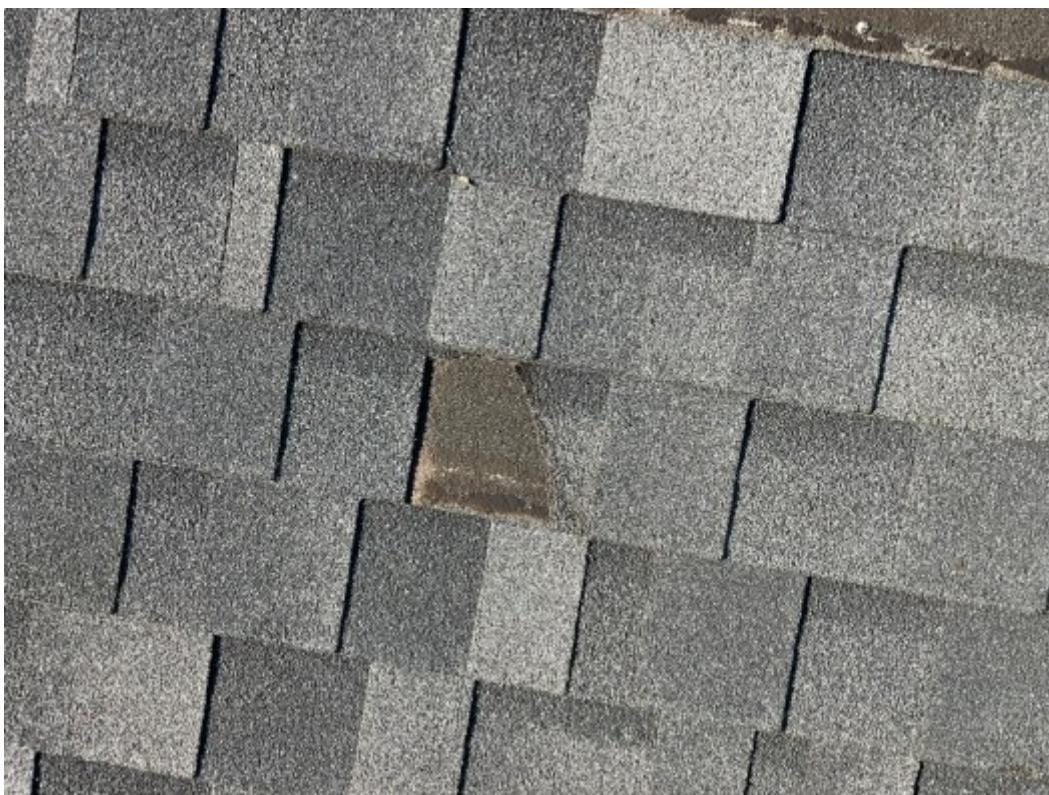
28-Building Roof

It appears as the wind has damaged 15 shingles on the front facing slope of the church building roof.

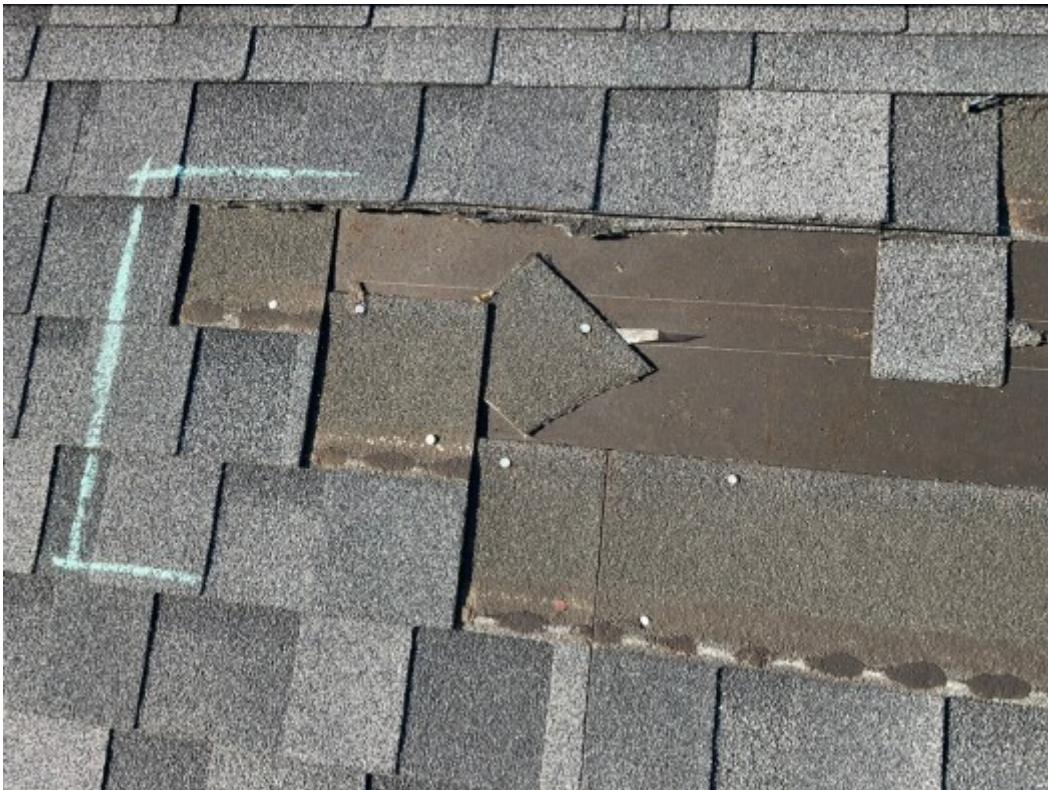
29-Building Roof

It appears as the wind has damaged 15 shingles on the front facing slope of the church building roof.
