Photo Sheet

Eberl Claims Service

Insured: NEW ZION HILL MISSIONARY BAPTIST CHURCH INCORPORATED

Claim #: AA190825

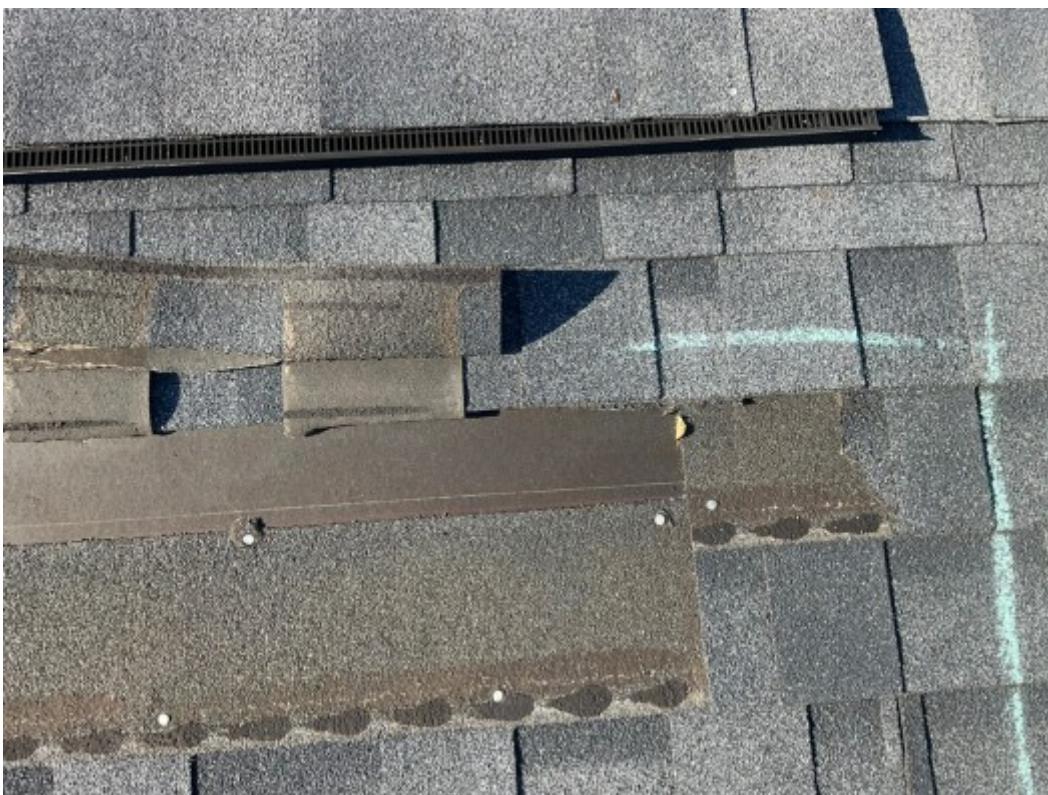
30-Building Roof

It appears as the wind has damaged 15 shingles on the front facing slope of the church building roof.

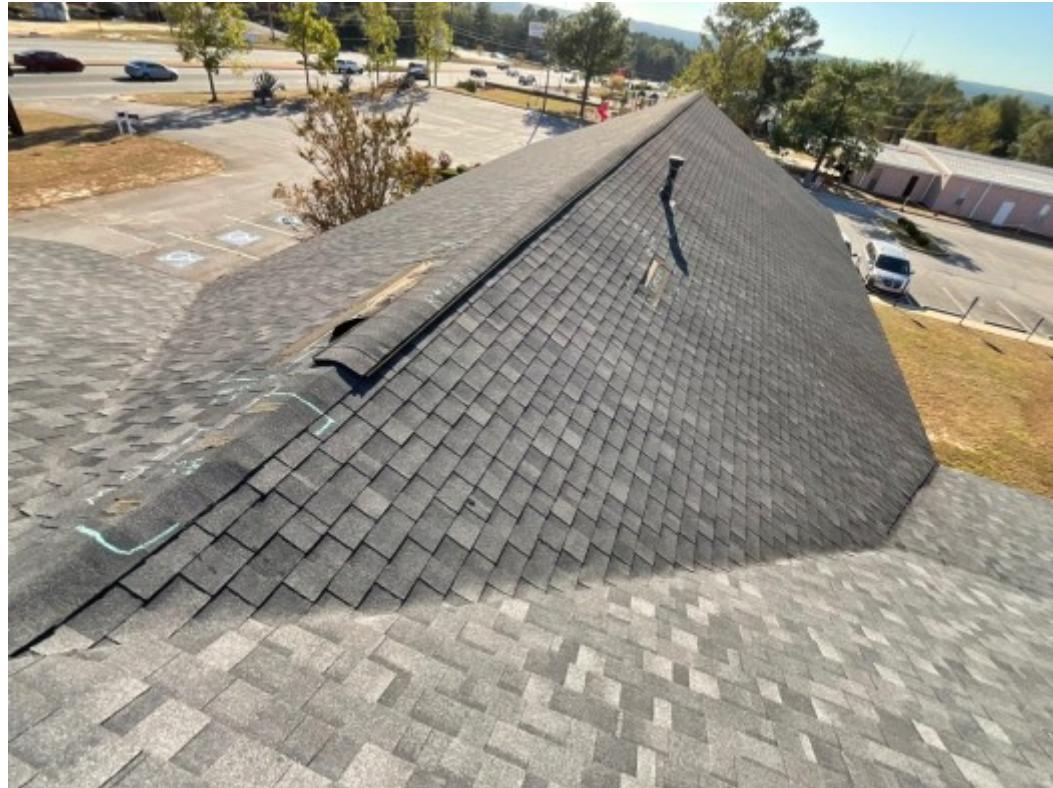
31-Building Roof

It appears as the wind has damaged 11 shingles on the rear facing slope of the church building roof.

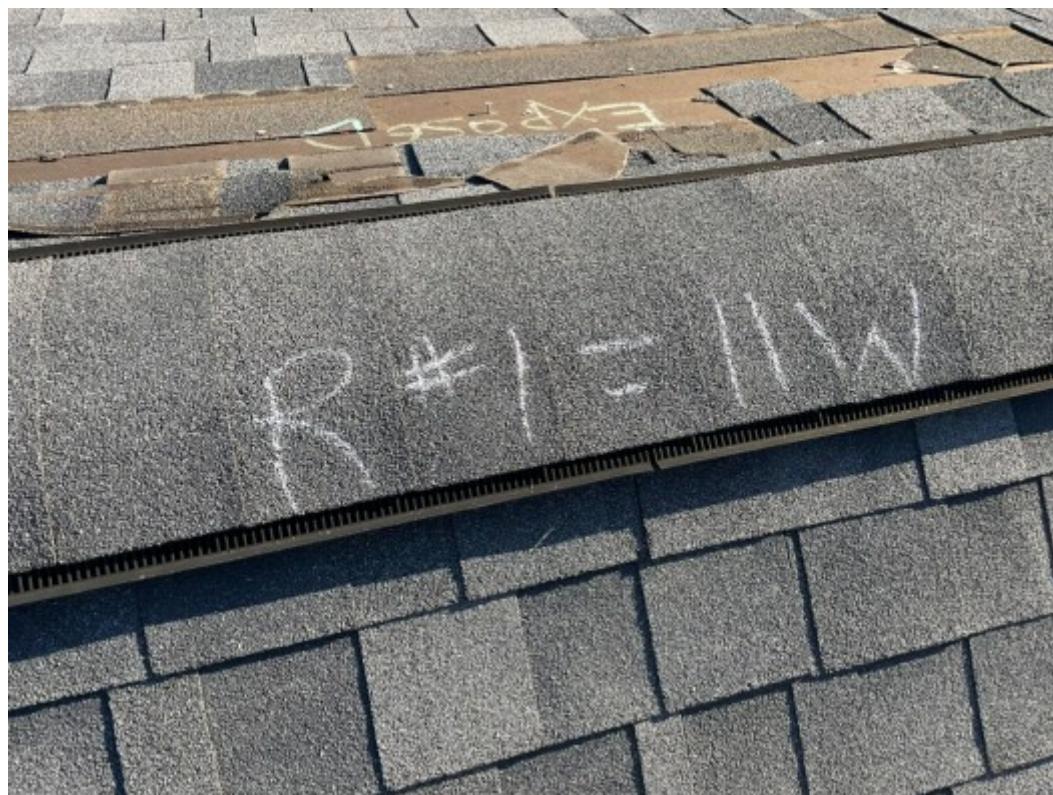
32-Building Roof

It appears as the wind has damaged 11 shingles on the rear facing slope of the church building roof.

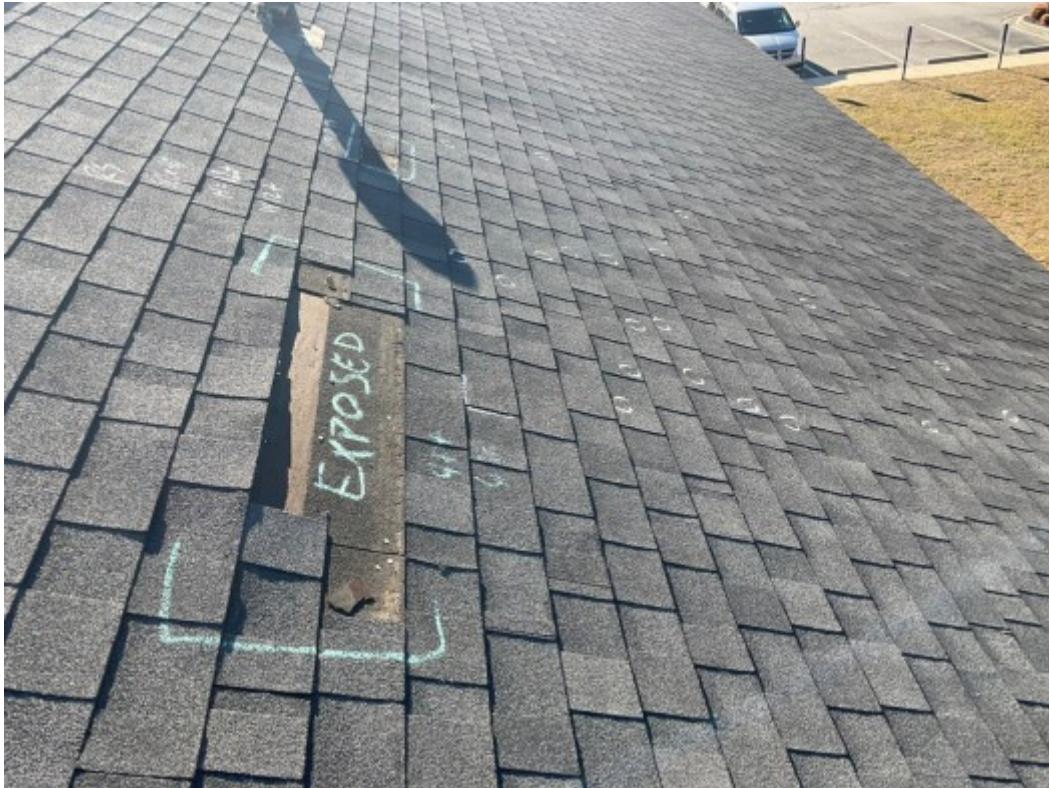
33-Building Roof

It appears as the wind has damaged 11 shingles on the rear facing slope of the church building roof.

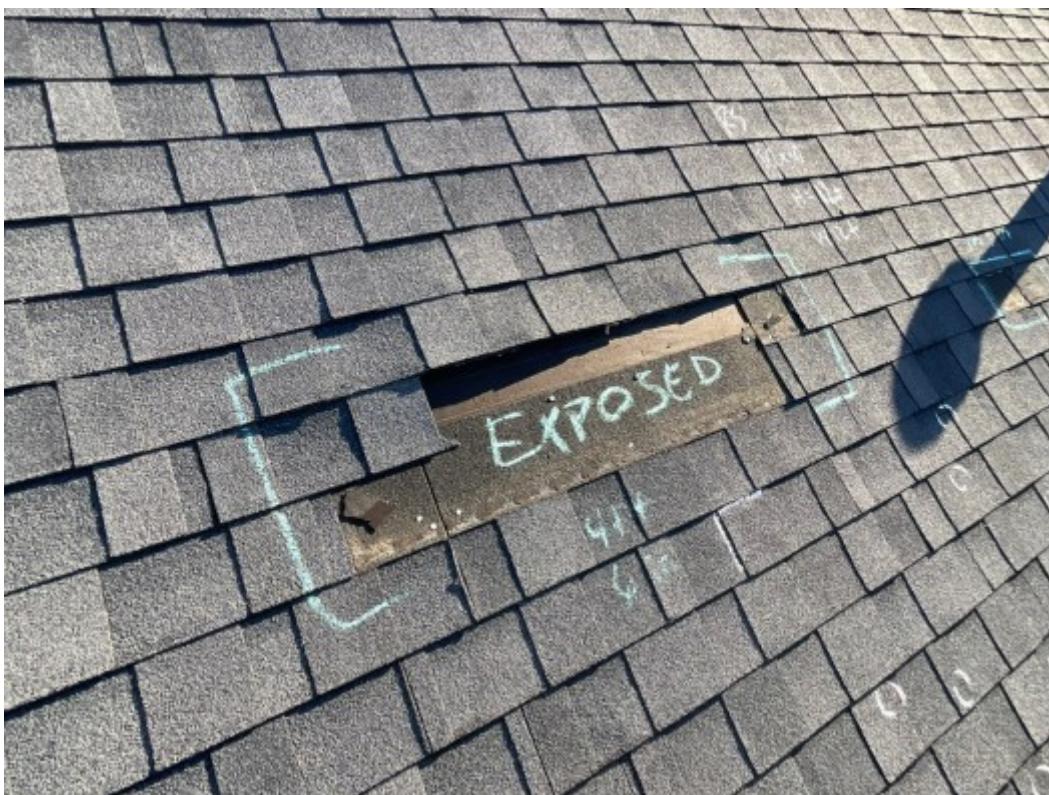
34-Building Roof

It appears as the wind has damaged 11 shingles on the rear facing slope of the church building roof.

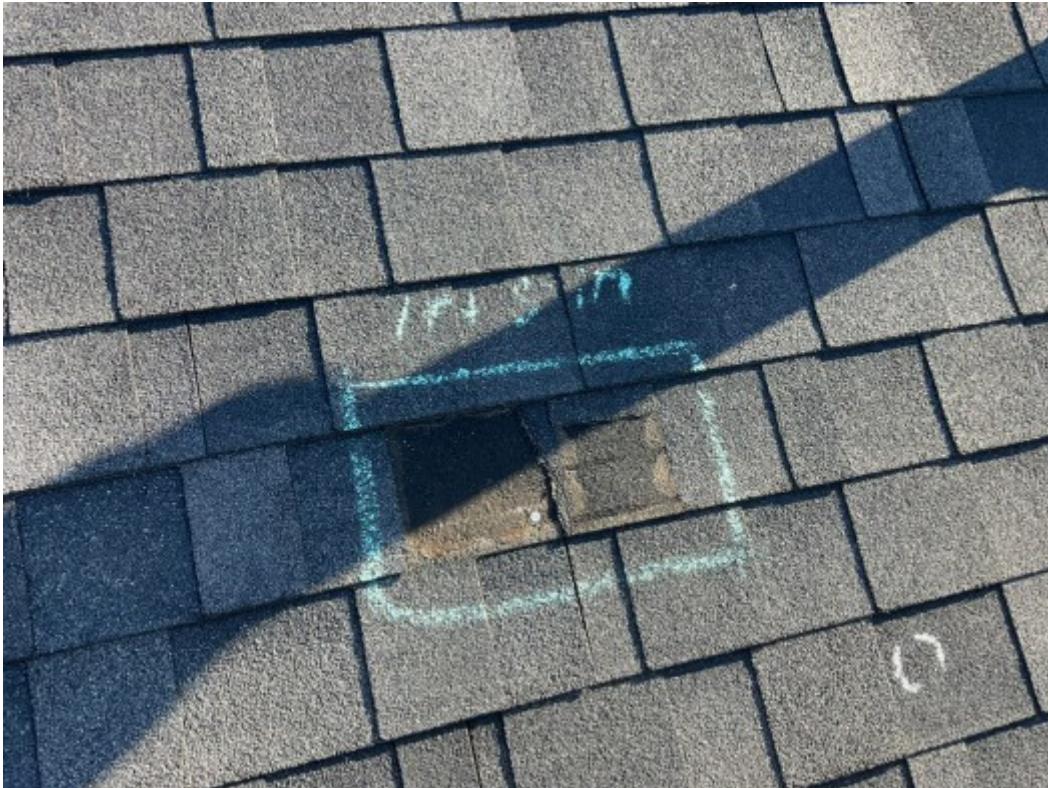
35-Building Roof

It appears as the wind has damaged 11 shingles on the rear facing slope of the church building roof.

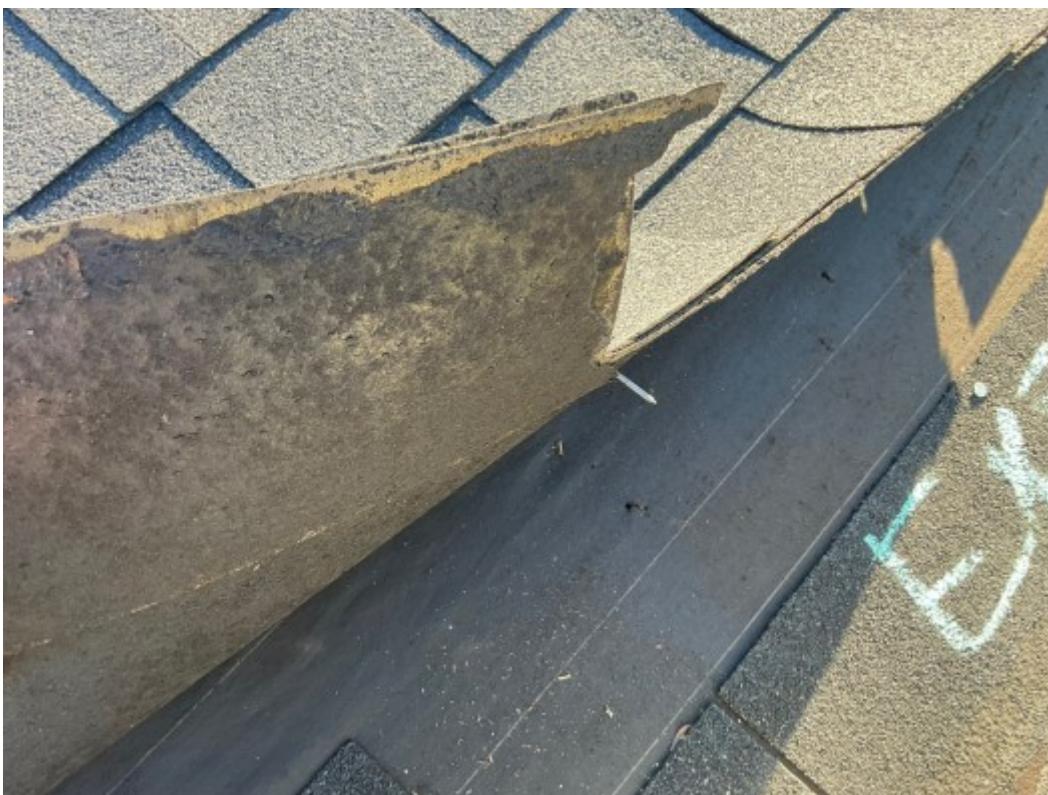
36-Building Roof

It appears as the wind has damaged 11 shingles on the rear facing slope of the church building roof.

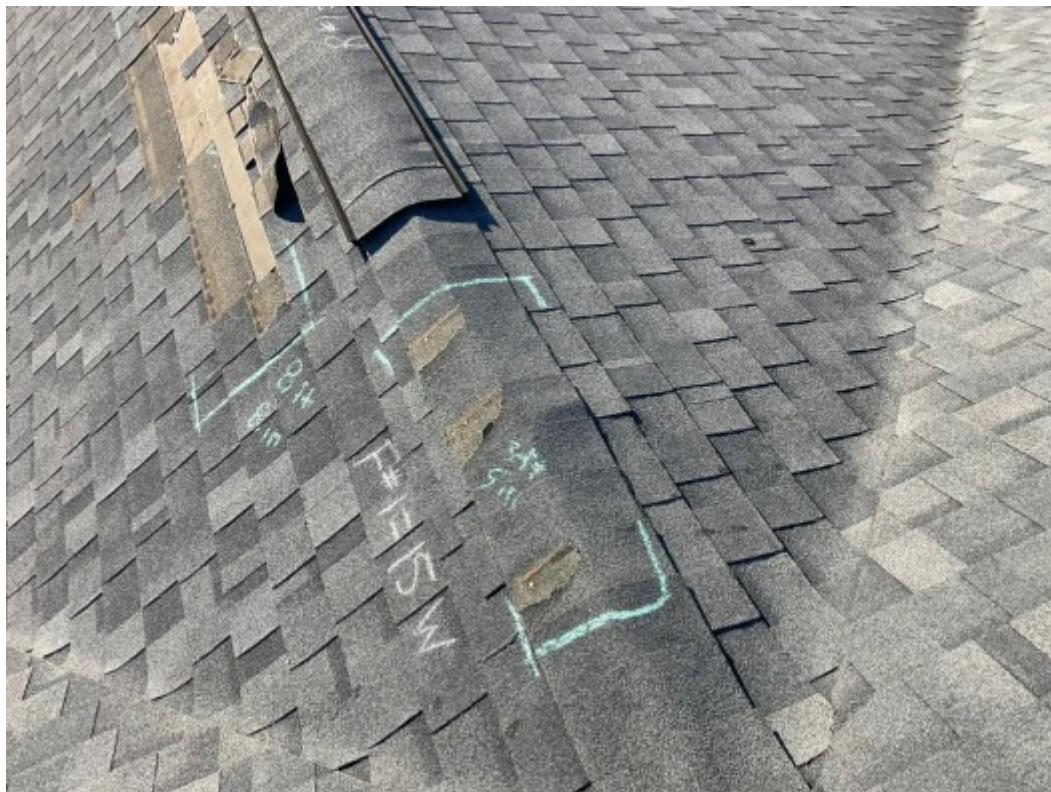
37-Building Roof

Ridge cap throughout the church building roof has been damaged by wind.

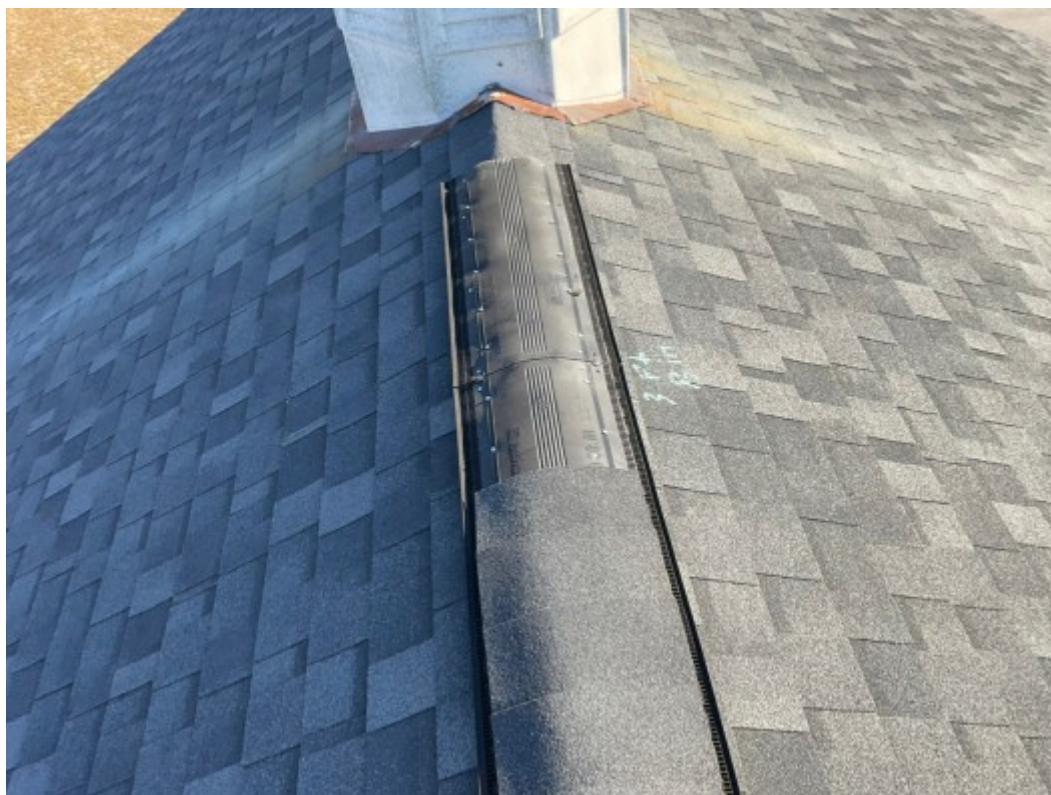
38-Building Roof

Ridge cap throughout the church building roof has been damaged by wind.

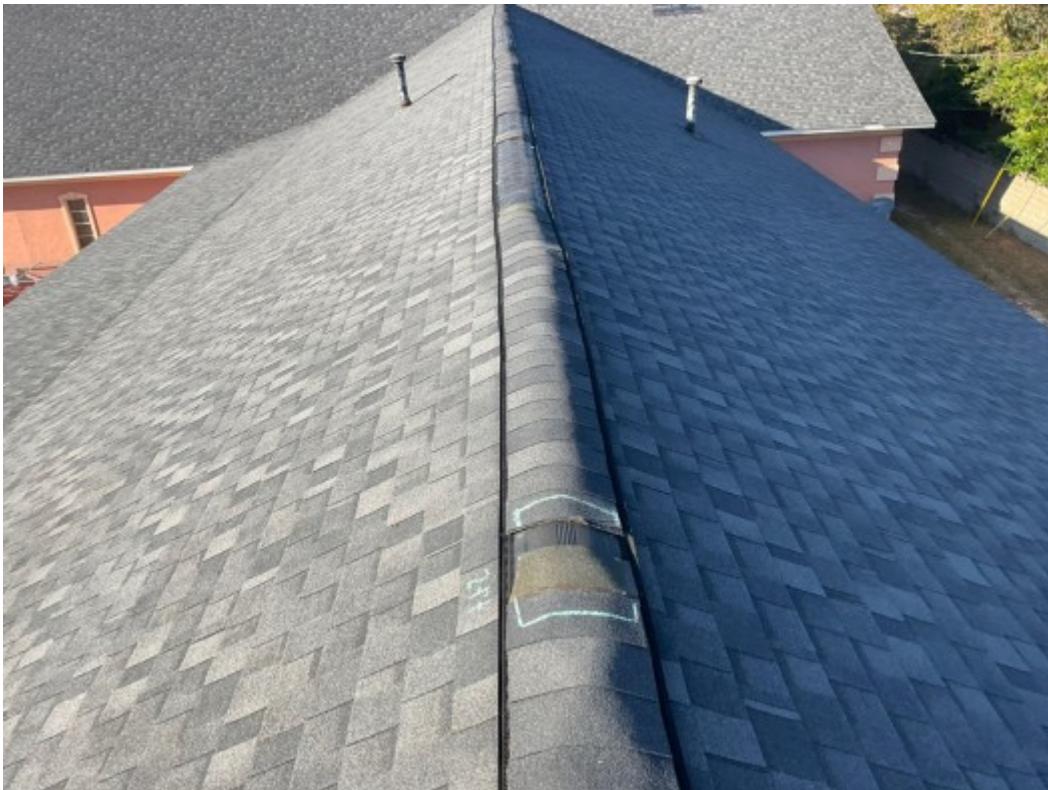
39-Building Roof

Ridge cap throughout the church building roof has been damaged by wind.

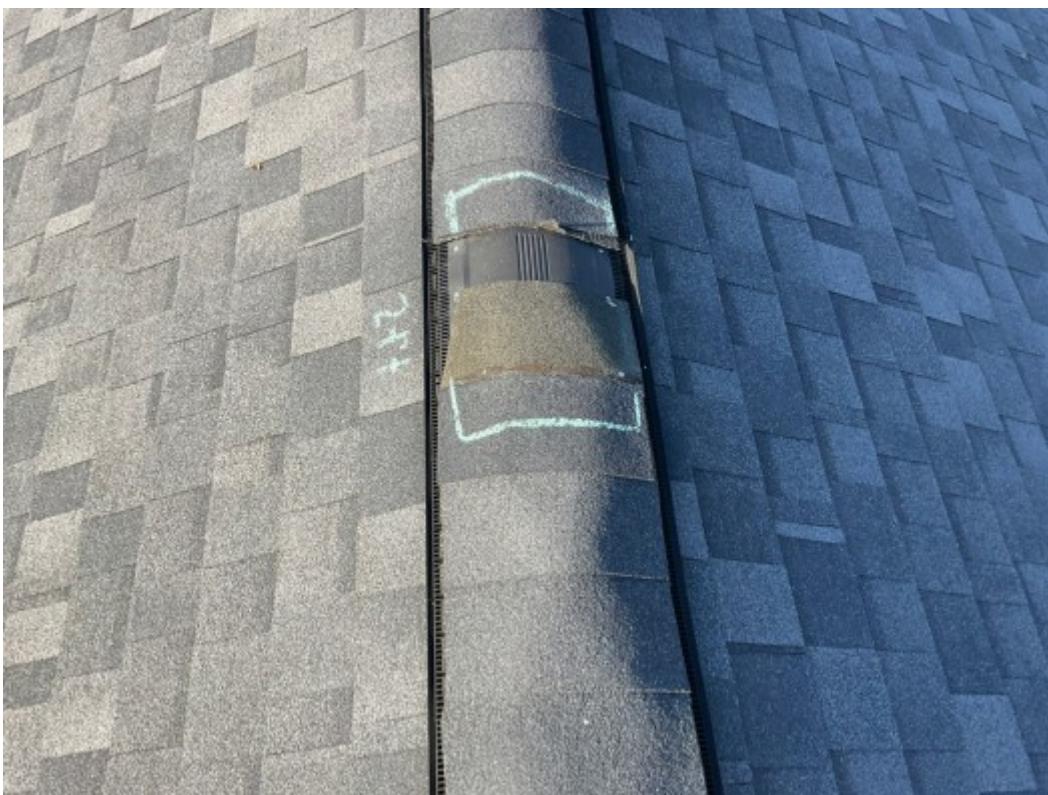
40-Building Roof

Ridge cap throughout the church building roof has been damaged by wind.

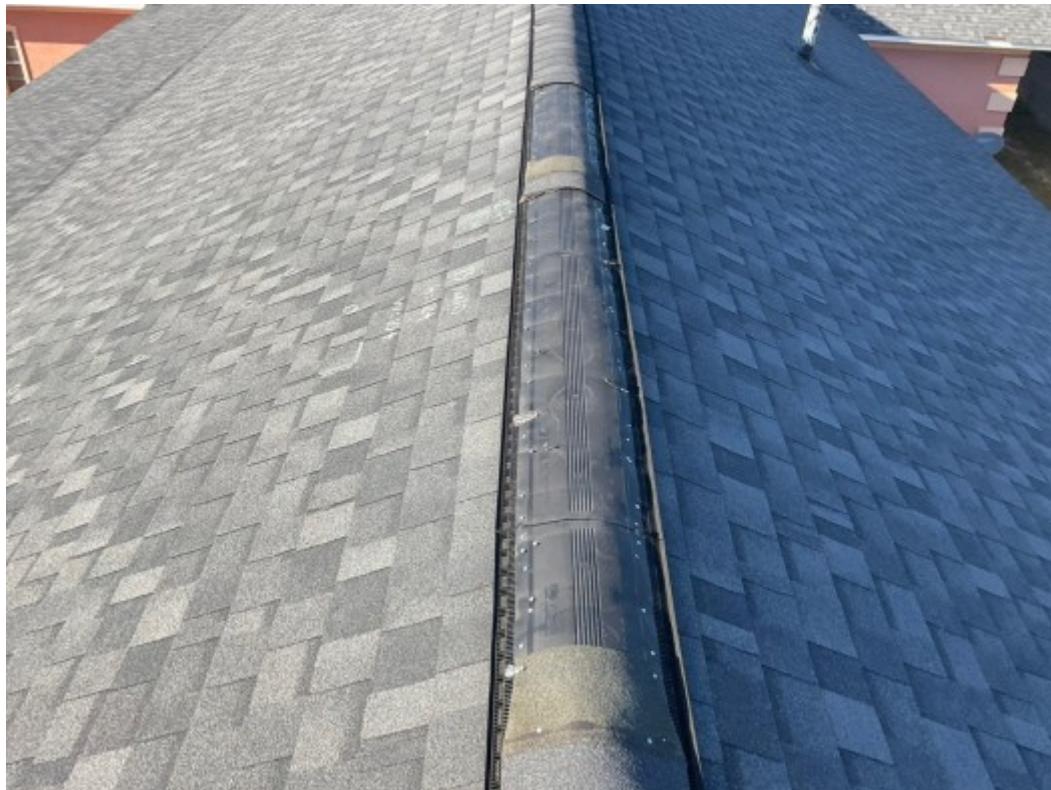
41-Building Roof

Ridge cap throughout the church building roof has been damaged by wind.

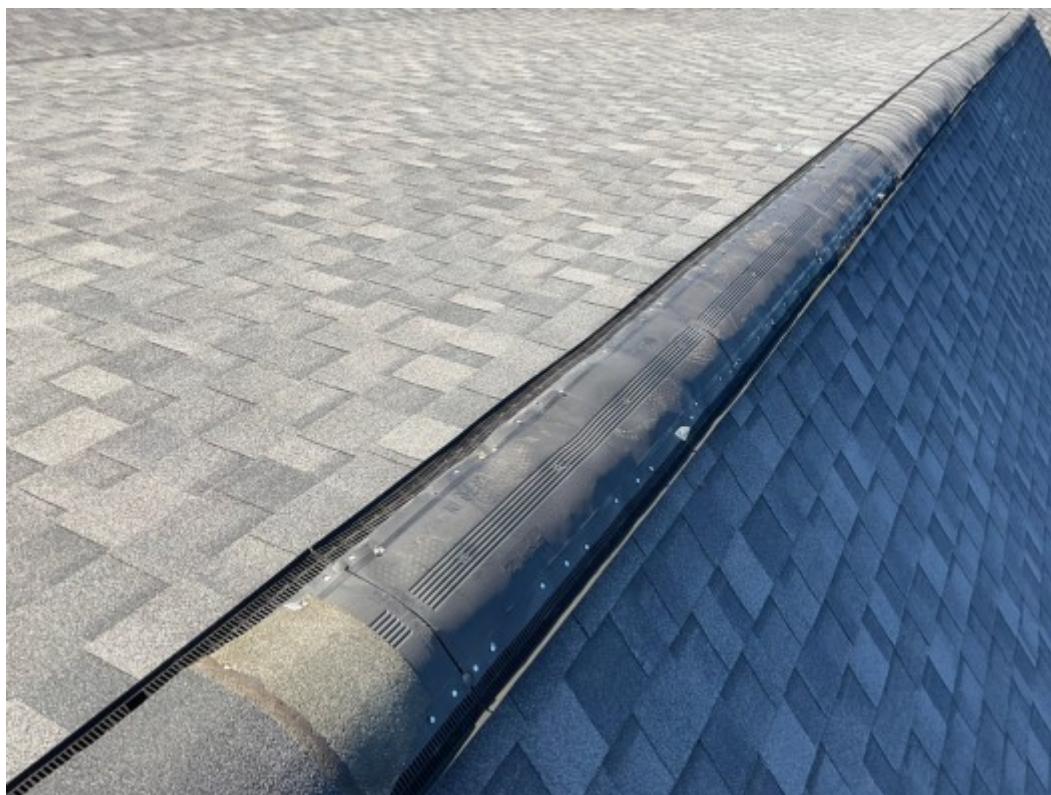
42-Building Roof

Ridge cap throughout the church building roof has been damaged by wind.

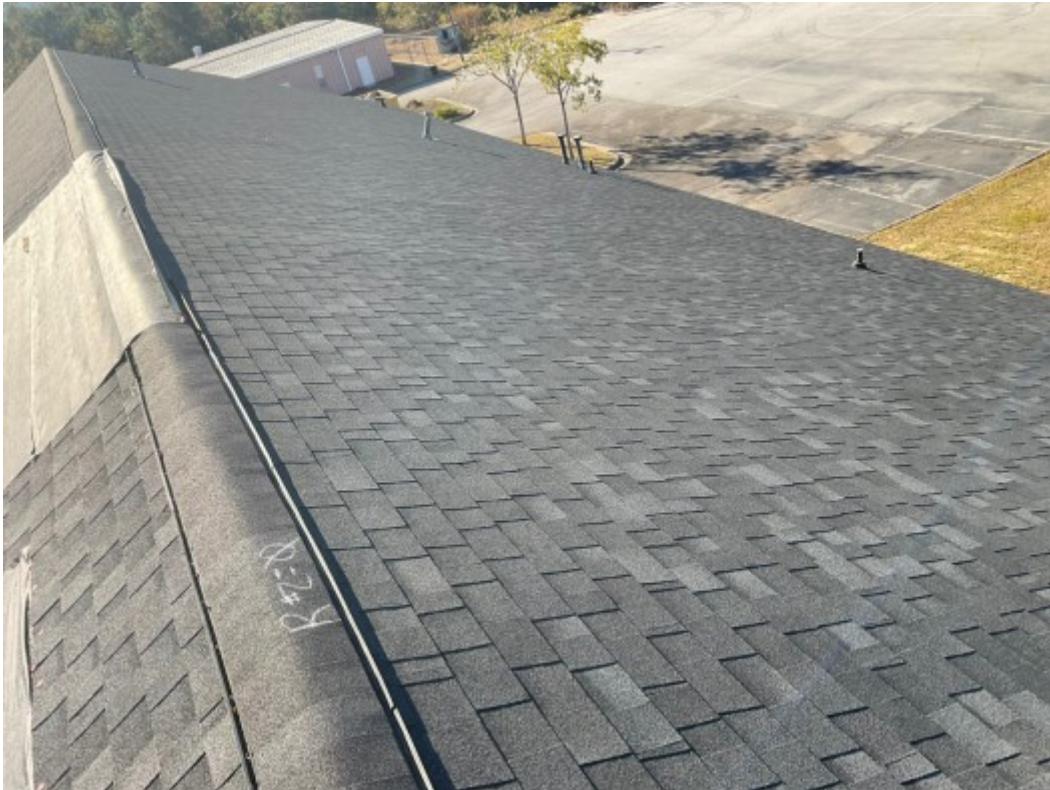
43-Building Roof

The rear most slope has been inspected and found to be free from storm related damage.

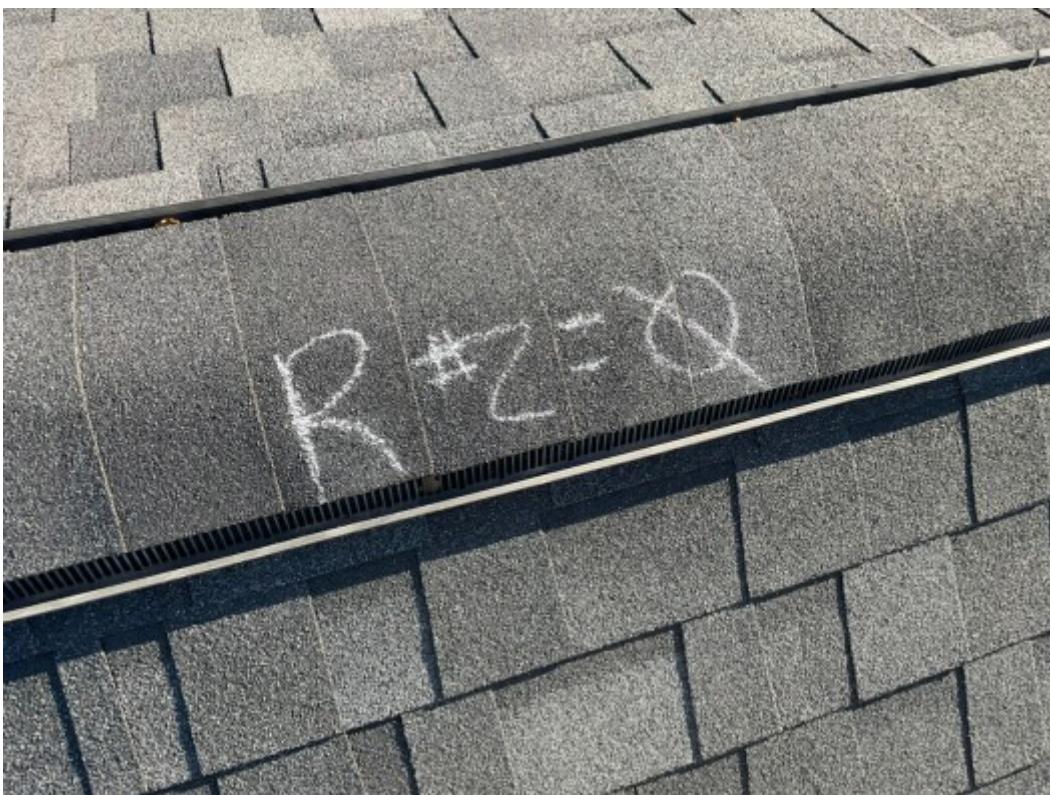
44-Building Roof

The rear most slope has been inspected and found to be free from storm related damage.

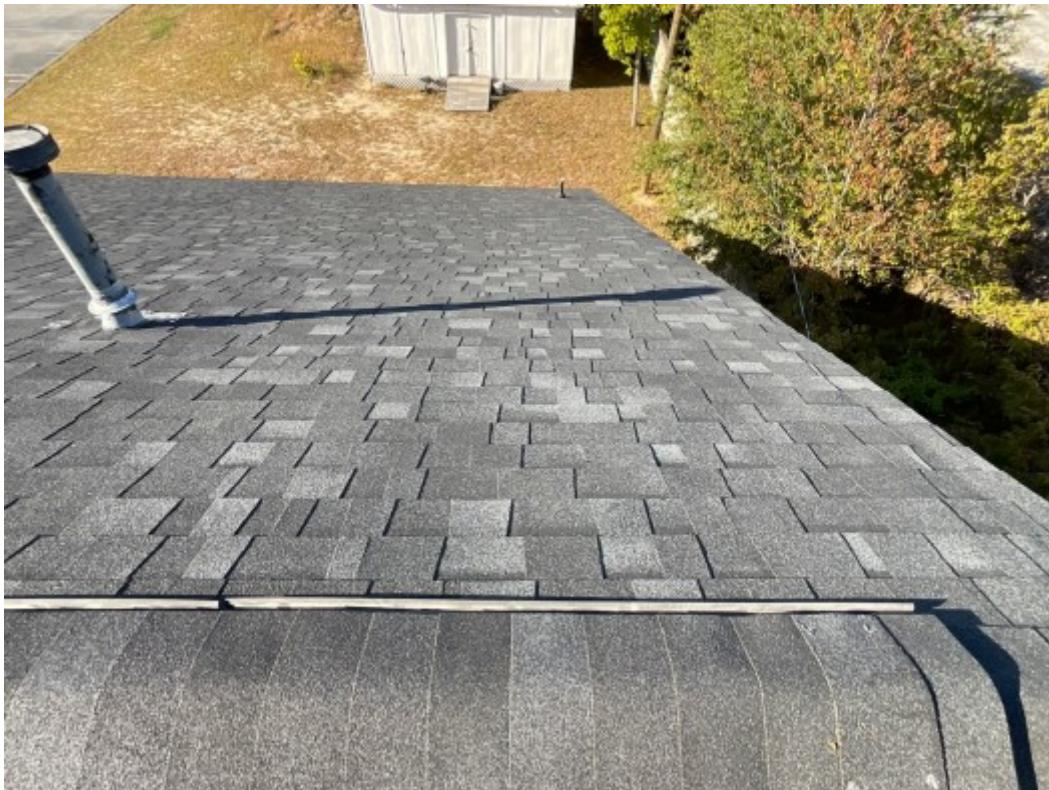
45-Building Roof

The rear most slope has been inspected and found to be free from storm related damage.

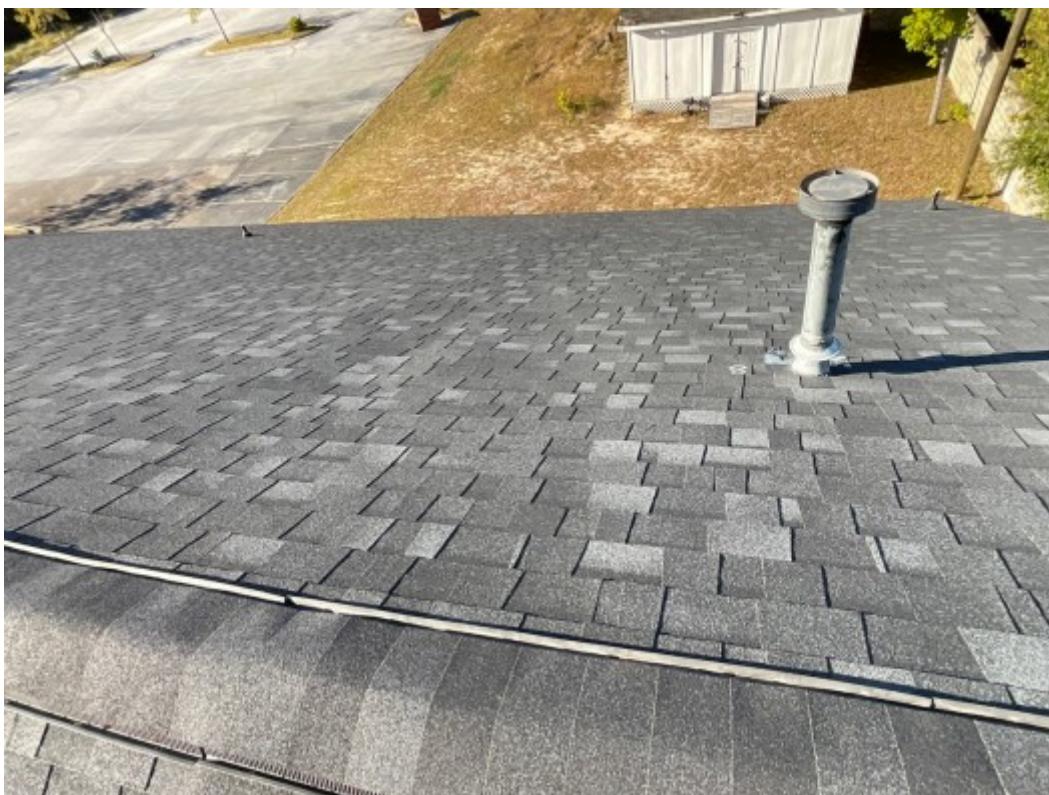
46-Building Roof

The rear most slope has been inspected and found to be free from storm related damage.

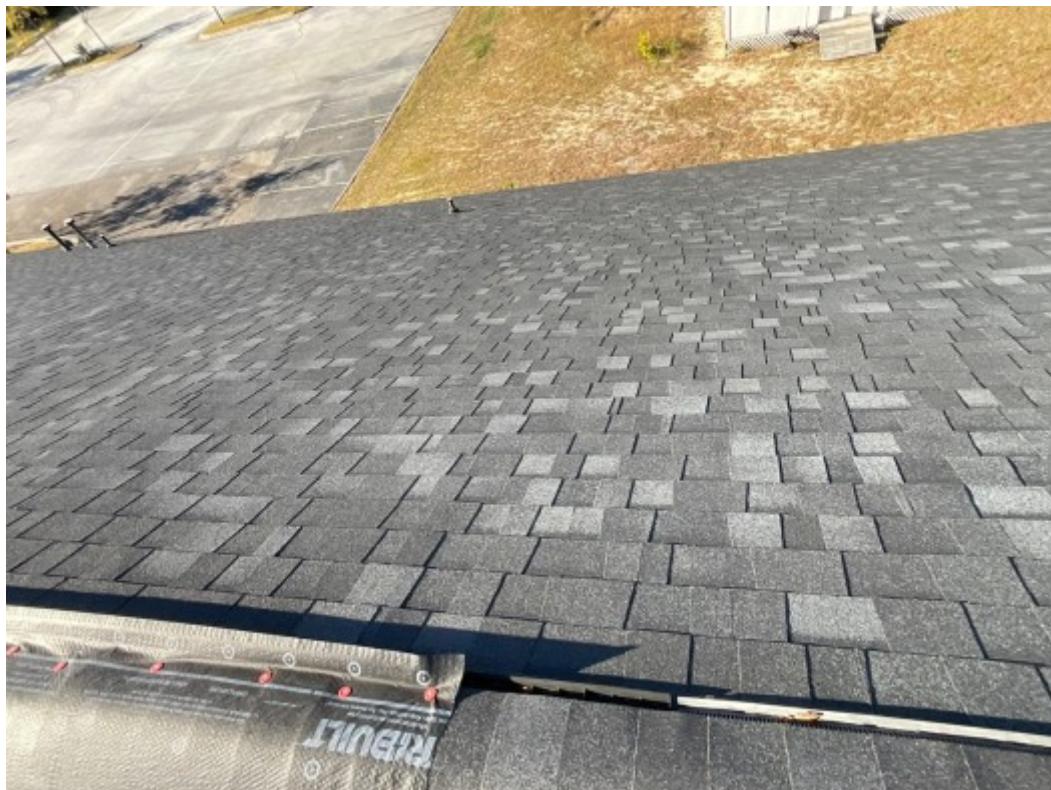
47-Building Roof

The rear most slope has been inspected and found to be free from storm related damage.

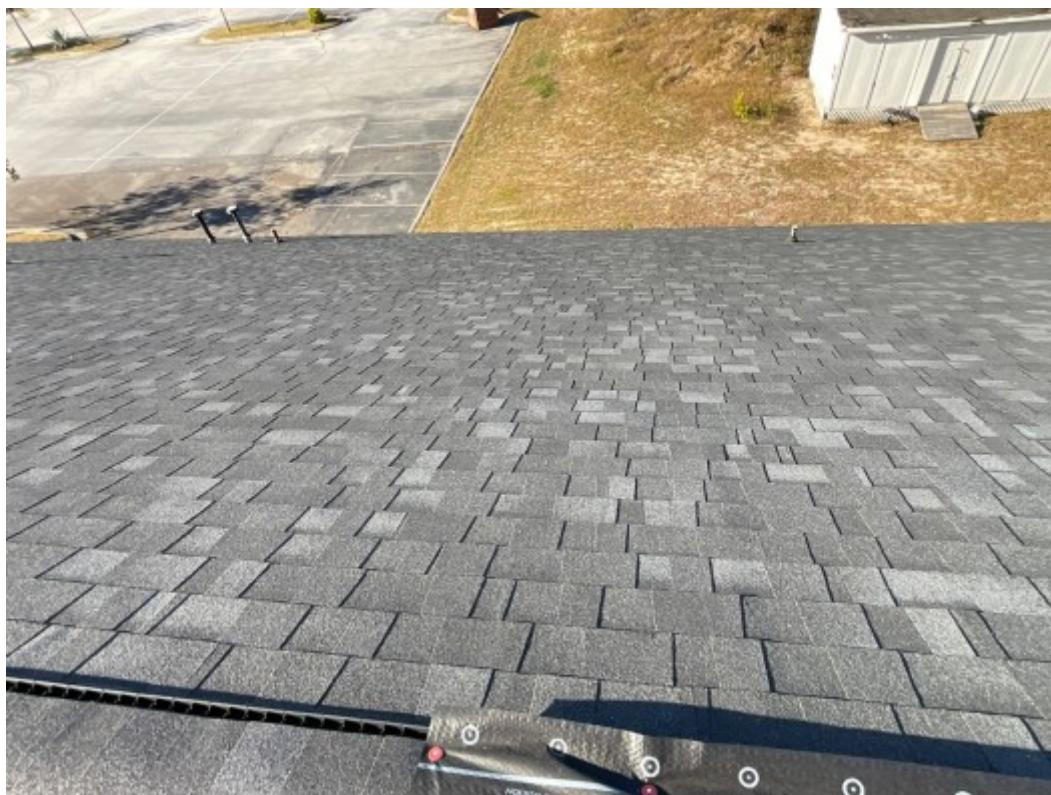
48-Building Roof

The rear most slope has been inspected and found to be free from storm related damage.

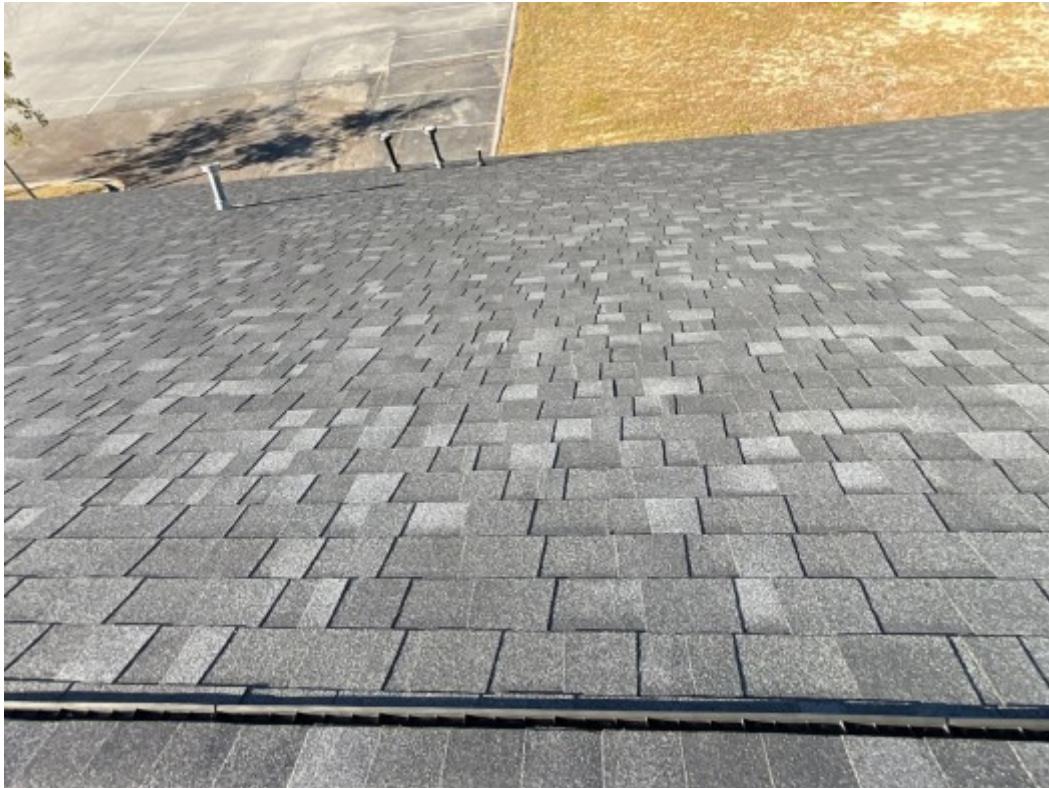
49-Building Roof

The rear most slope has been inspected and found to be free from storm related damage.

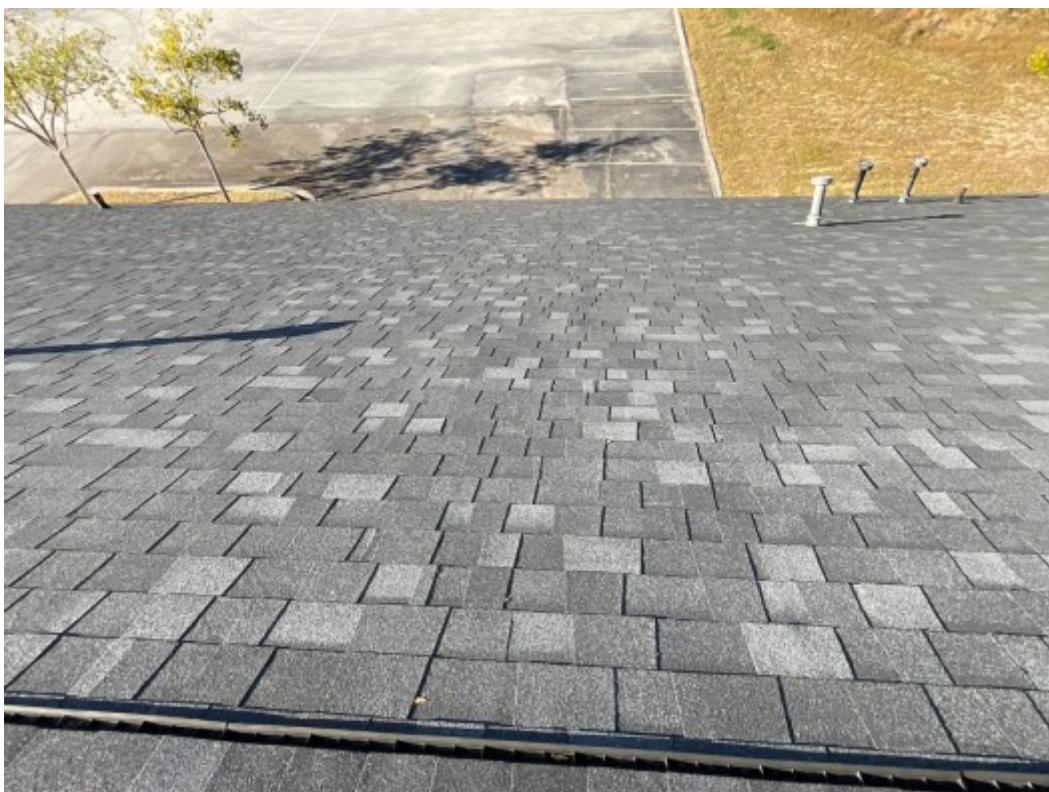
50-Building Roof

The rear most slope has been inspected and found to be free from storm related damage.

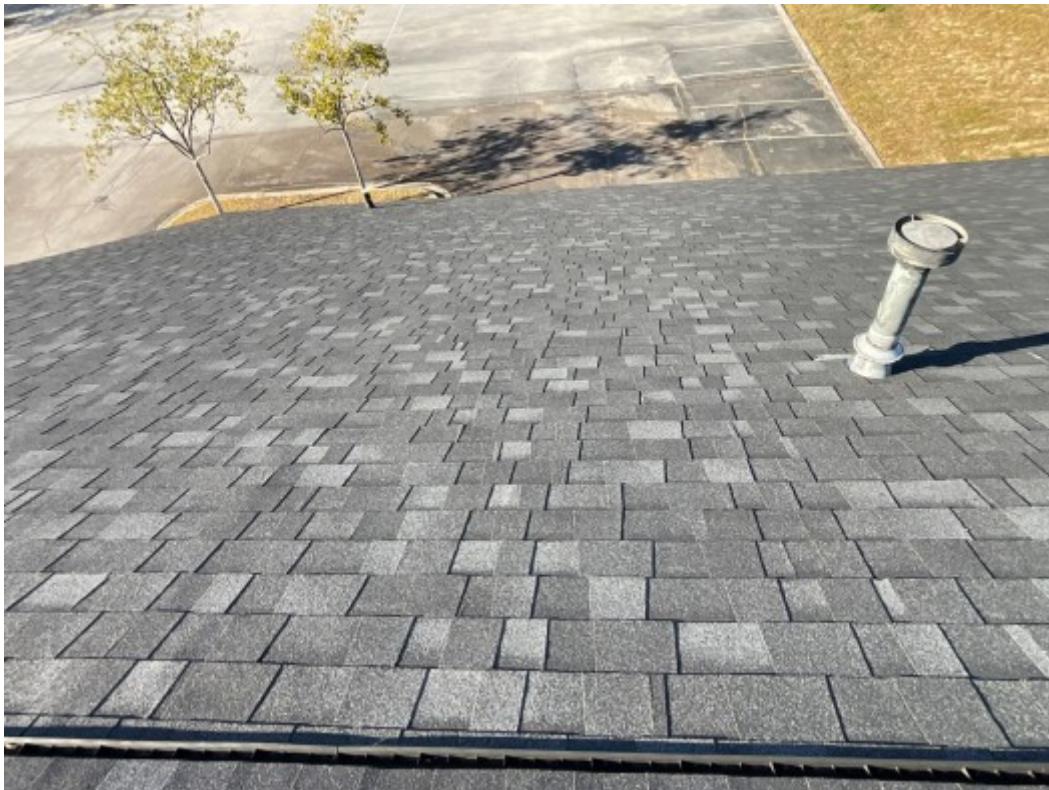
51-Building Roof

The rear most slope has been inspected and found to be free from storm related damage.

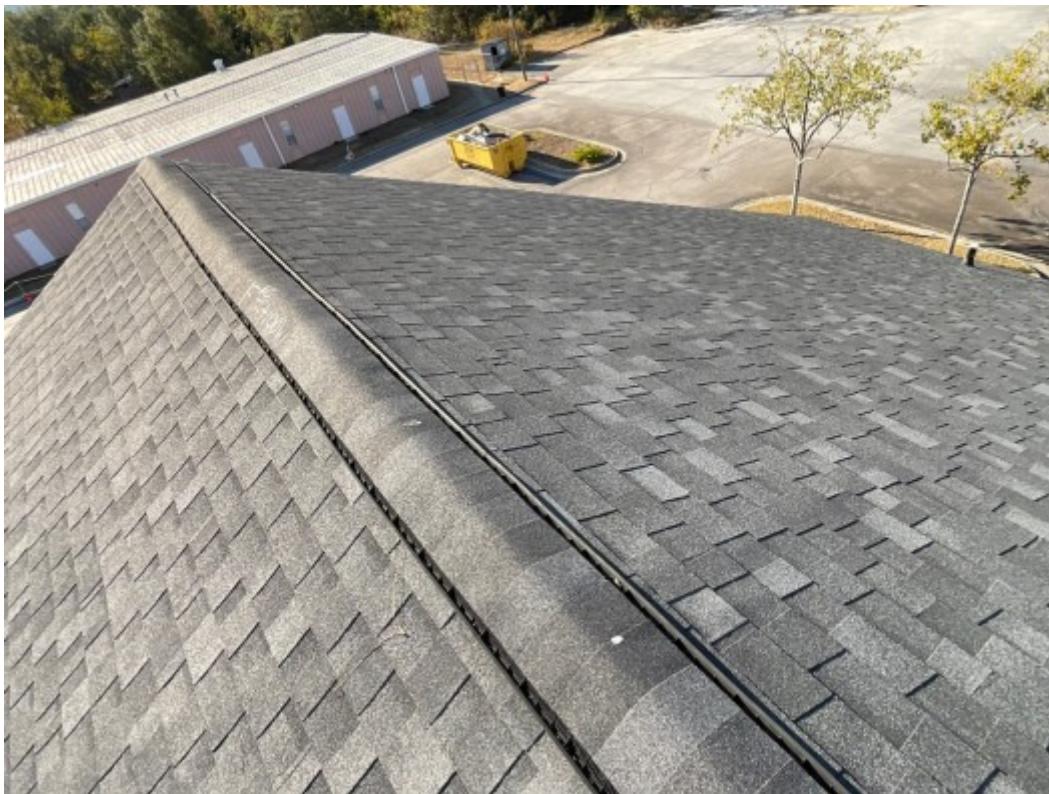
52-Building Roof

The rear most slope has been inspected and found to be free from storm related damage.

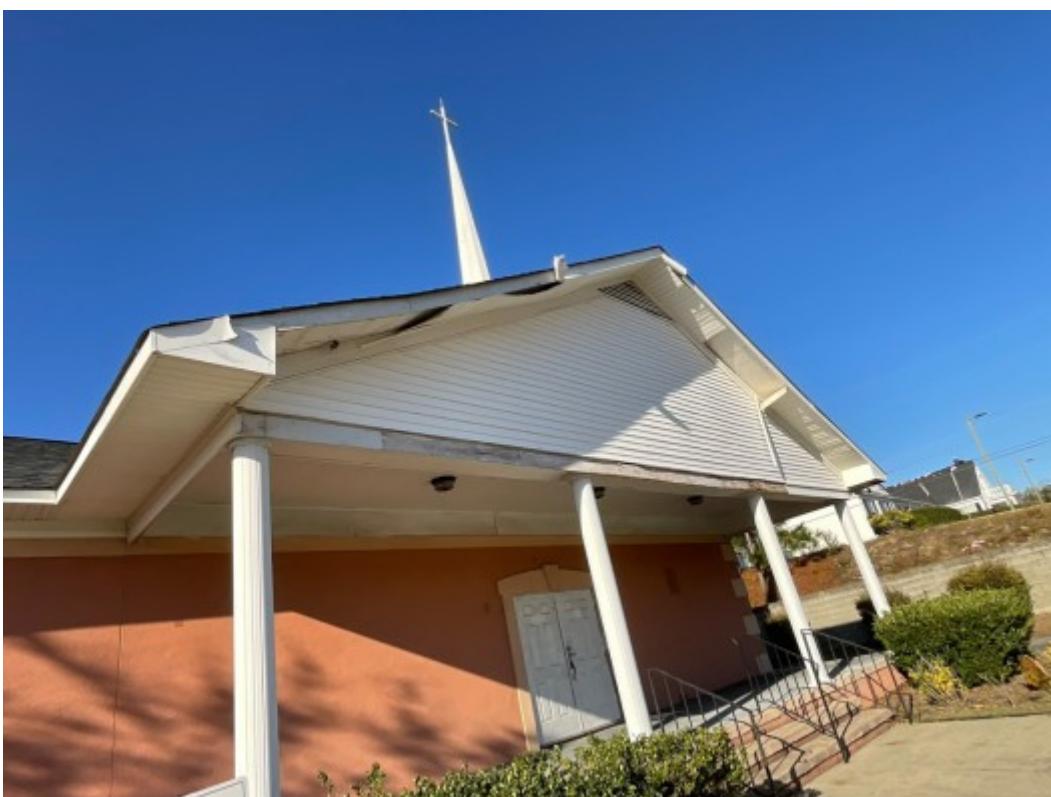
54-Building Elevations

Vinyl soffit and aluminum facia have been damaged by wind on the front elevation of the church building.

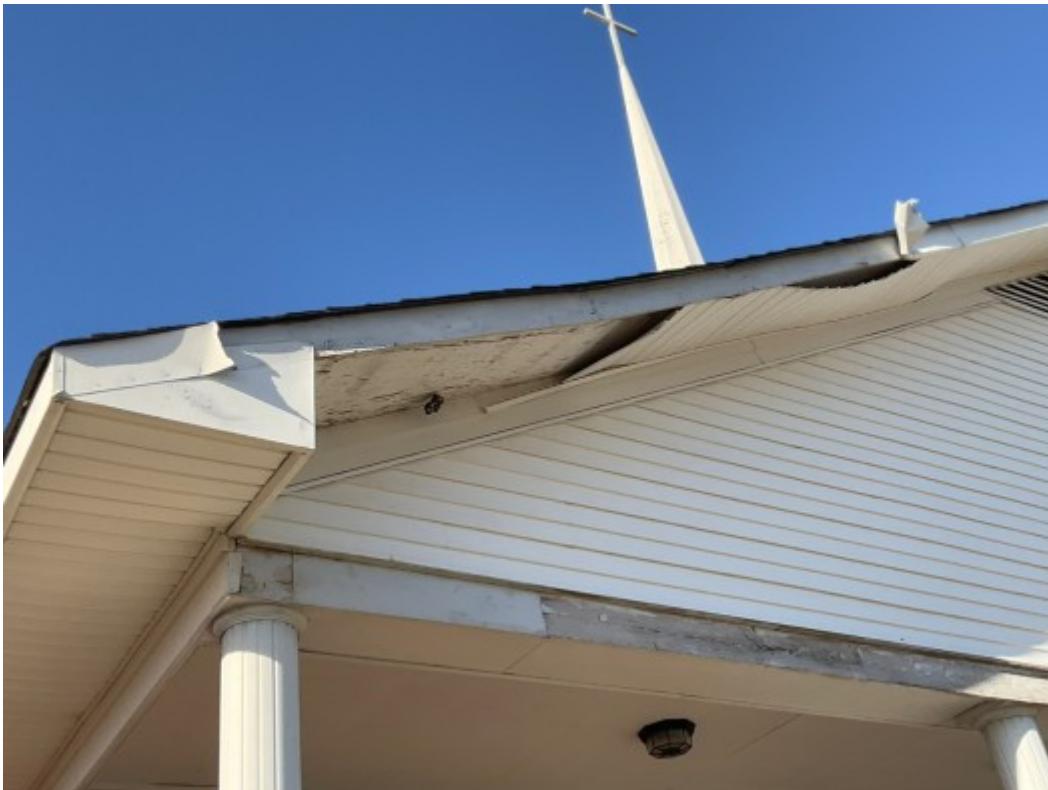
55-Building Elevations

Vinyl soffit and aluminum facia have been damaged by wind on the front elevation of the church building.

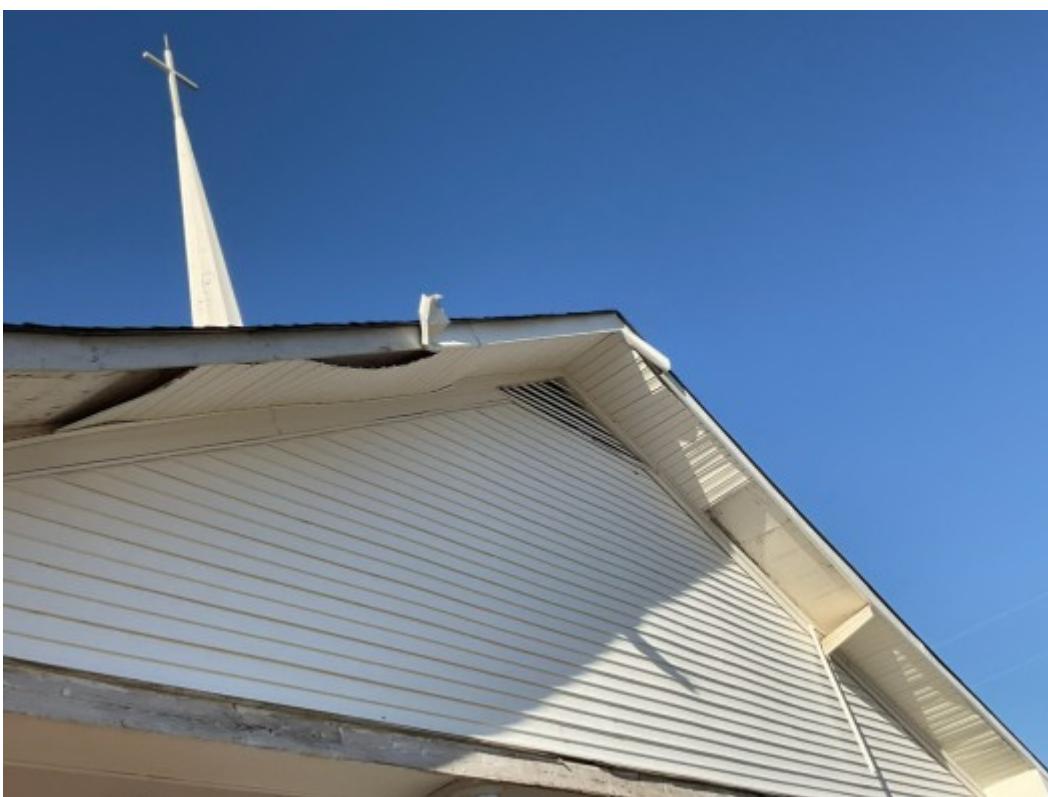
56-Building Elevations

Vinyl soffit and aluminum facia have been damaged by wind on the front elevation of the church building.

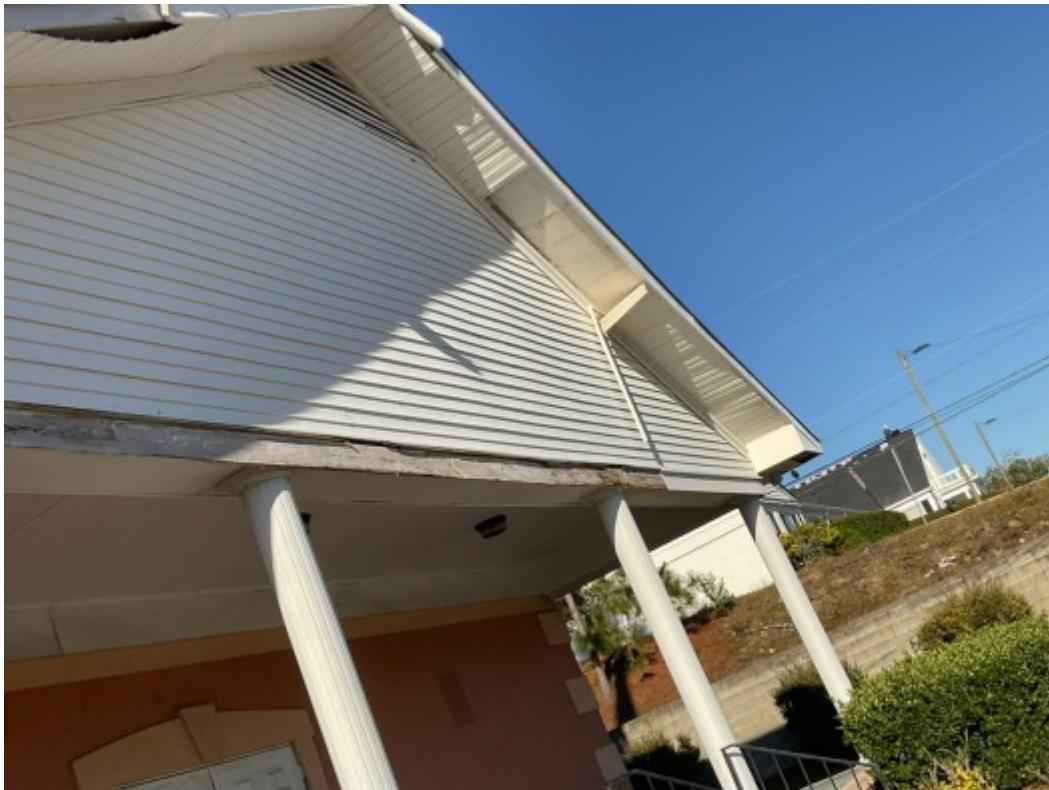
57-Building Elevations

Vinyl soffit and aluminum facia have been damaged by wind on the front elevation of the church building.
