Photo Sheet

Eberl Claims Service

Insured: NEW ZION HILL MISSIONARY BAPTIST CHURCH INCORPORATED

Claim #: AA190825

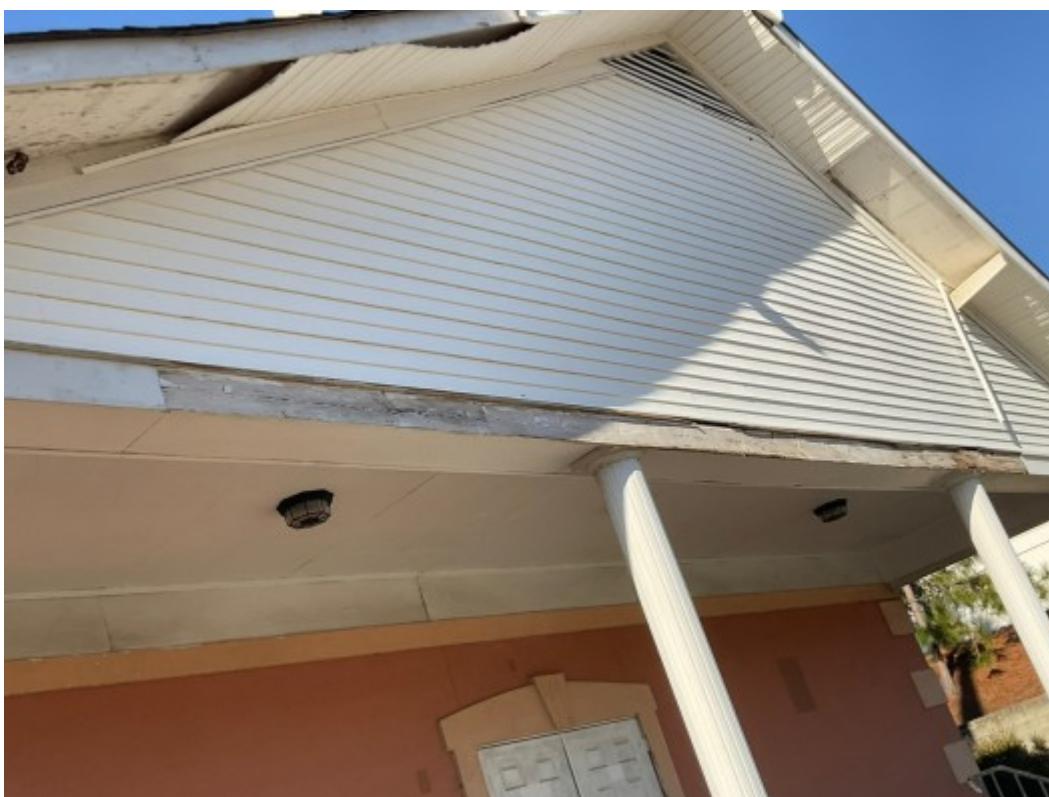
58-Building Elevations

Vinyl soffit and aluminum facia have been damaged by wind on the front elevation of the church building.

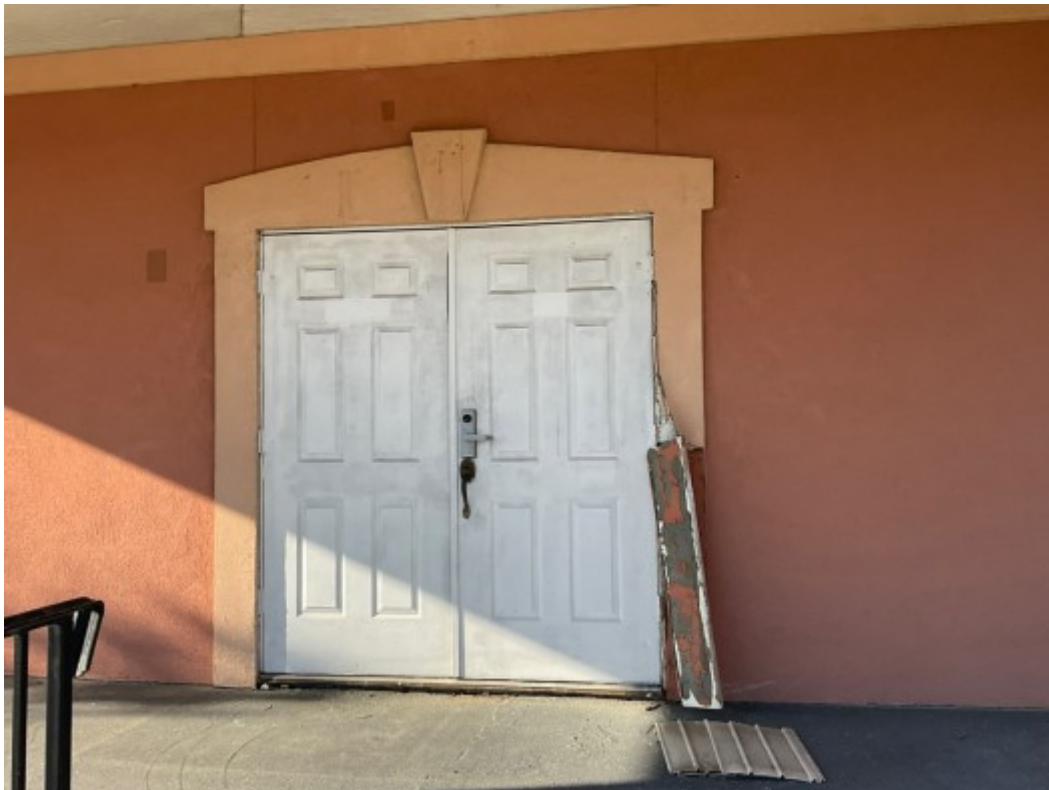
59-Building Elevations

It appears as though wind has damaged the Styrofoam and stucco trim around the double doors on the front elevation.

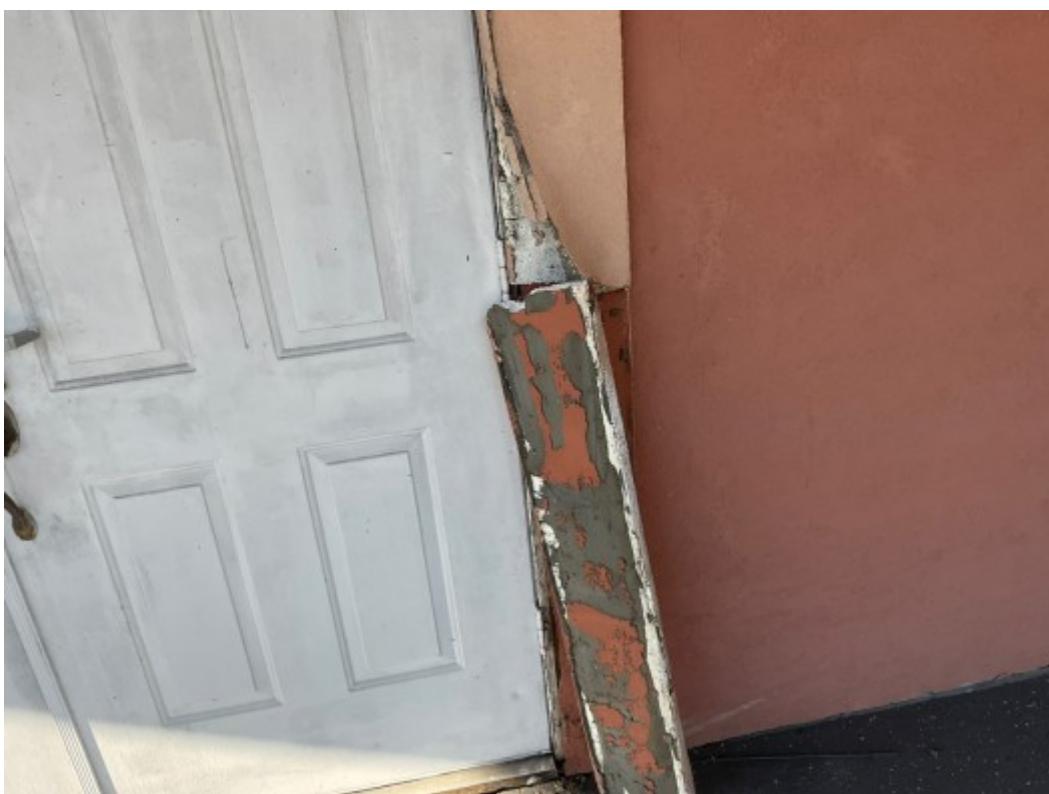
60-Building Elevations

It appears as though wind has damaged the Styrofoam and stucco trim around the double doors on the front elevation.

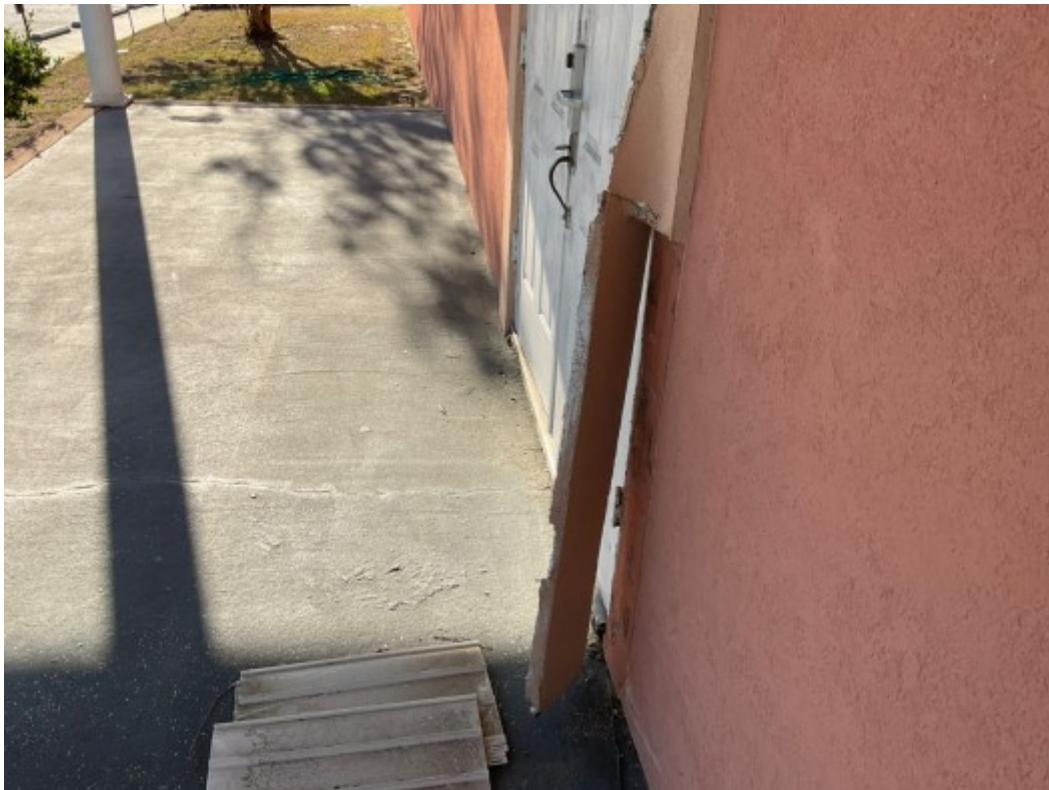
61-Building Elevations

It appears as though wind has damaged the Styrofoam and stucco trim around the double doors on the front elevation.

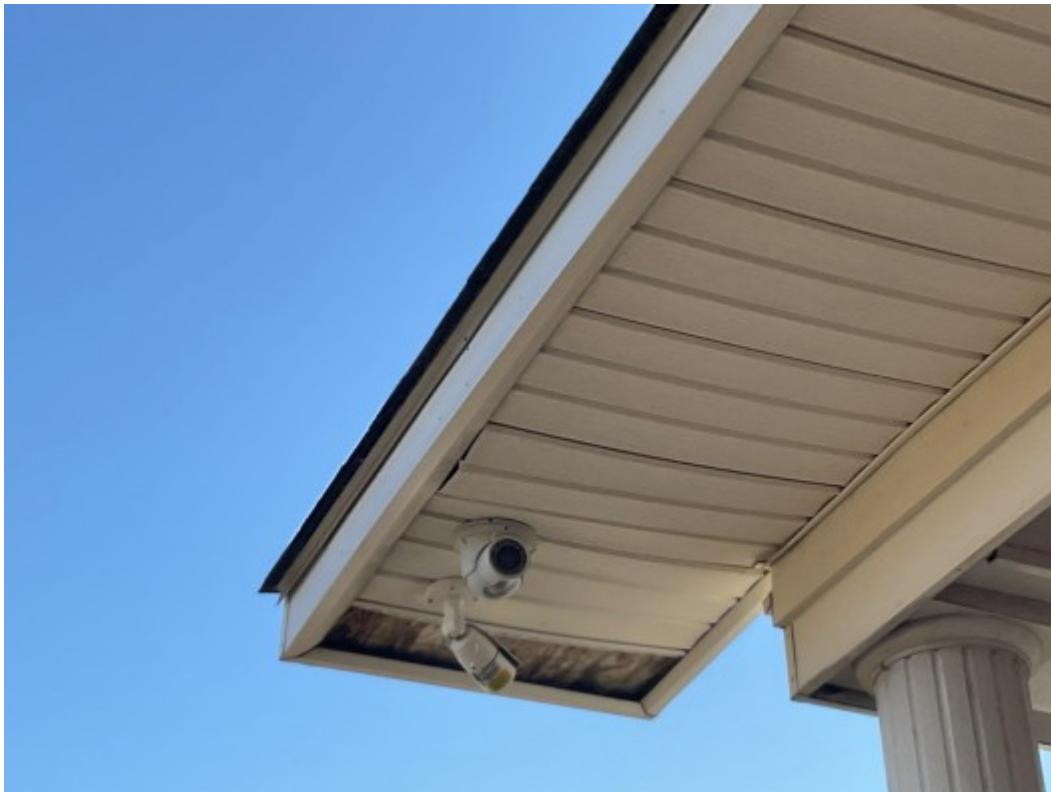
63-Building Elevations

Vinyl soffit and aluminum facia has been damaged by wind on the right elevation of the church building.

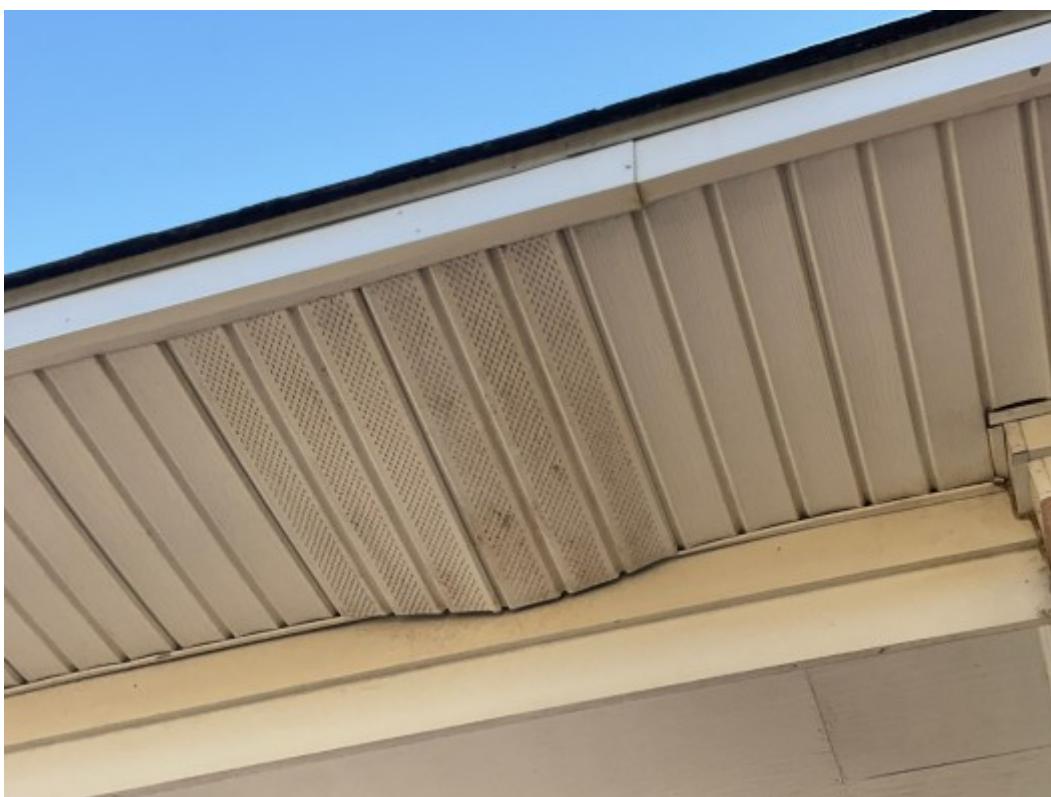
64-Building Elevations

Vinyl soffit and aluminum facia has been damaged by wind on the right elevation of the church building.

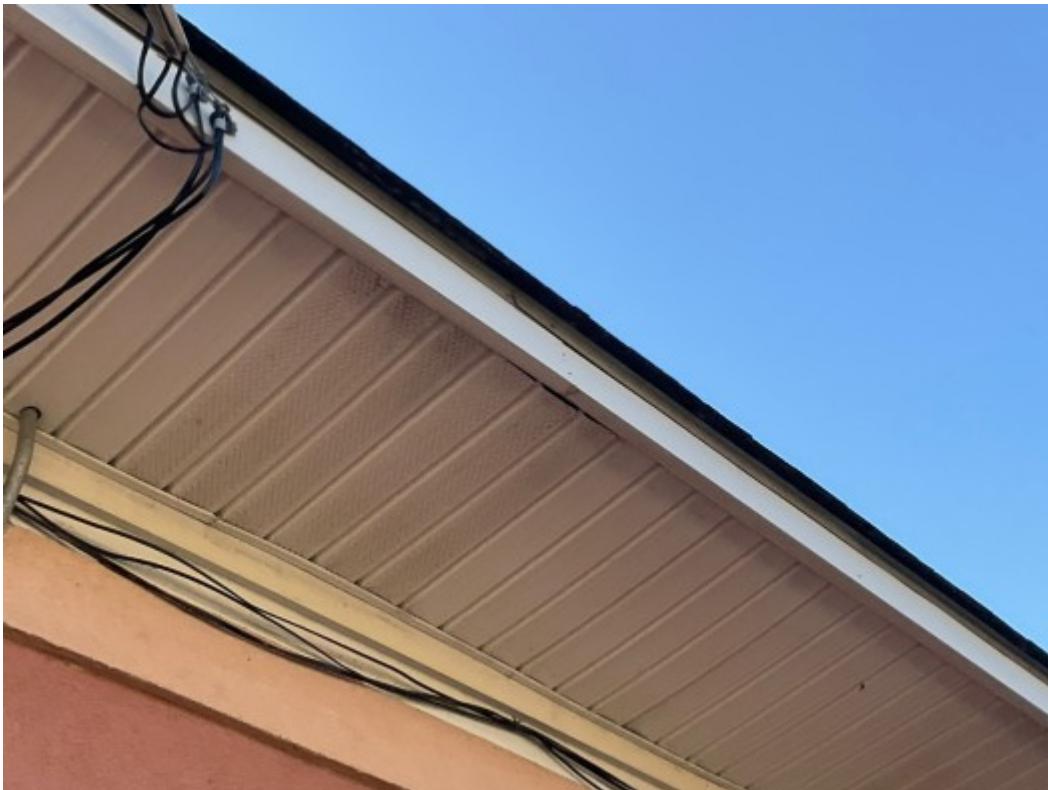
65-Building Elevations

Vinyl soffit and aluminum facia has been damaged by wind on the right elevation of the church building.

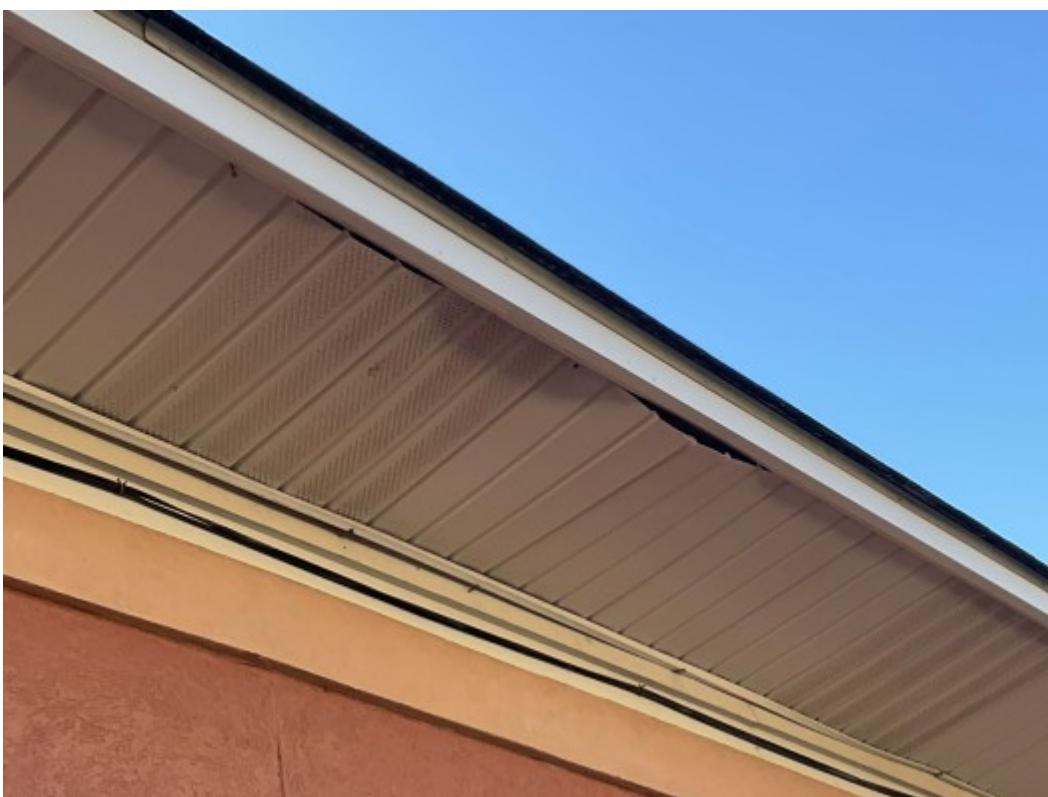
66-Building Elevations

Vinyl soffit and aluminum facia has been damaged by wind on the right elevation of the church building.

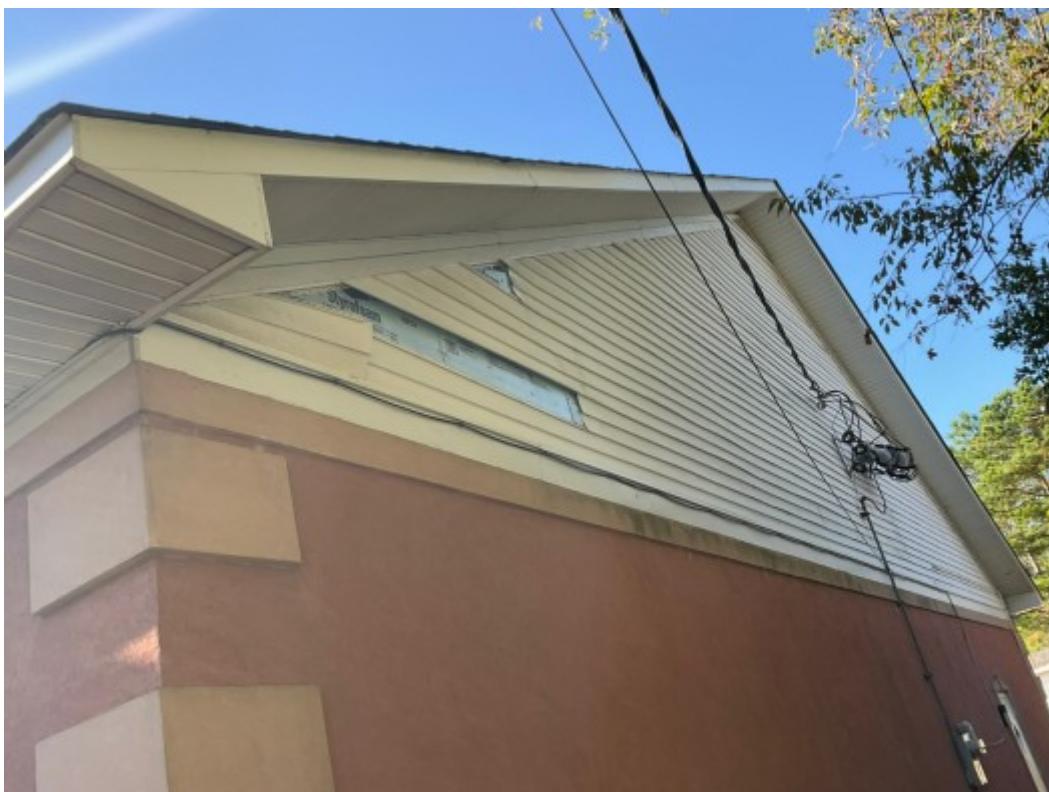
68-Building Elevations

It appears as the wind has damaged the vinyl siding on the upper triangle on the right elevation.

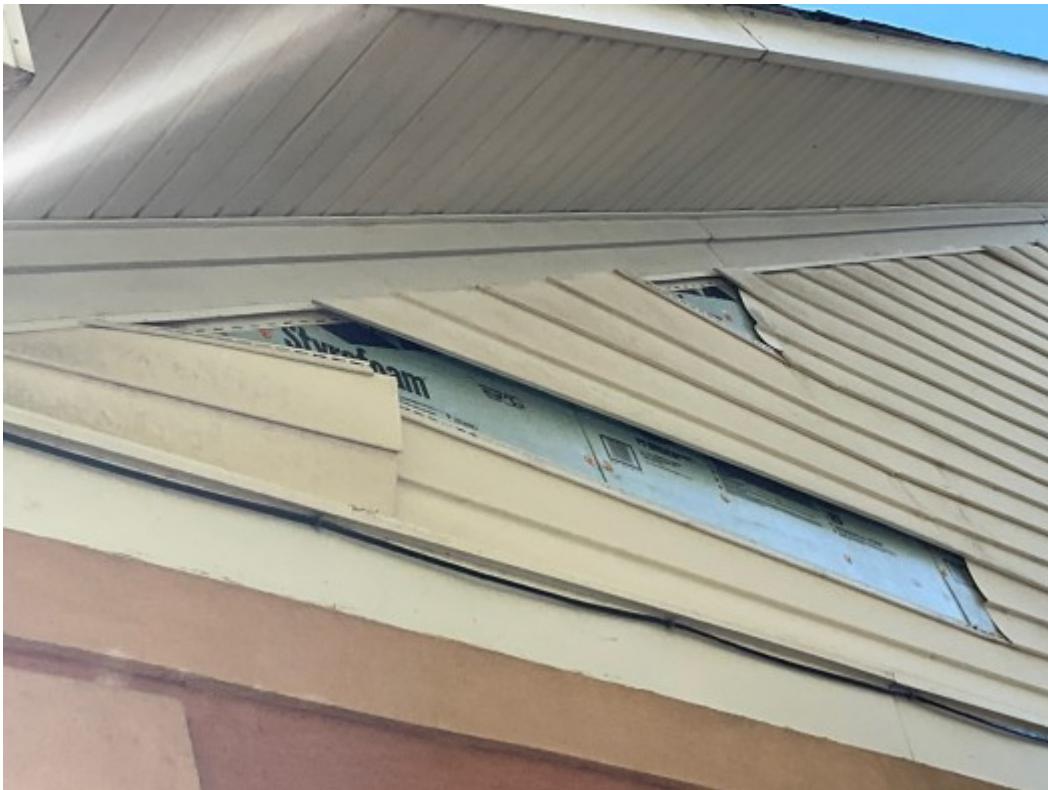
69-Building Elevations

It appears as the wind has damaged the vinyl siding on the upper triangle on the right elevation.

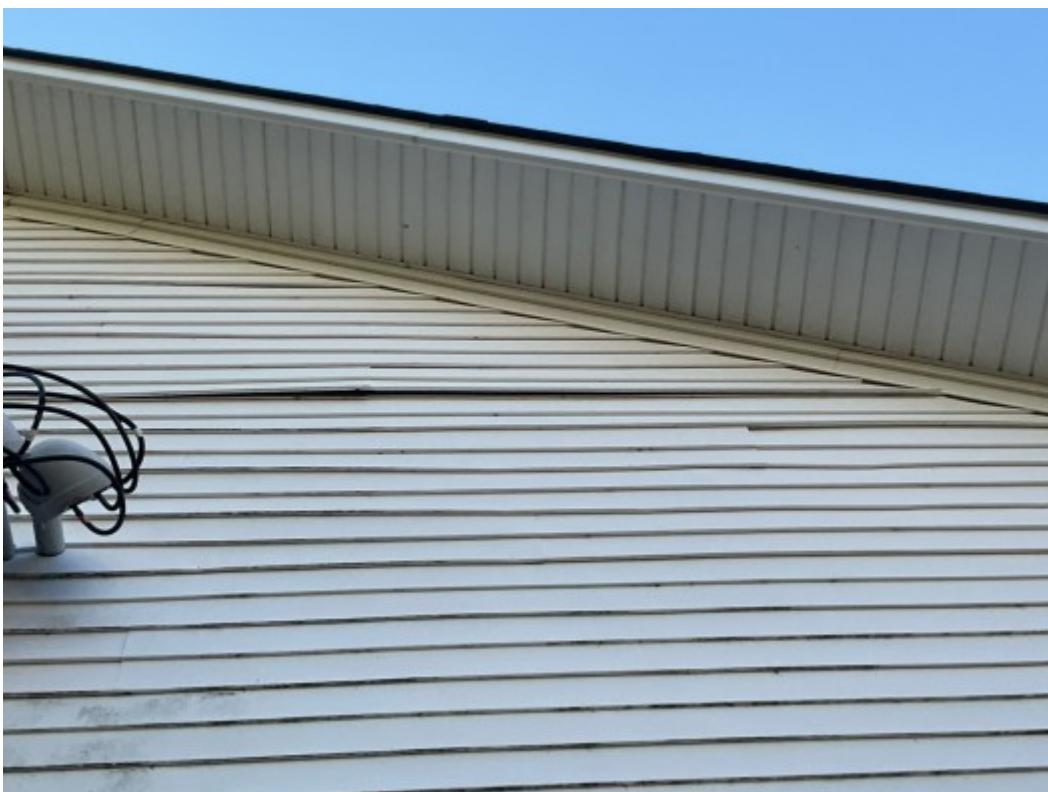
70-Building Elevations

It appears as the wind has damaged the vinyl siding on the upper triangle on the right elevation.

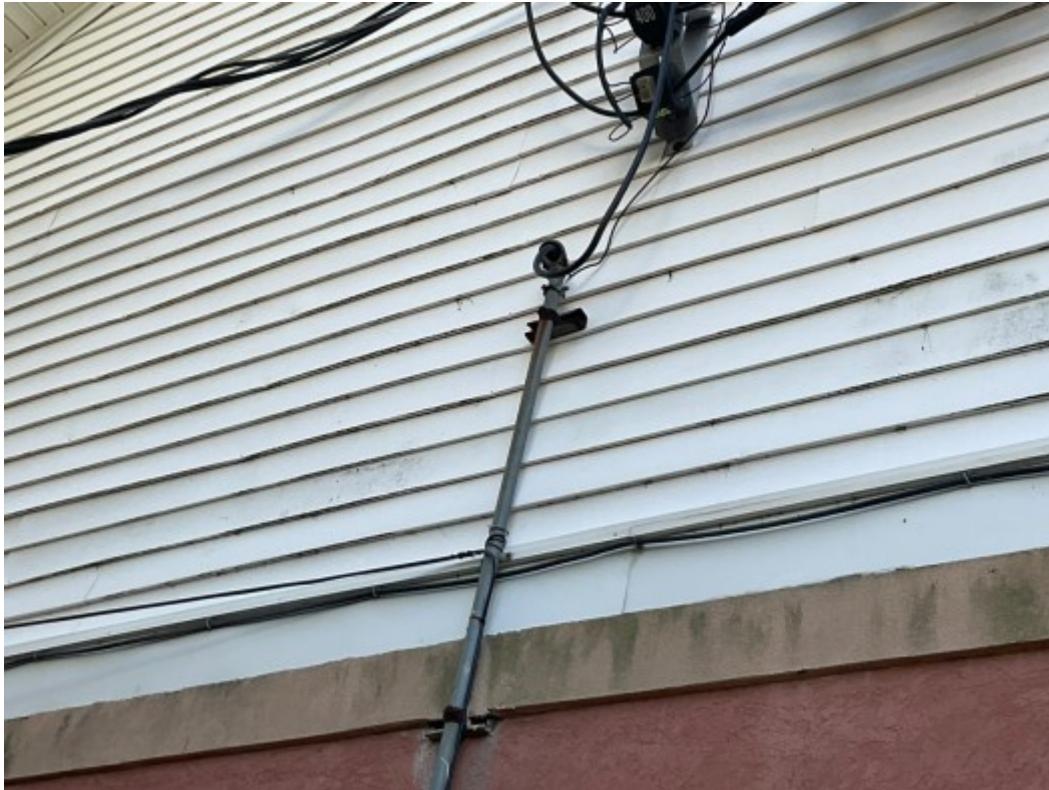
71-Building Elevations

1 meter mast is fastened through the vinyl siding on the right elevation.

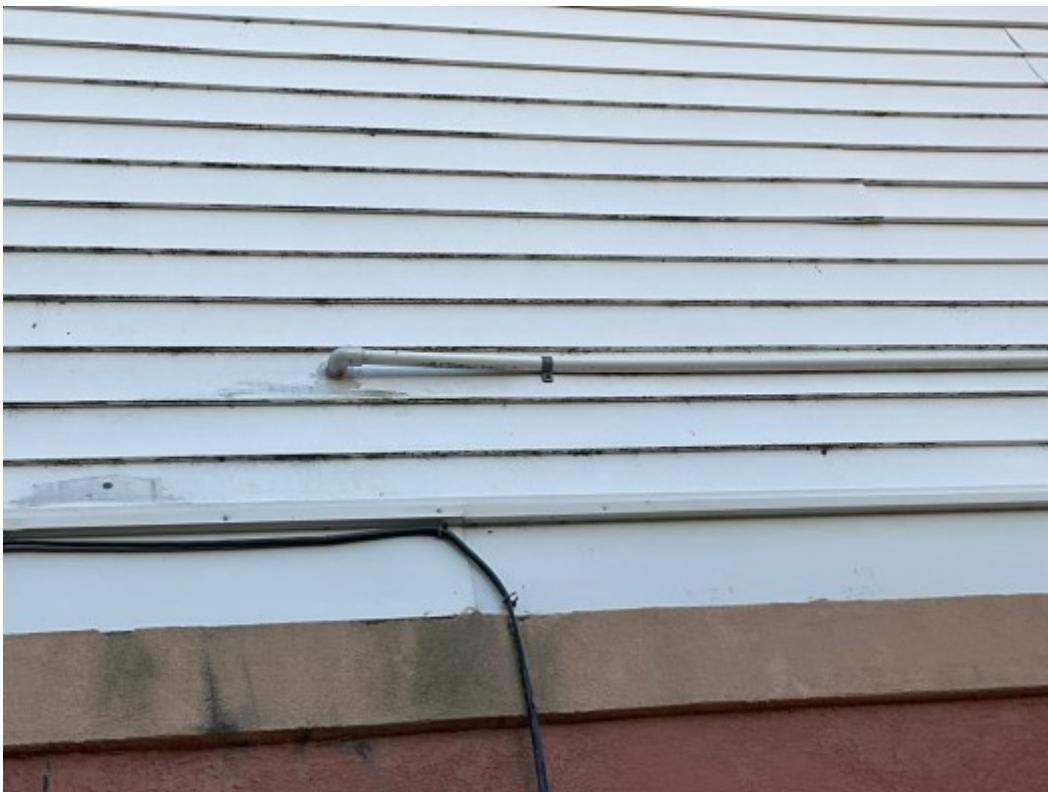
73-Building Elevations

A fifth pipe penetration is installed over the siding on the right elevation.

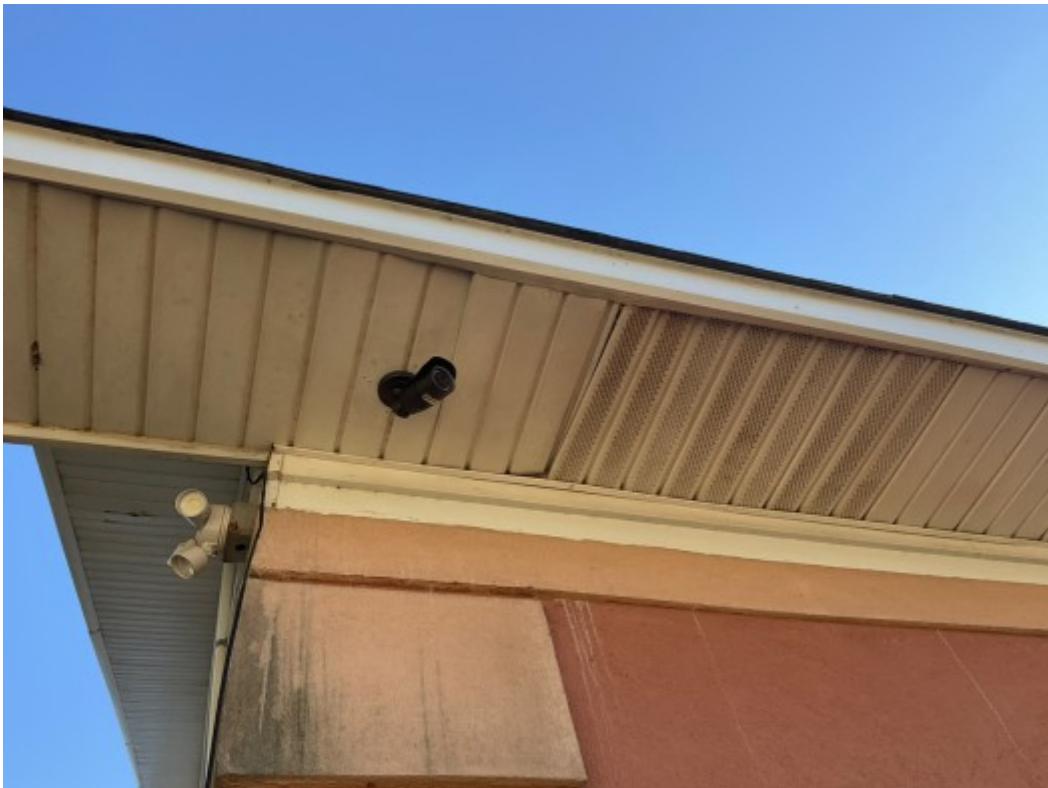
75-Building Elevations

It appears as the wind has damaged soffit and facia on the rear elevation of the church building.

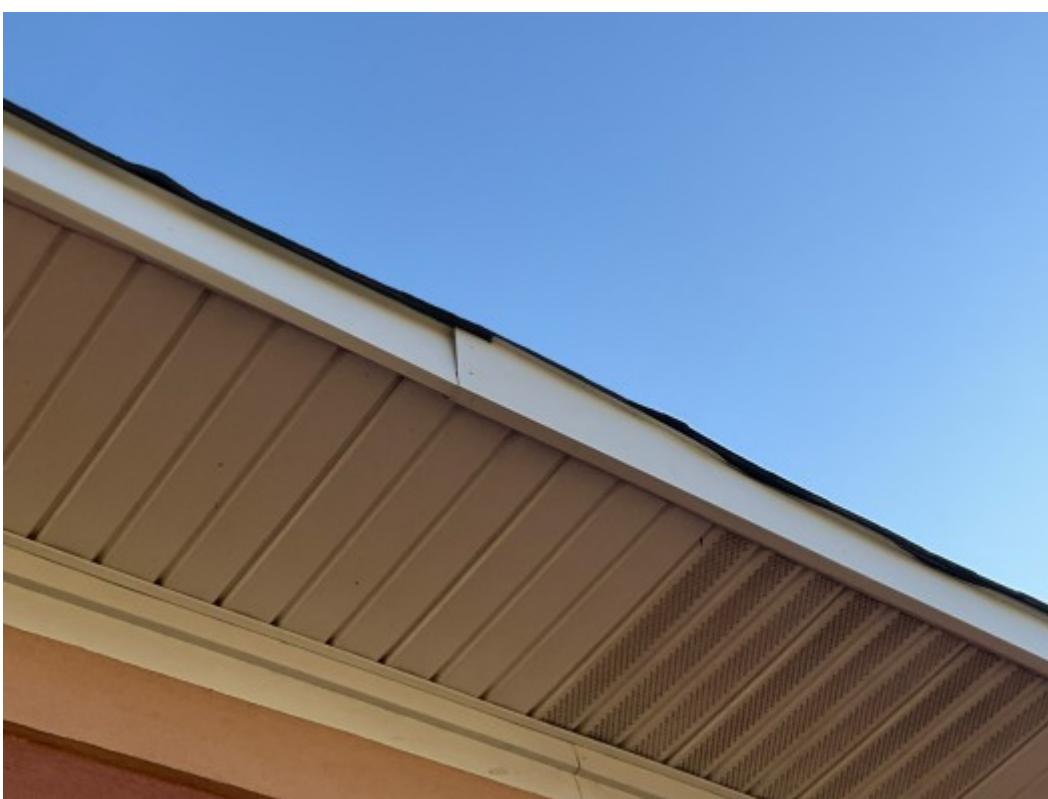
76-Building Elevations

It appears as the wind has damaged soffit and facia on the rear elevation of the church building.

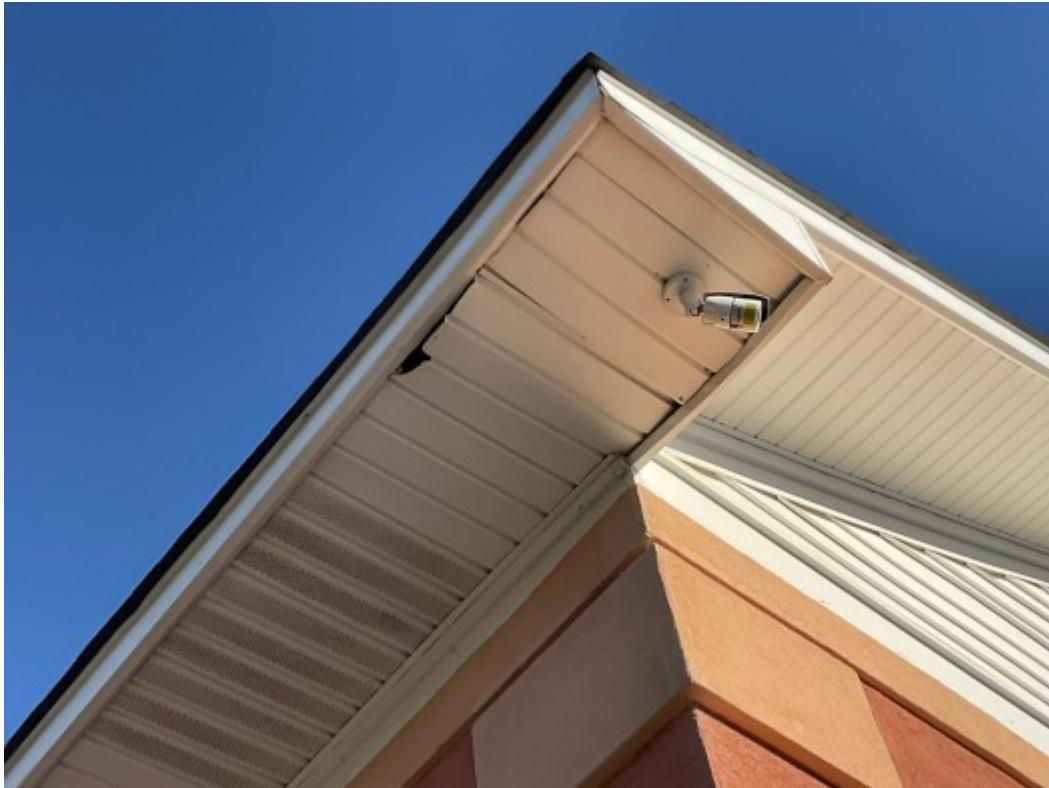
77-Building Elevations

It appears as the wind has damaged soffit and fascia on the rear elevation of the church building.

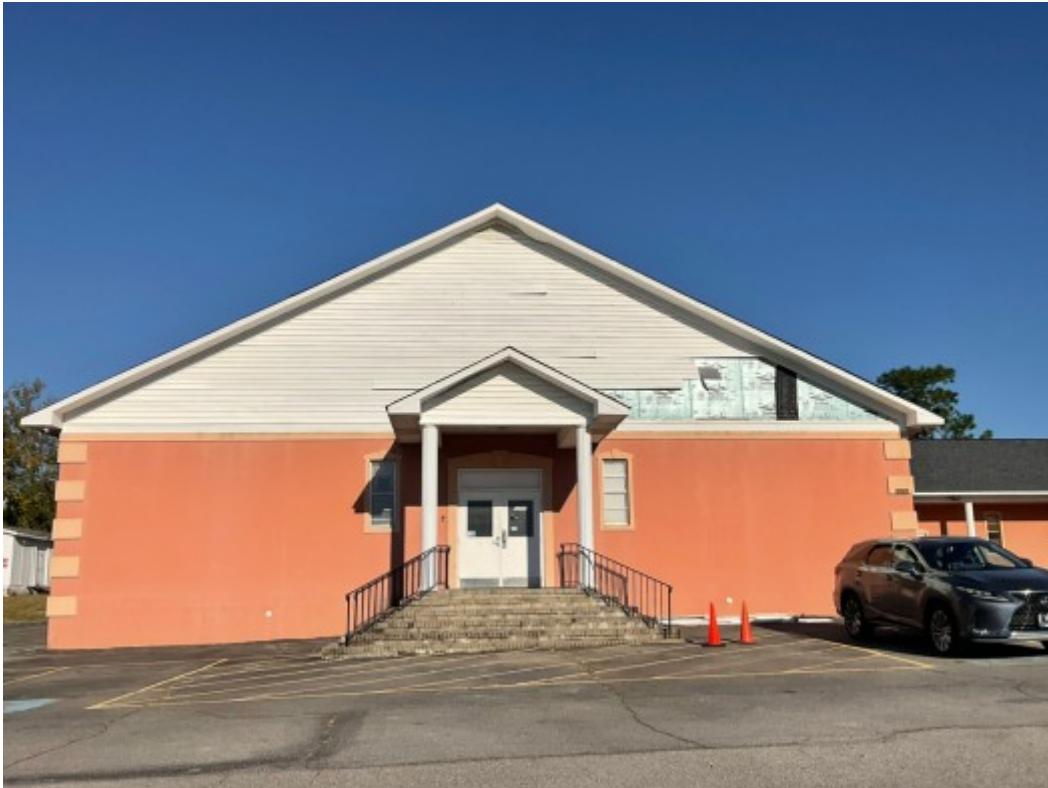
79-Building Elevations

It appears as the wind has damaged the vinyl siding on one of the upper triangles on the left elevation of the church building.

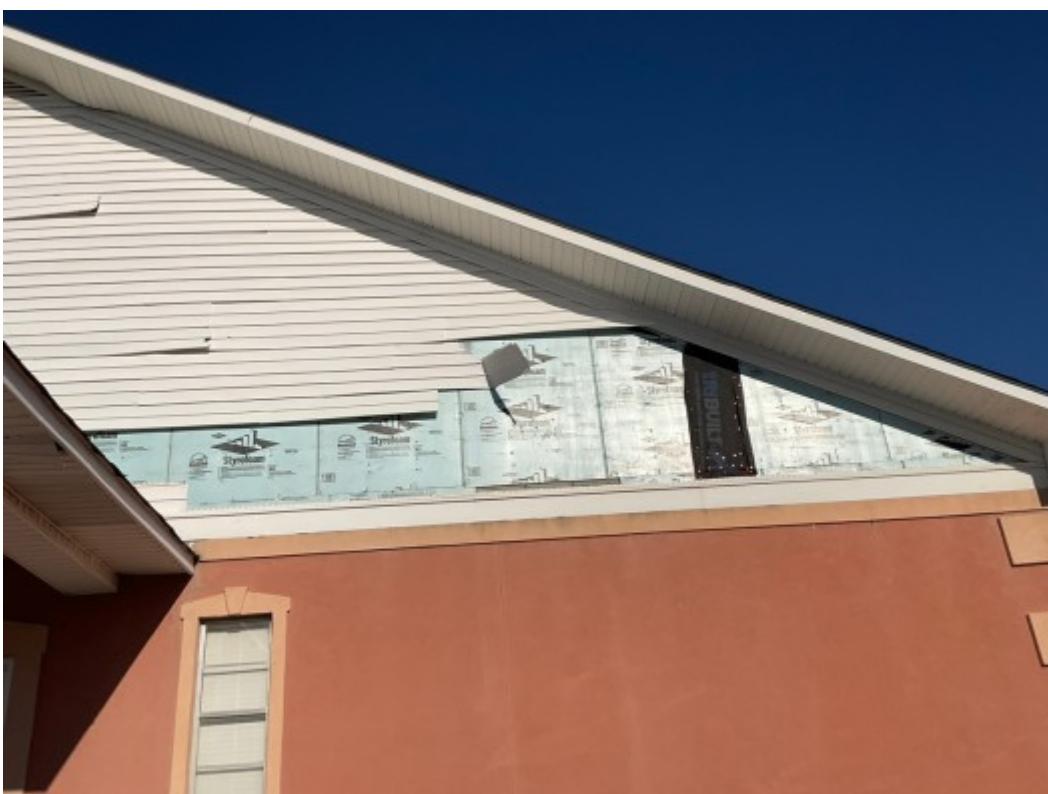
80-Building Elevations

It appears as the wind has damaged the vinyl siding on one of the upper triangles on the left elevation of the church building.

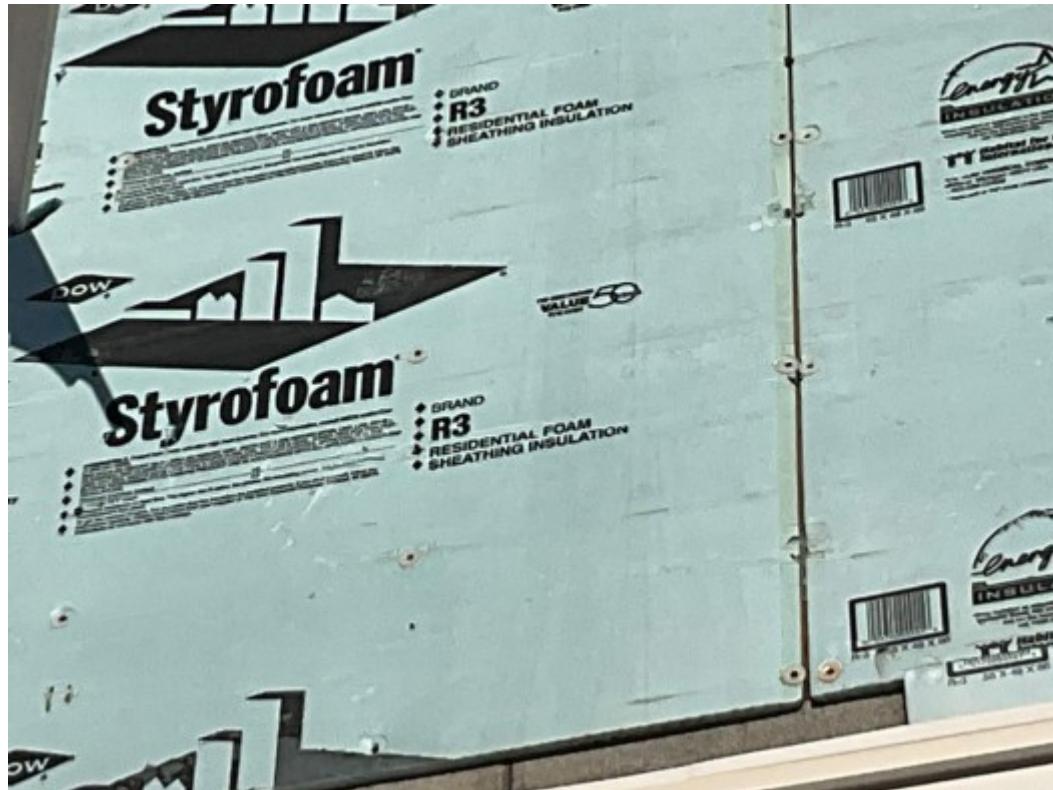
81-Building Elevations

It appears as the wind has damaged the vinyl siding on one of the upper triangles on the left elevation of the church building.

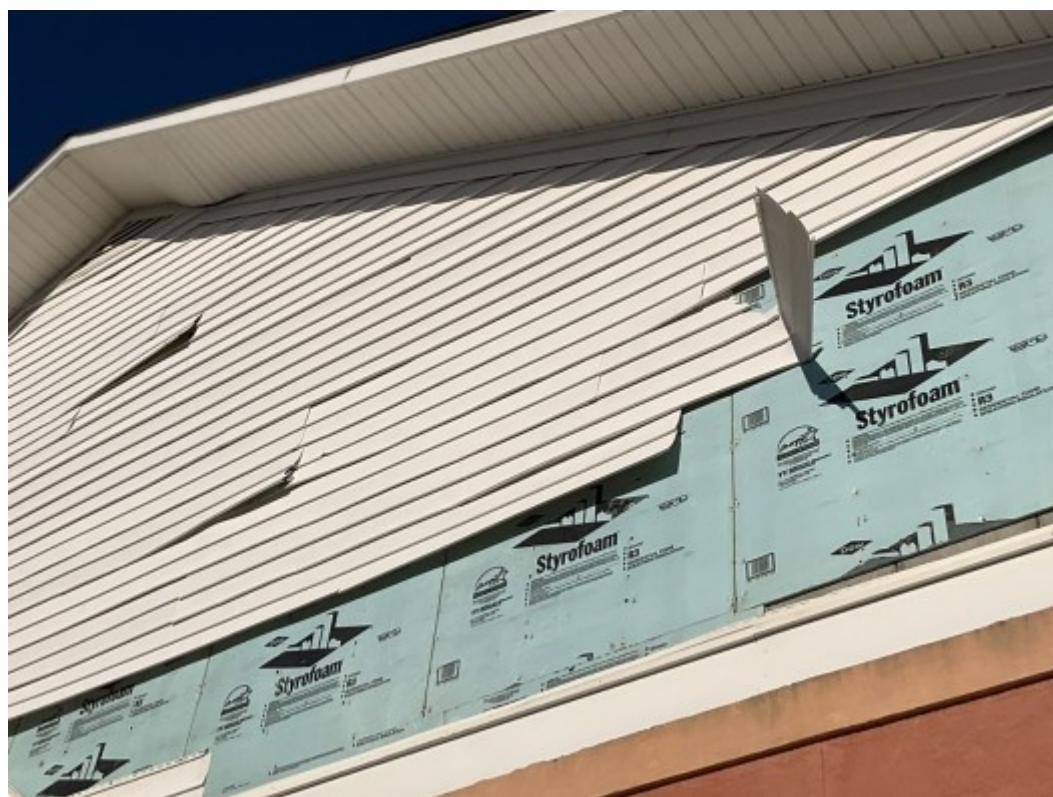
82-Building Elevations

It appears as the wind has damaged the vinyl siding on one of the upper triangles on the left elevation of the church building.

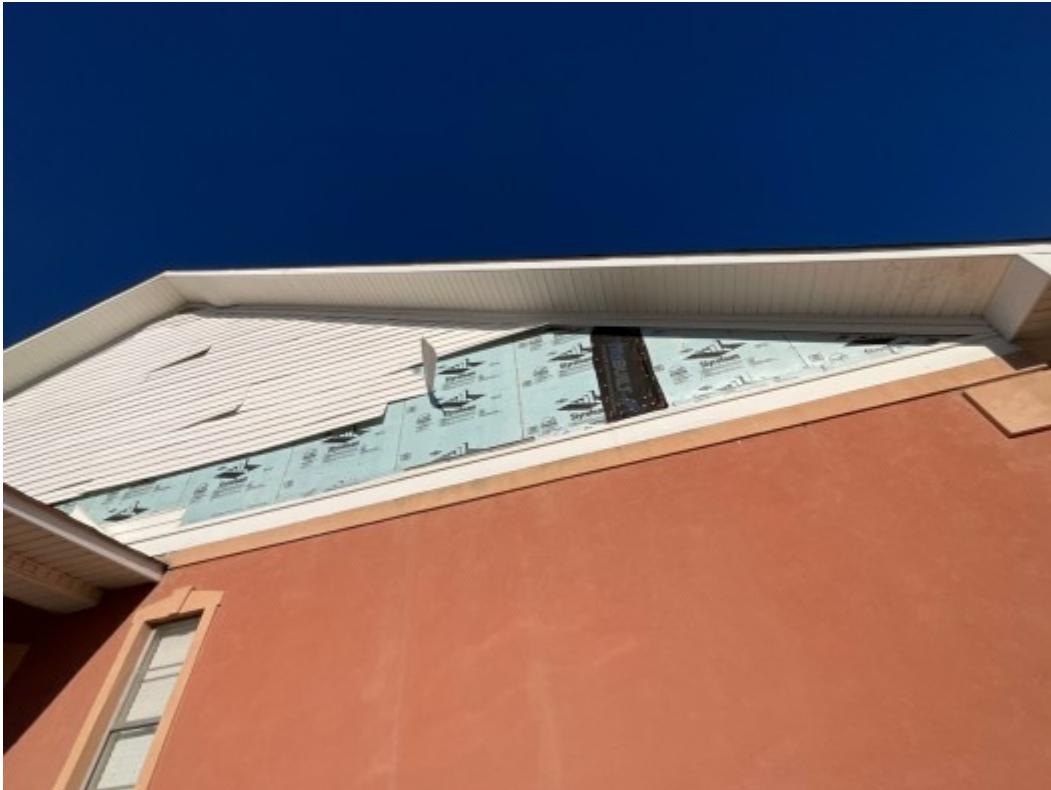
83-Building Elevations

It appears as the wind has damaged the vinyl siding on one of the upper triangles on the left elevation of the church building.

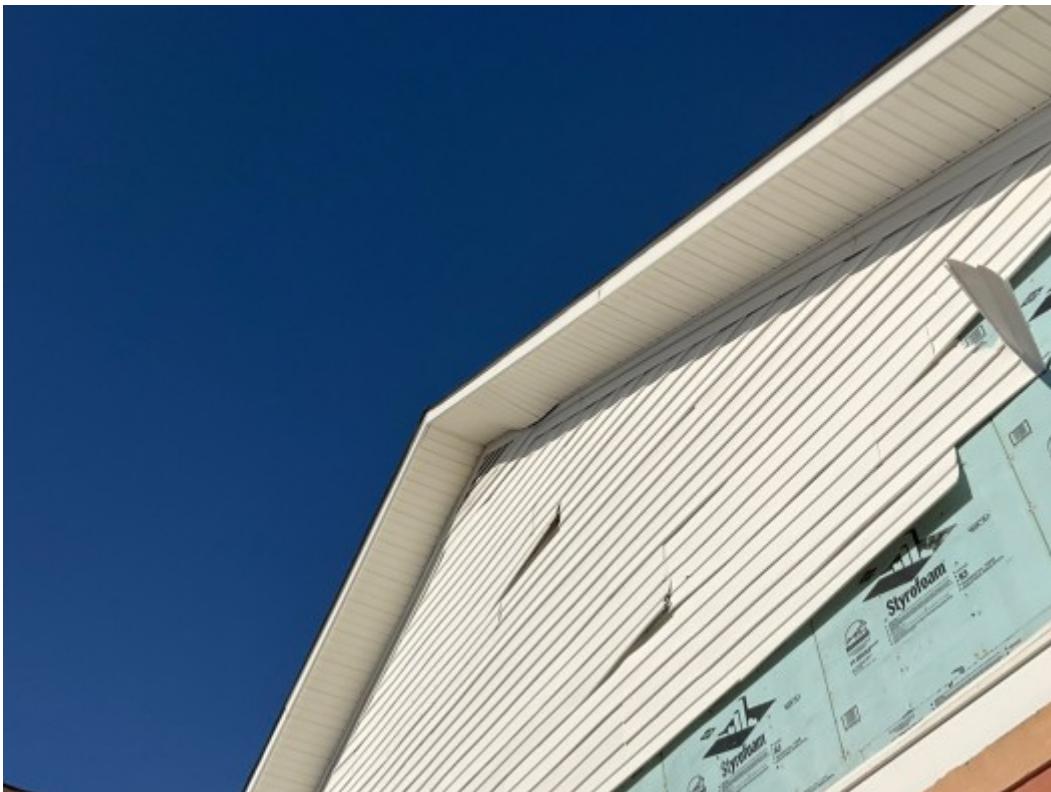
84-Building Elevations

It appears as the wind has damaged the vinyl siding on one of the upper triangles on the left elevation of the church building.

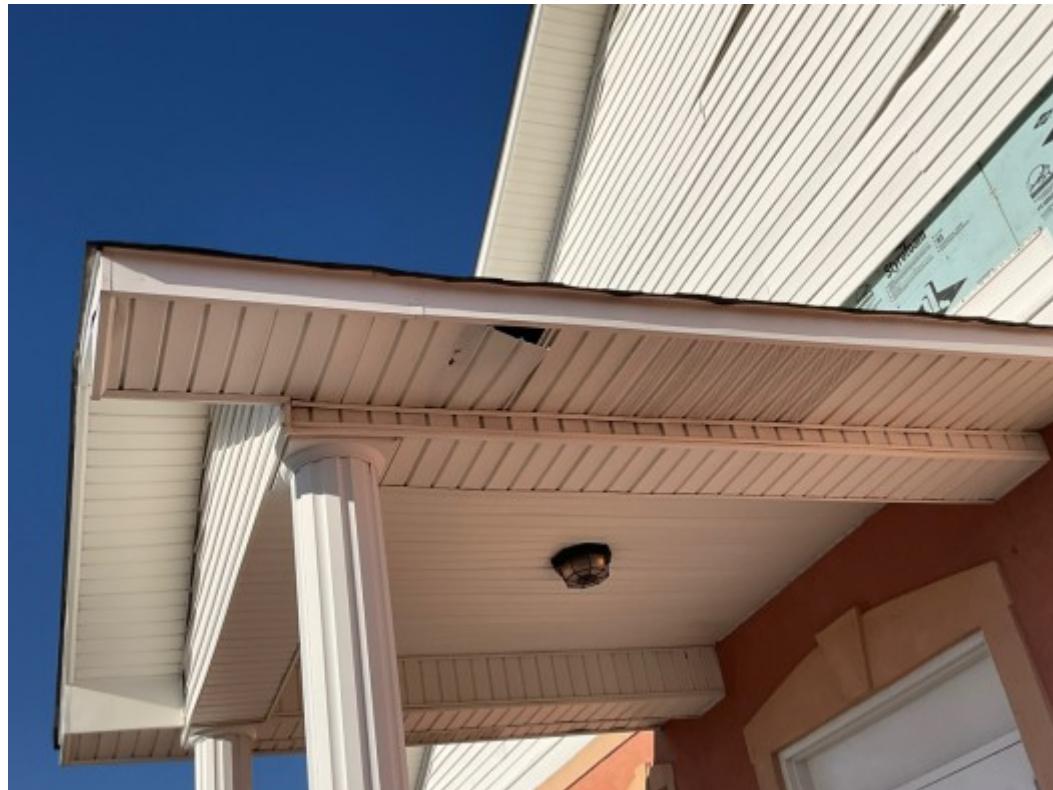
85-Building Elevations

It appears as the wind has damaged, soffit and facia on the left elevation of the church building.

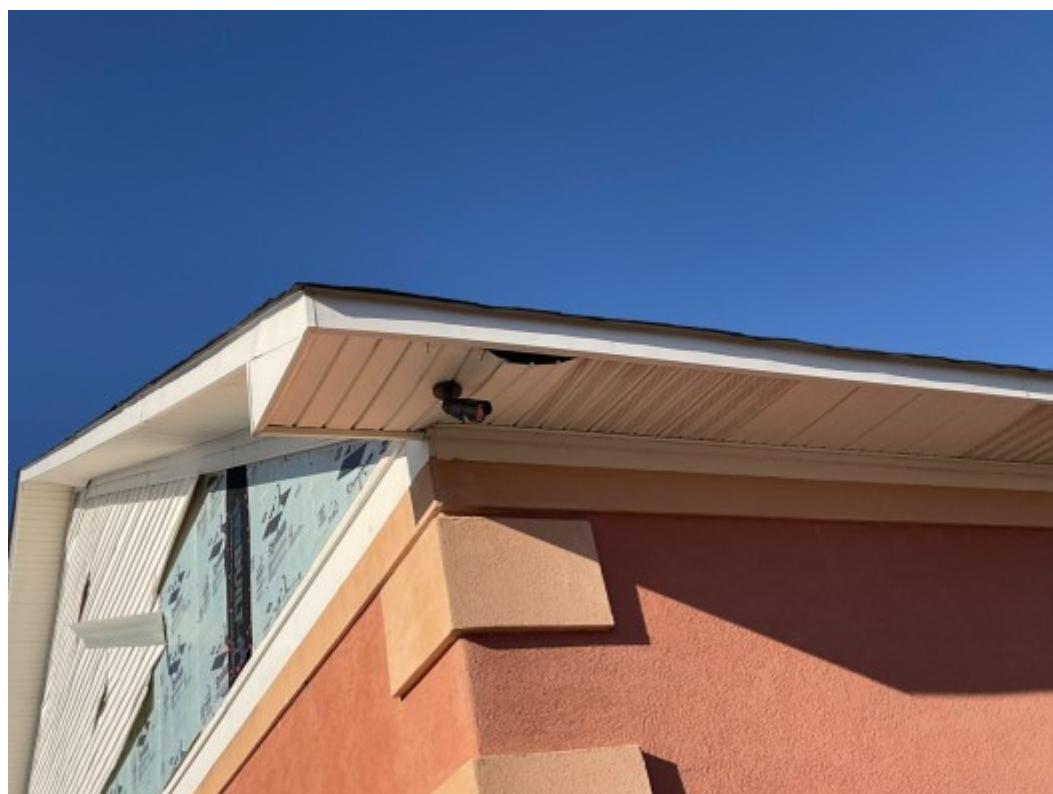
86-Building Elevations

It appears as the wind has damaged, soffit and facia on the left elevation of the church building.

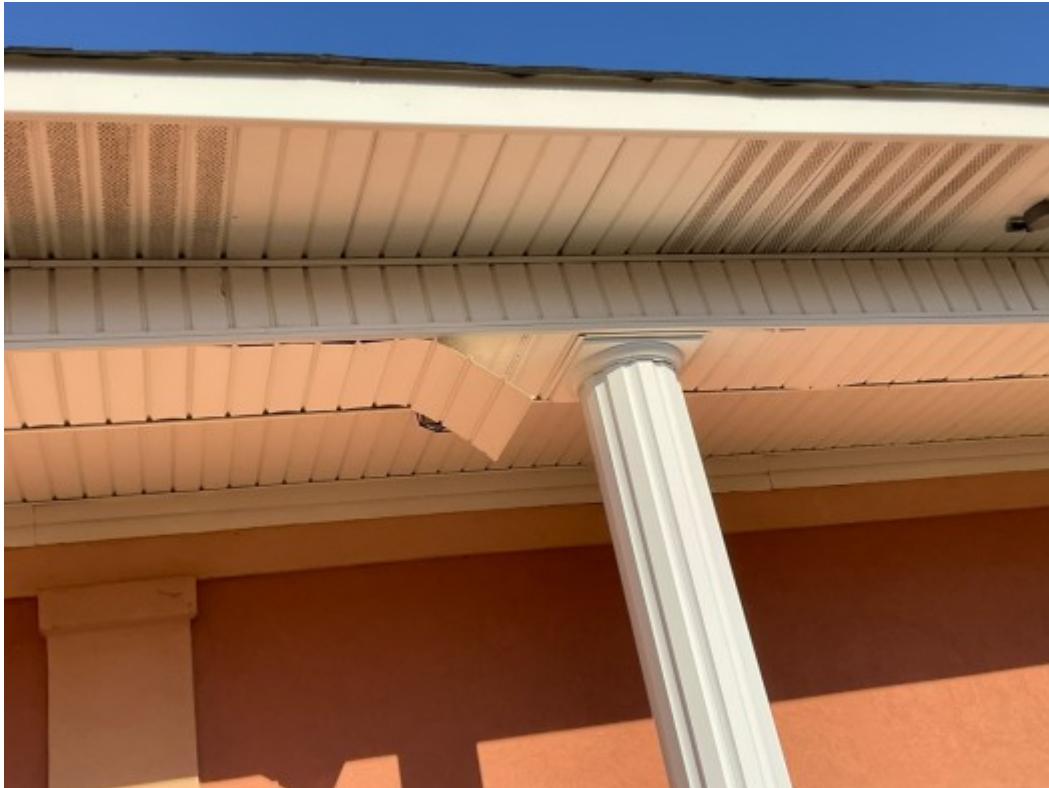
87-Building Elevations

It appears as the wind has damaged, soffit and facia on the left elevation of the church building.

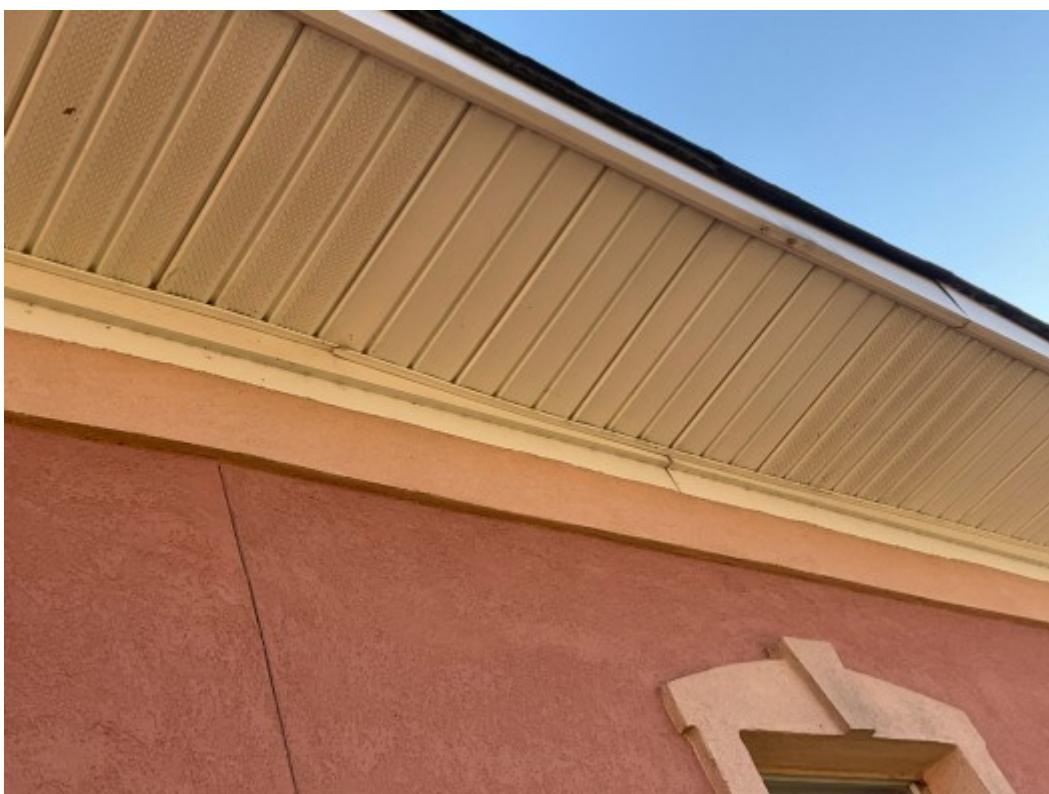
88-Building Elevations

It appears as the wind has damaged, soffit and facia on the left elevation of the church building.
