Photo Sheet

Eberl Claims Service

Insured: NEW ZION HILL MISSIONARY BAPTIST CHURCH INCORPORATED

Claim #: AA190825

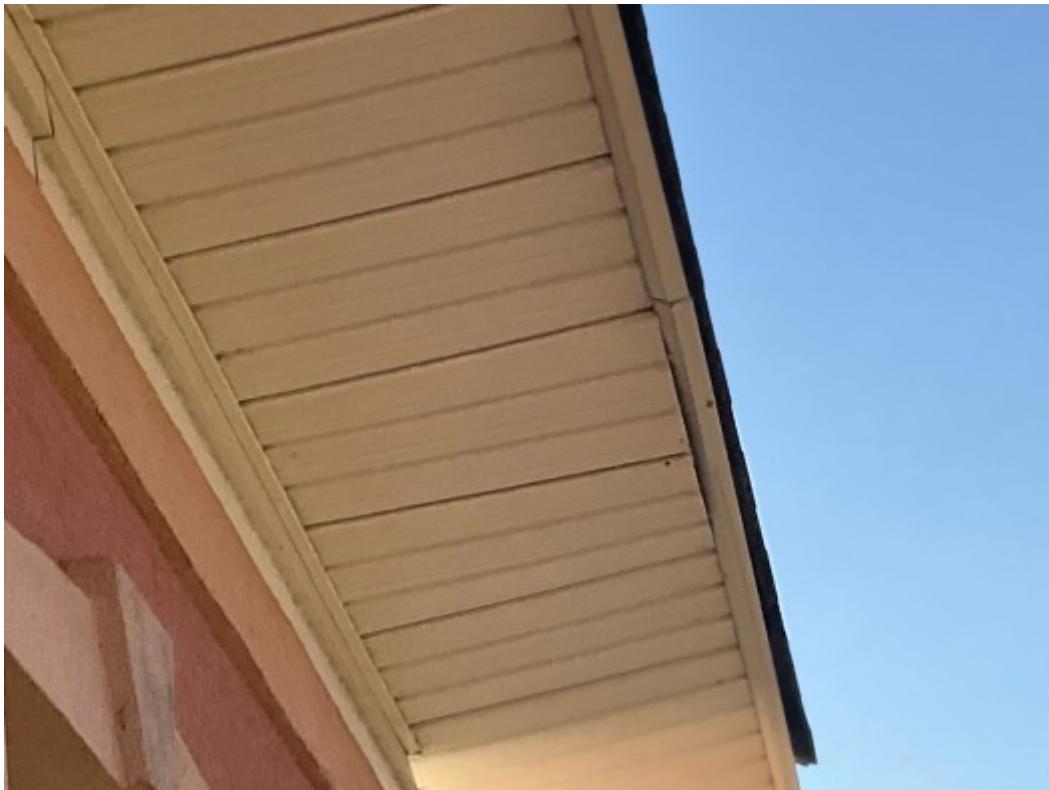
89-Building Elevations

It appears as the wind has damaged, soffit and fascia on the left elevation of the church building.

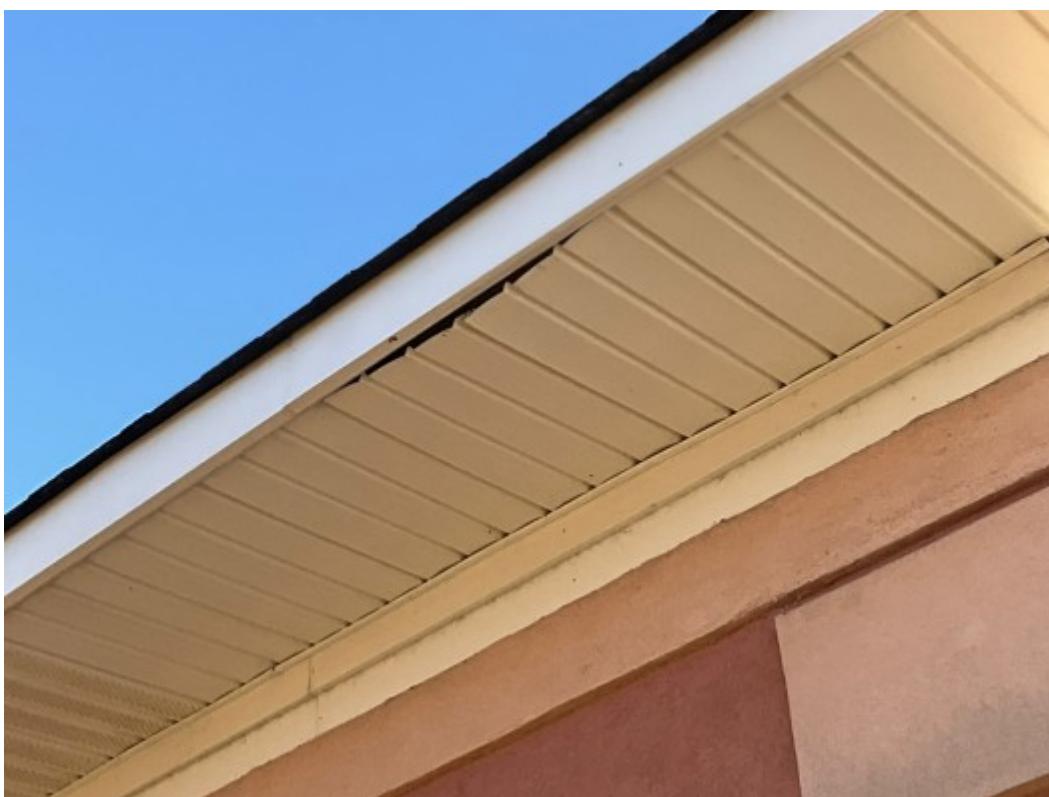
90-Building Elevations

It appears as the wind has damaged, soffit and fascia on the left elevation of the church building.

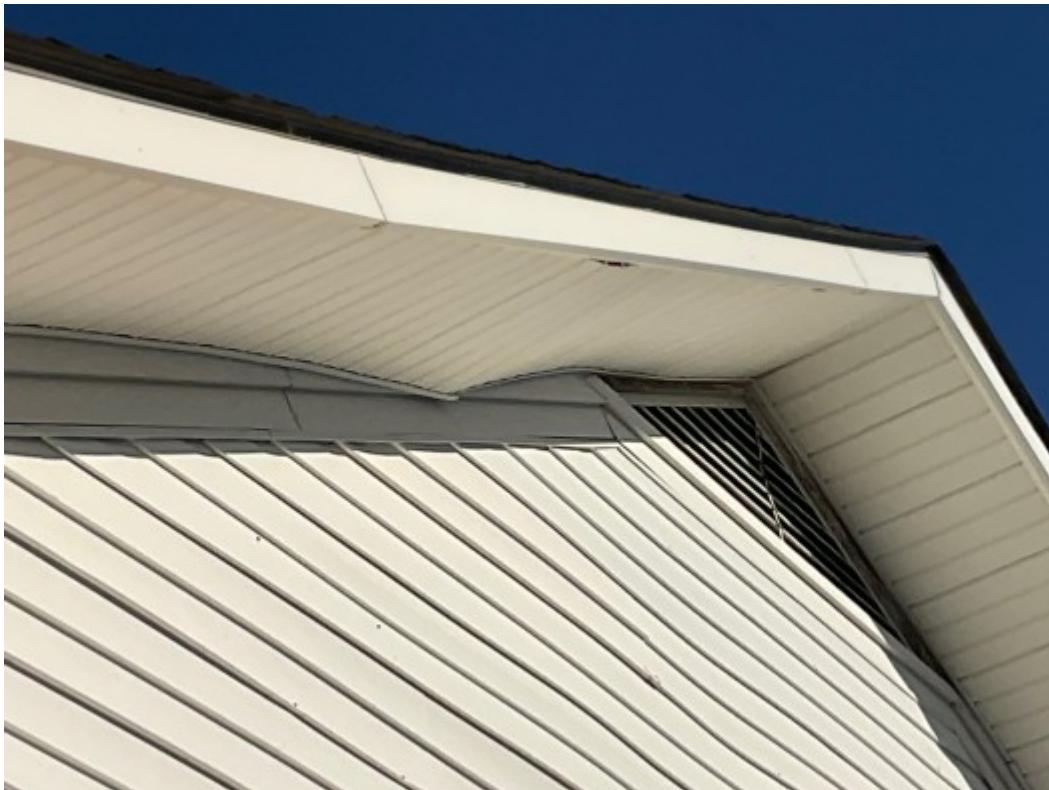
91-Building Elevations

It appears as the wind has damaged, soffit and fascia on the left elevation of the church building.

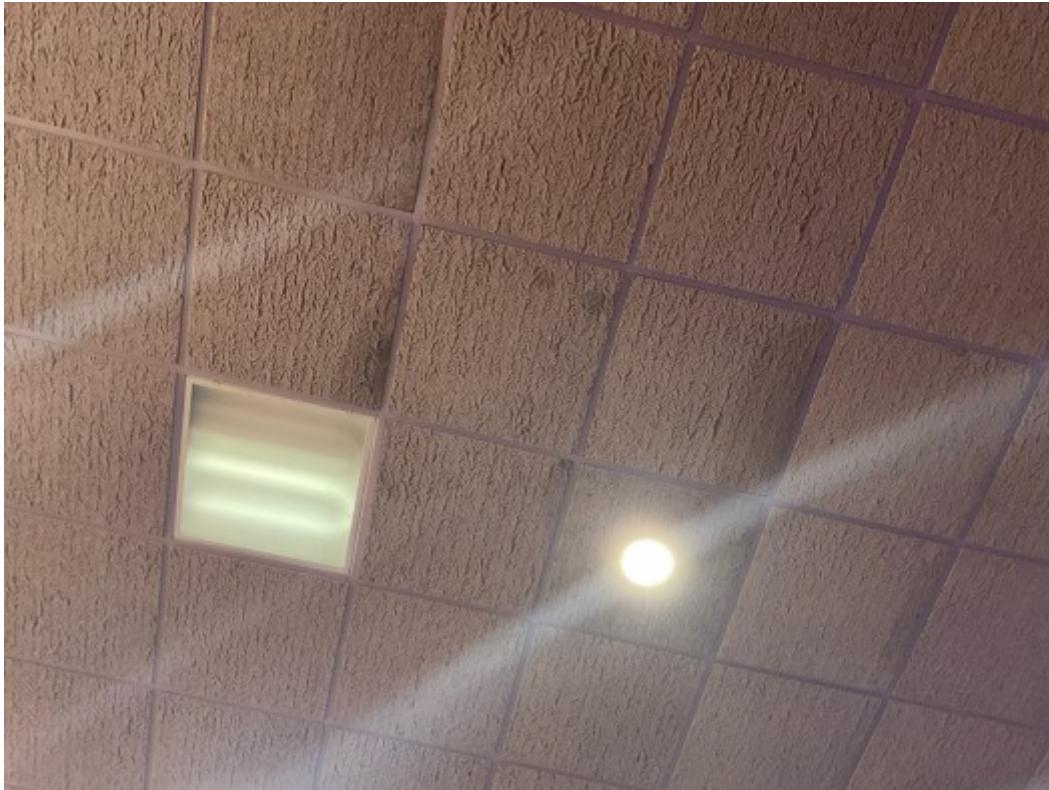
95-Sanctuary

It appears as though water has entered through the roof during the storm and caused damage to the lavender colored suspended ceiling tiles in the sanctuary.

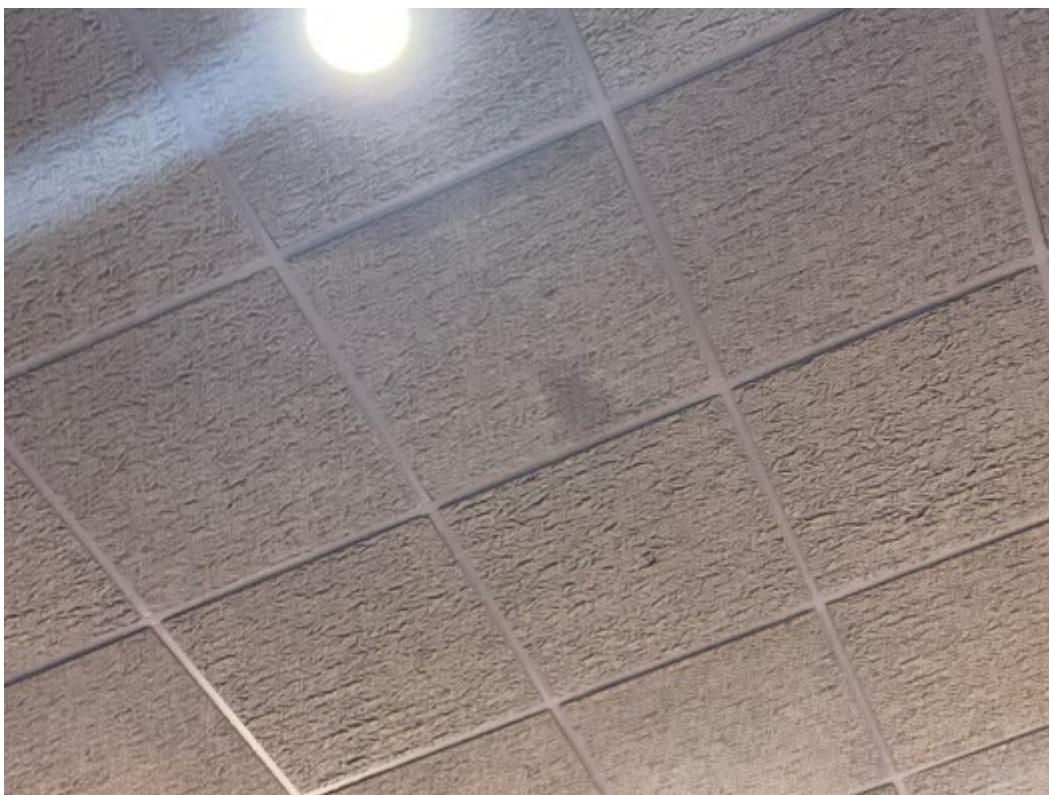
96-Sanctuary

It appears as though water has entered through the roof during the storm and caused damage to the lavender colored suspended ceiling tiles in the sanctuary.

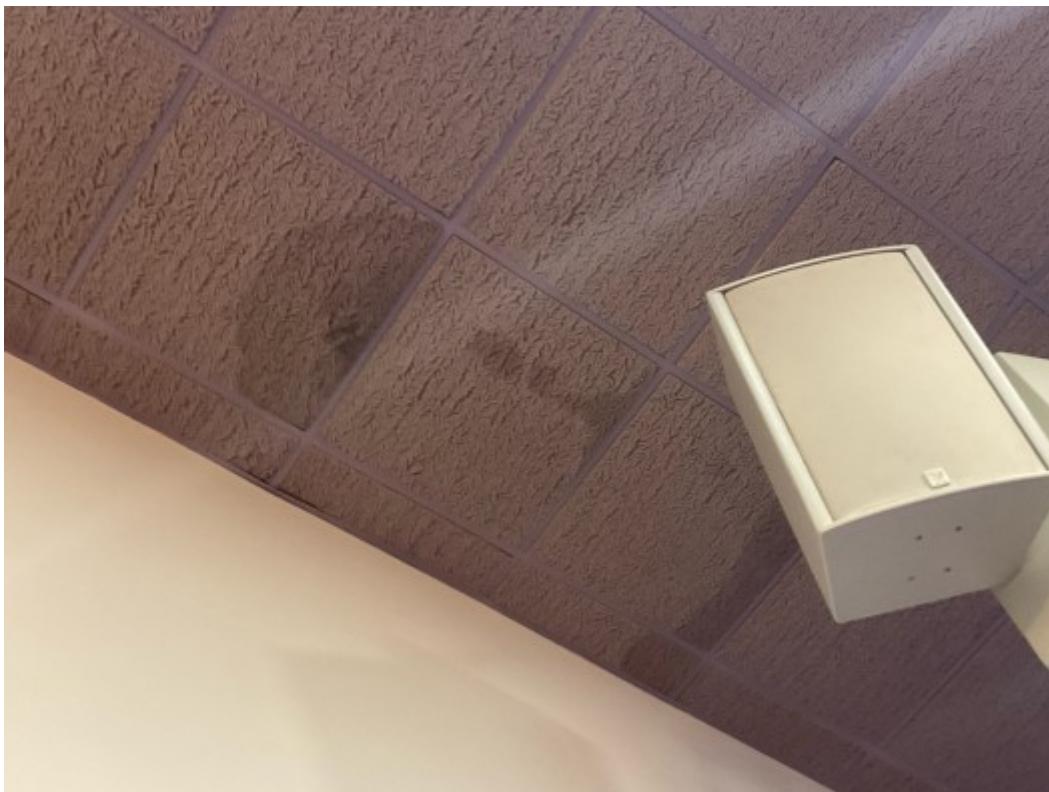
97-Sanctuary

It appears as though water has entered through the roof during the storm and caused damage to the lavender colored suspended ceiling tiles in the sanctuary.

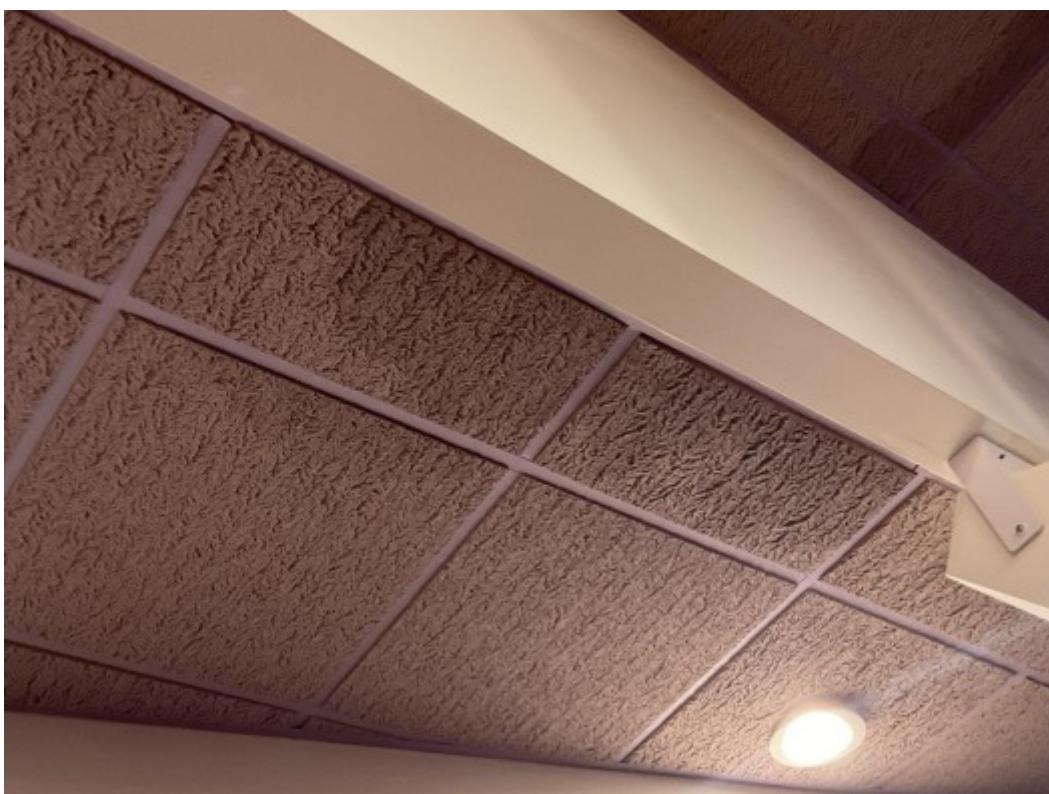
98-Sanctuary

It appears as though water has entered through the roof during the storm and caused damage to the lavender colored suspended ceiling tiles in the sanctuary.

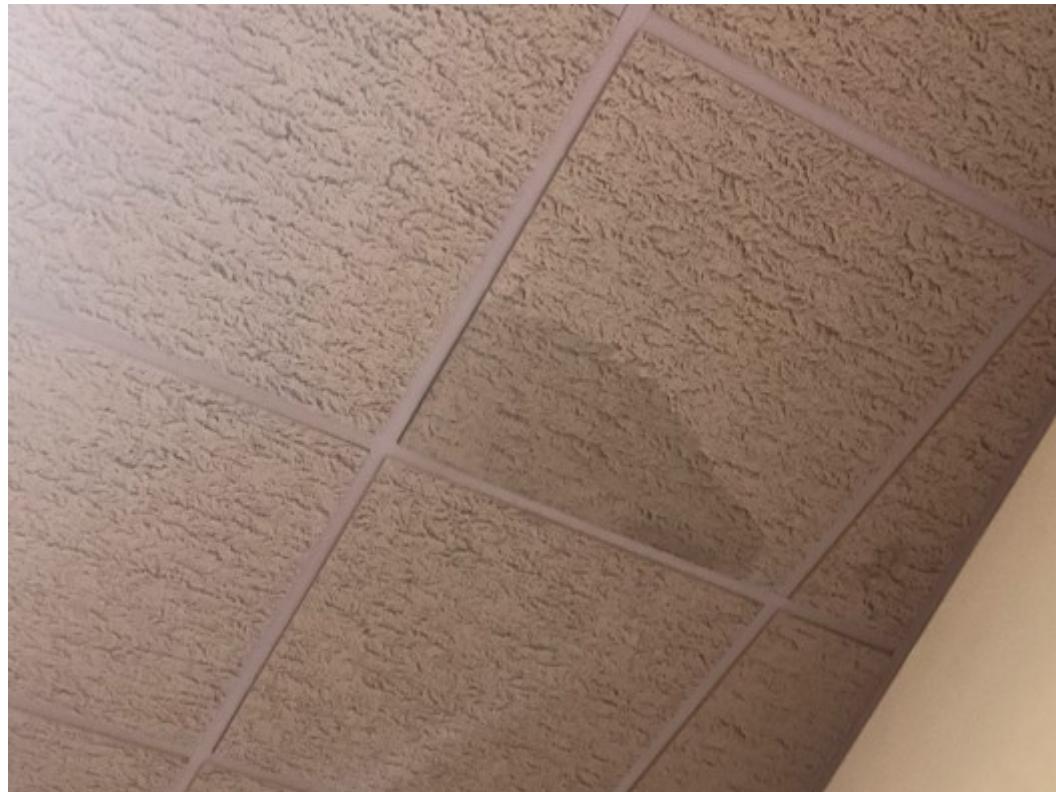
99-Sanctuary

It appears as though water has entered through the roof during the storm and caused damage to the lavender colored suspended ceiling tiles in the sanctuary.

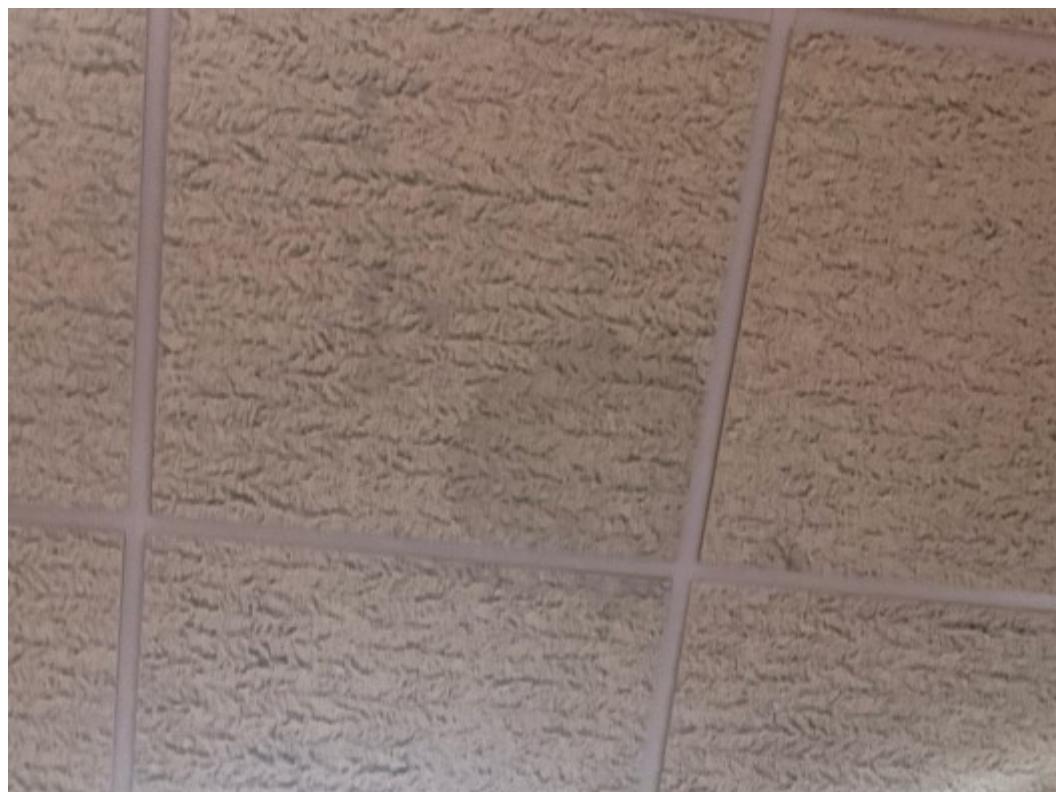
100-Sanctuary

It appears as though water has entered through the roof during the storm and caused damage to the lavender colored suspended ceiling tiles in the sanctuary.

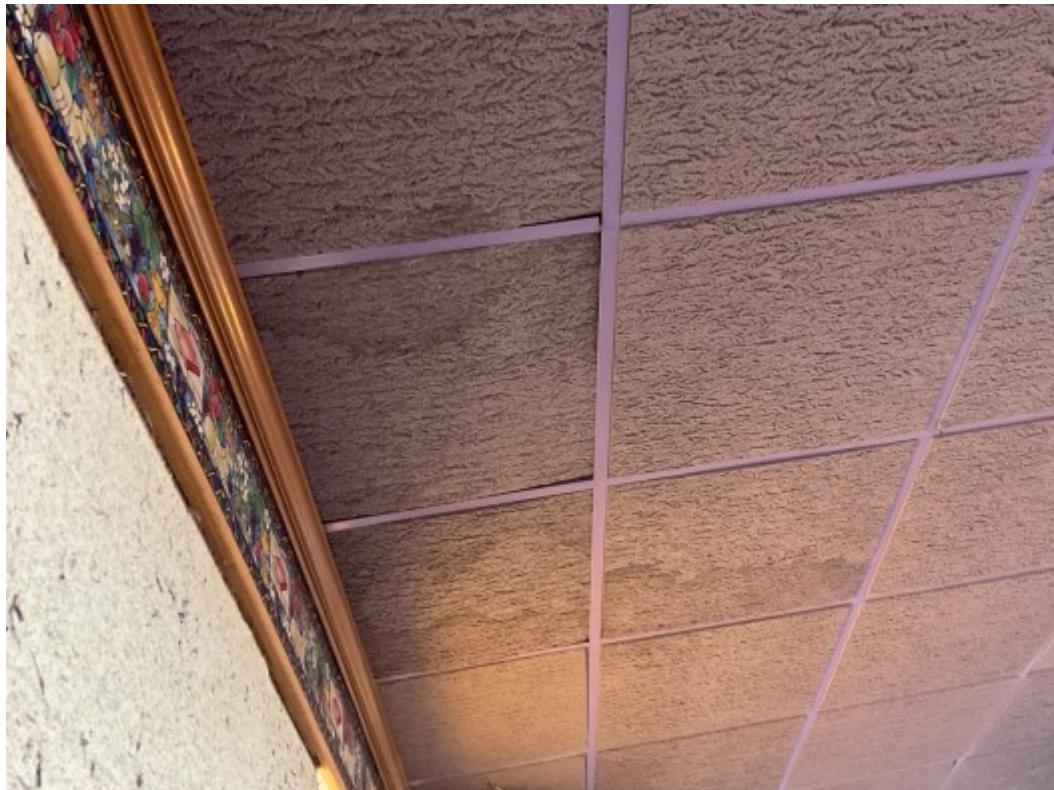
101-Sanctuary

It appears as though water has entered through the roof during the storm and caused damage to the lavender colored suspended ceiling tiles in the sanctuary.

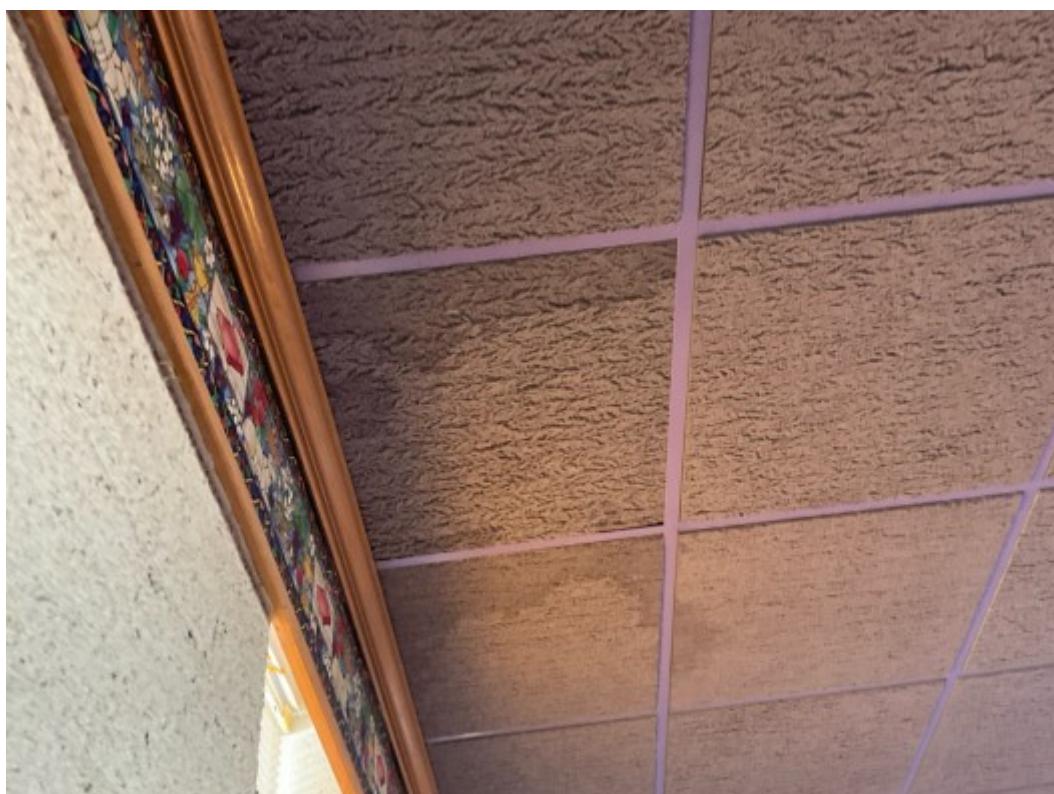
102-Sanctuary

It appears as though water has entered through the roof during the storm and caused damage to the lavender colored suspended ceiling tiles in the sanctuary.

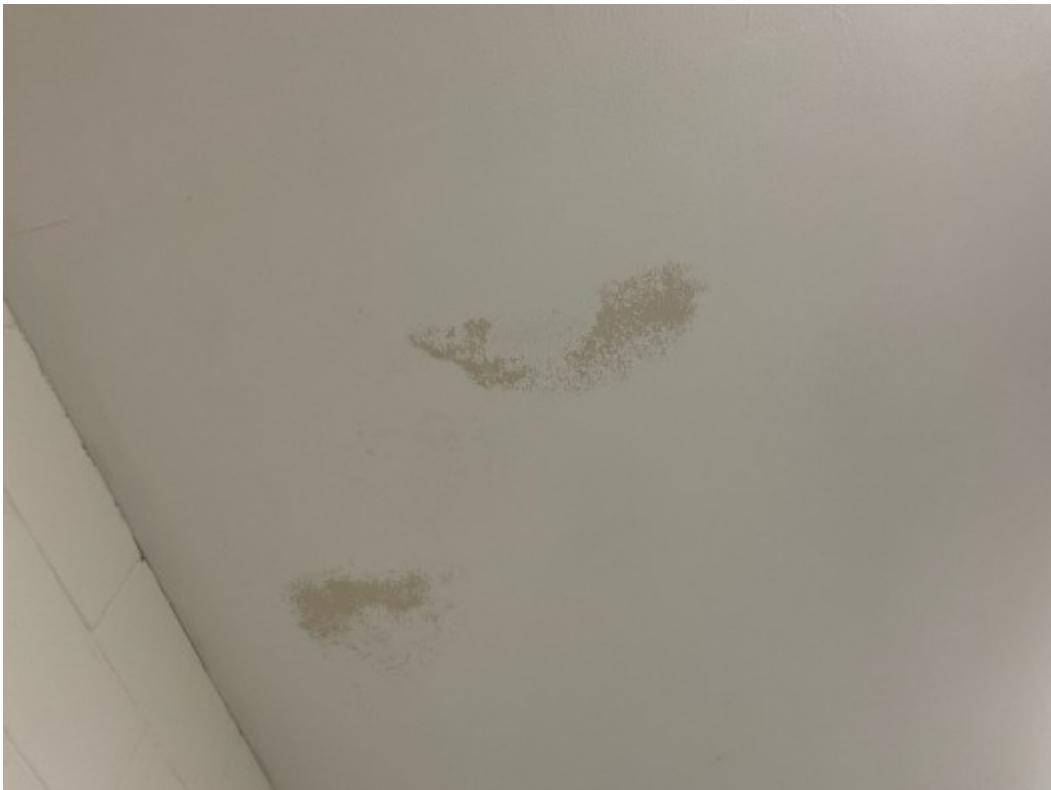
109-Kitchen

It appears as though water through the roof during the storm has damaged the smooth textured drywall ceiling in the kitchen.

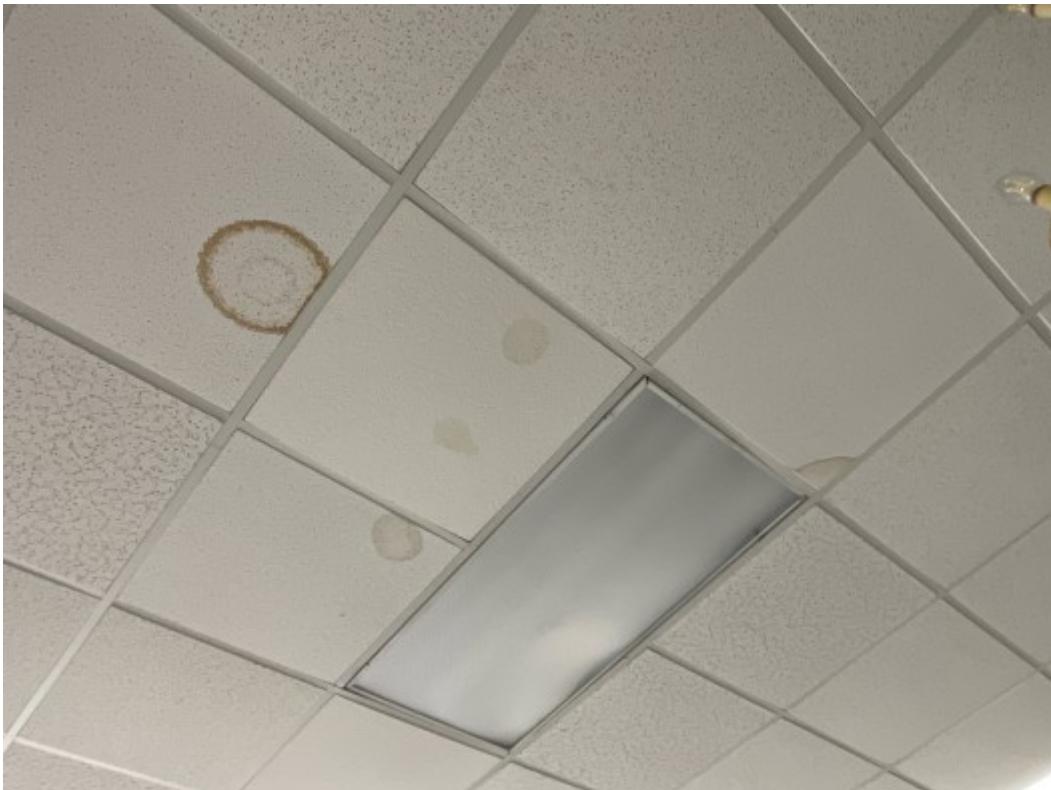
115-Kitchen

It appears as the water has come through the roof during the storm damaging 2 x 2 suspended ceiling tiles in the fellowship hall.

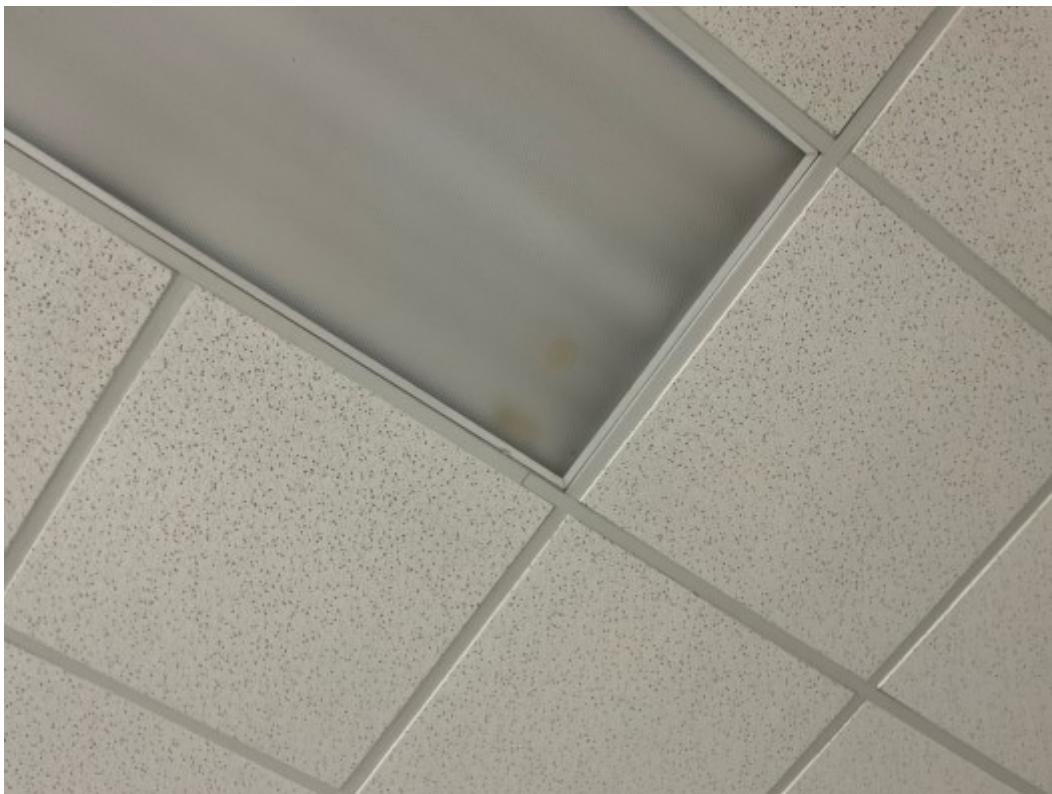
117-Kitchen

It appears as the water has come through the roof during the storm damaging 2 x 2 suspended ceiling tiles in the fellowship hall.

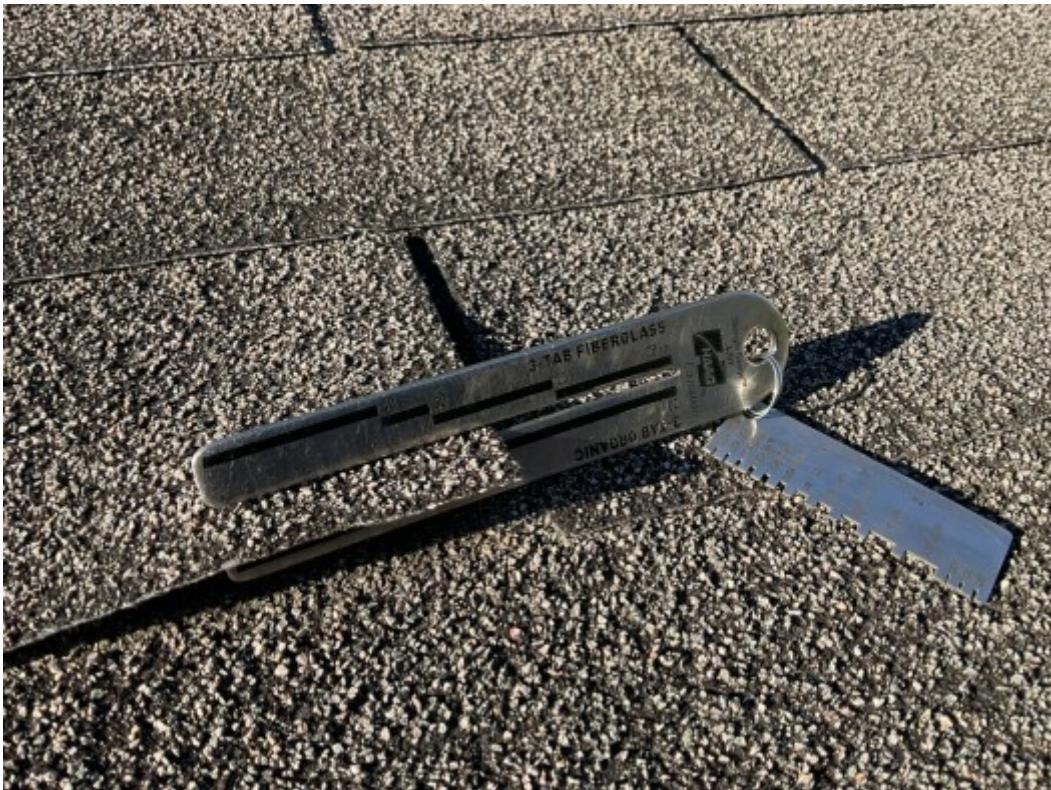
121-Shed Roof

25 year three tab shingles are present on the shed roof.

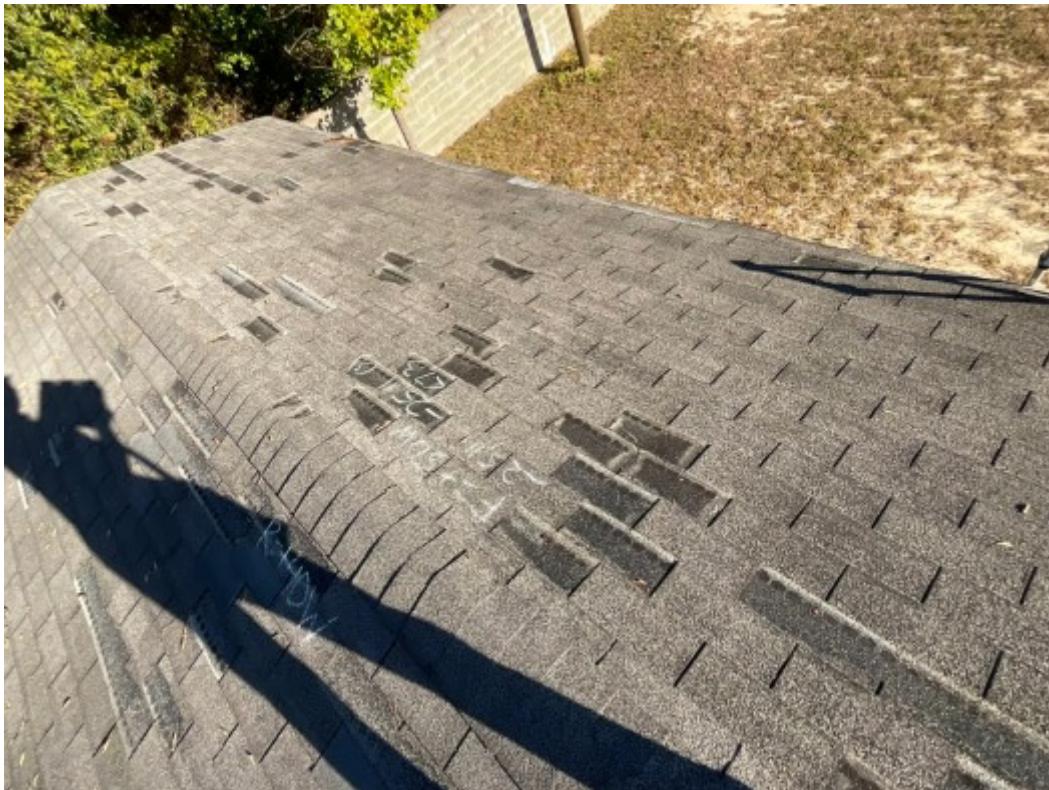
123-Shed Roof

It appears as the wind has damaged over 50 shingles on the front facing slope of the shed roof.

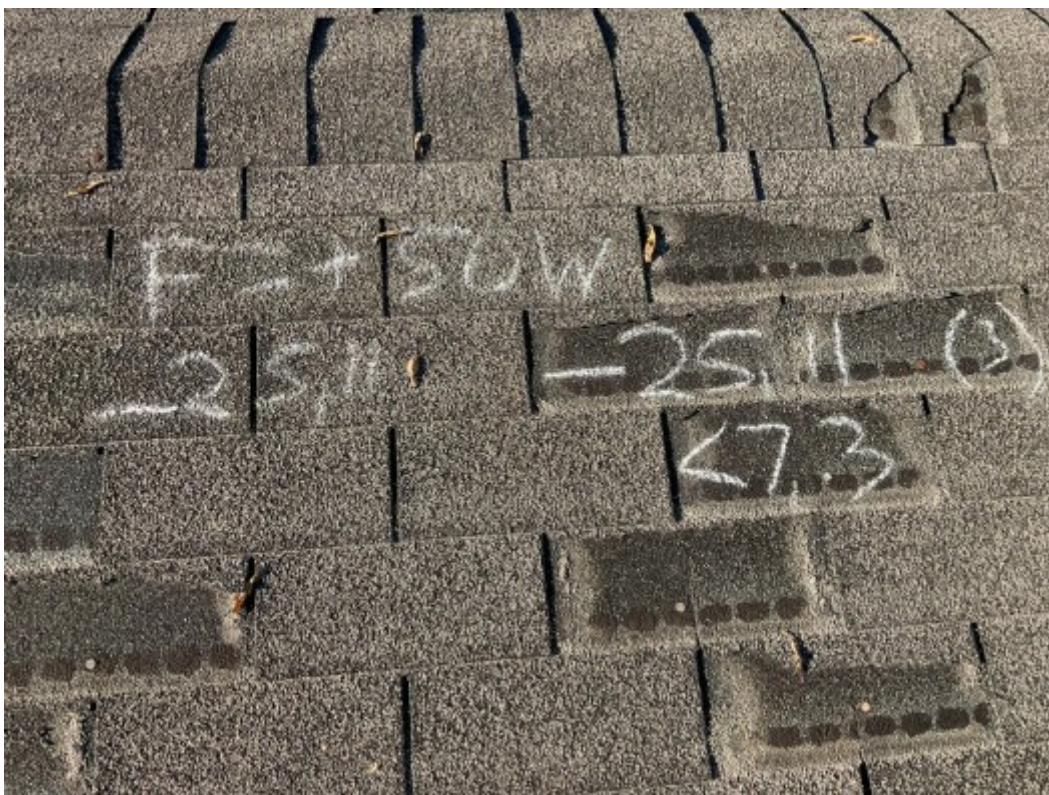
124-Shed Roof

It appears as the wind has damaged over 50 shingles on the front facing slope of the shed roof.

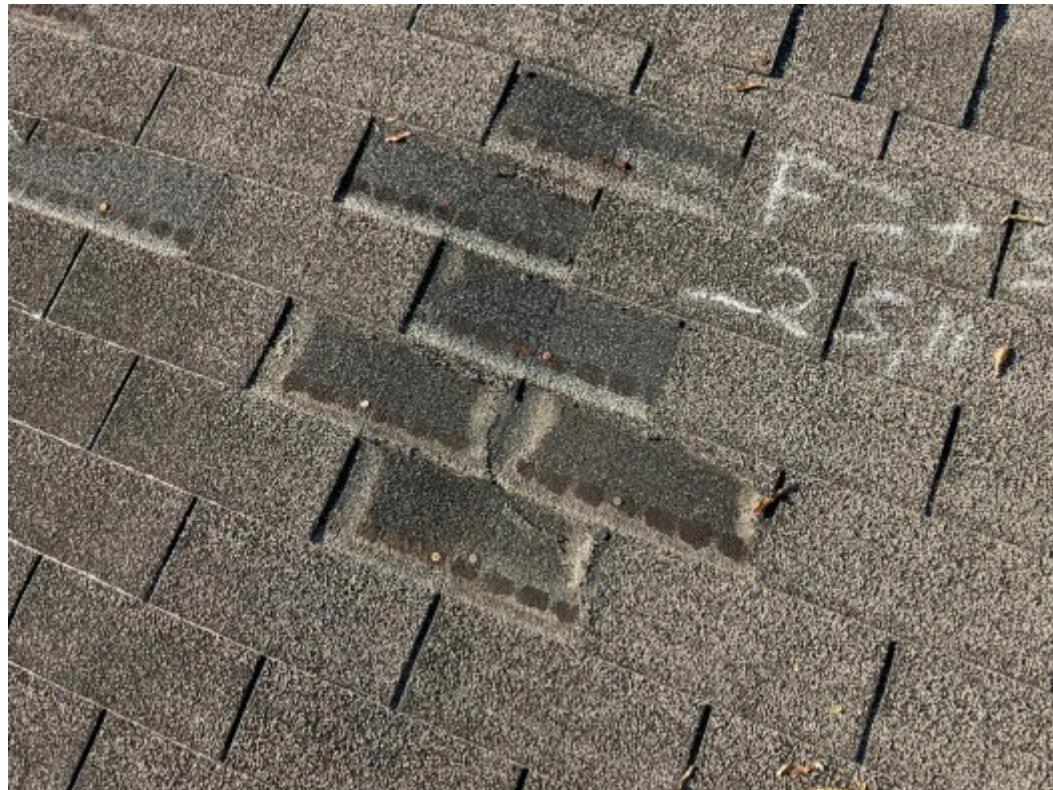
125-Shed Roof

It appears as the wind has damaged over 50 shingles on the front facing slope of the shed roof.

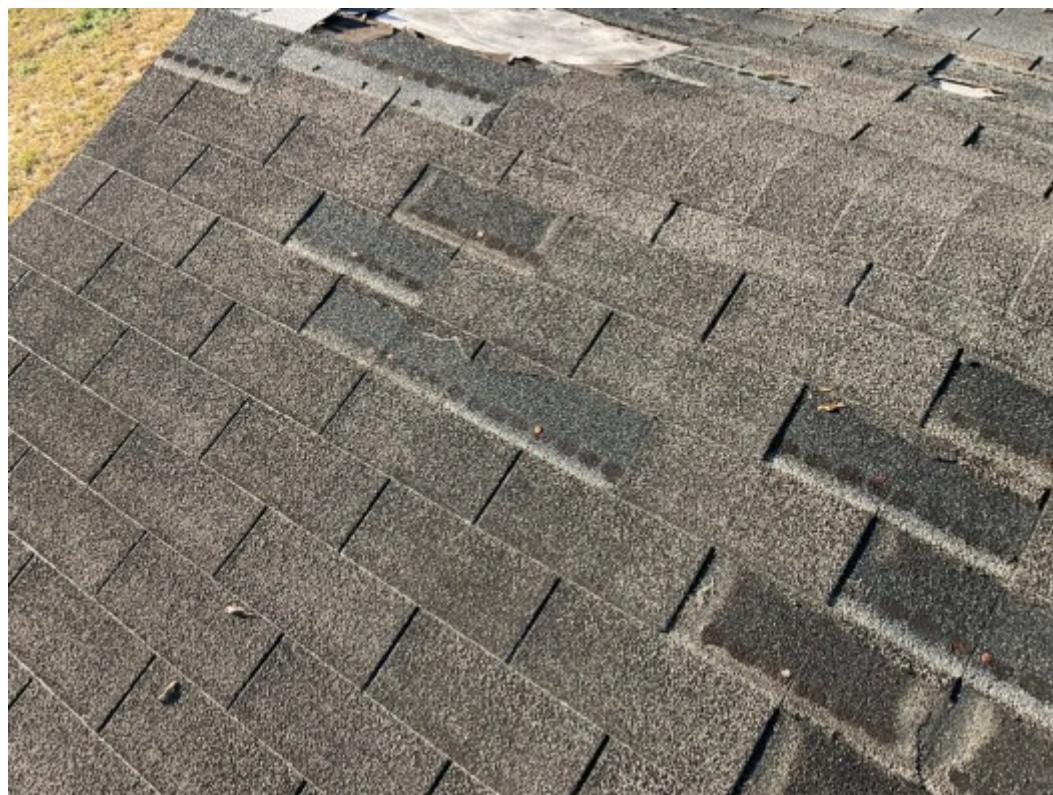
126-Shed Roof

It appears as the wind has damaged over 50 shingles on the front facing slope of the shed roof.

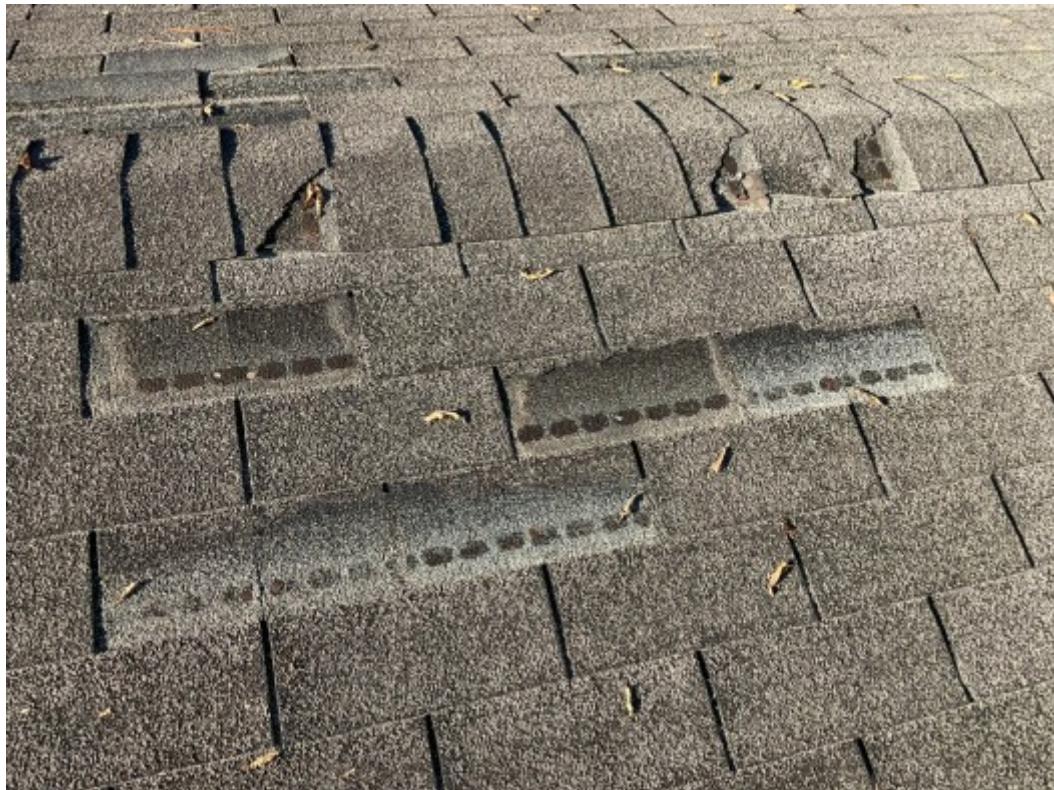
127-Shed Roof

It appears as the wind has damaged over 50 shingles on the front facing slope of the shed roof.

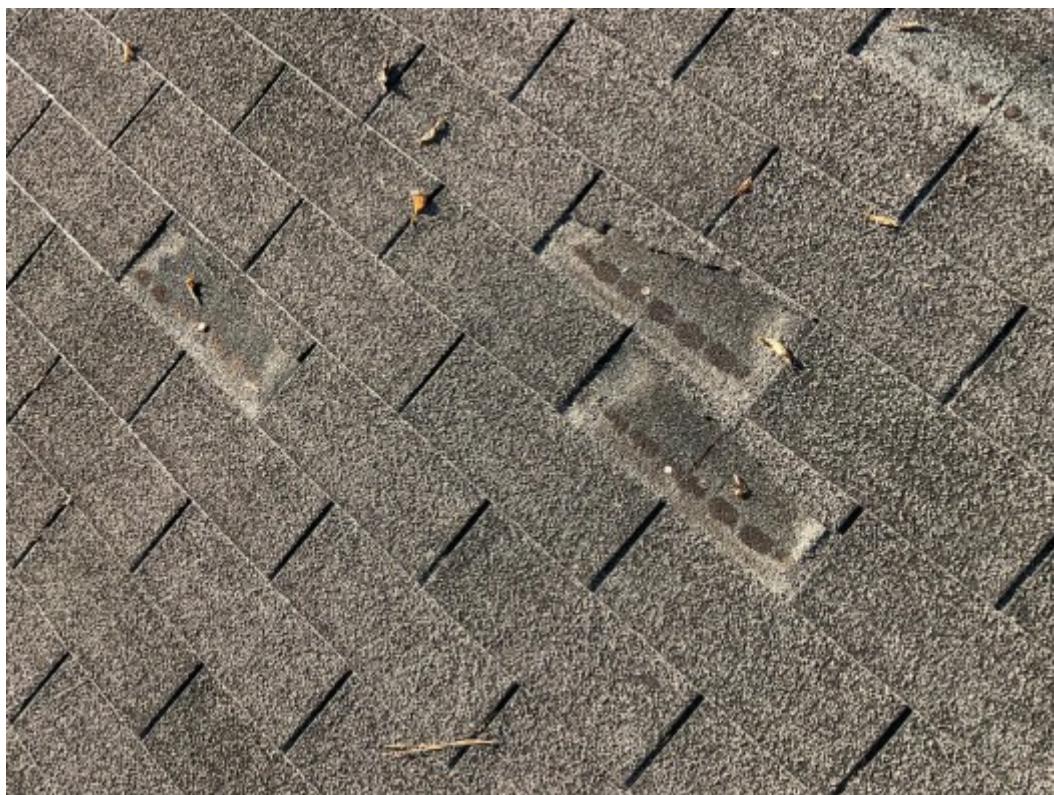
128-Shed Roof

It appears as the wind has damaged over 50 shingles on the front facing slope of the shed roof.

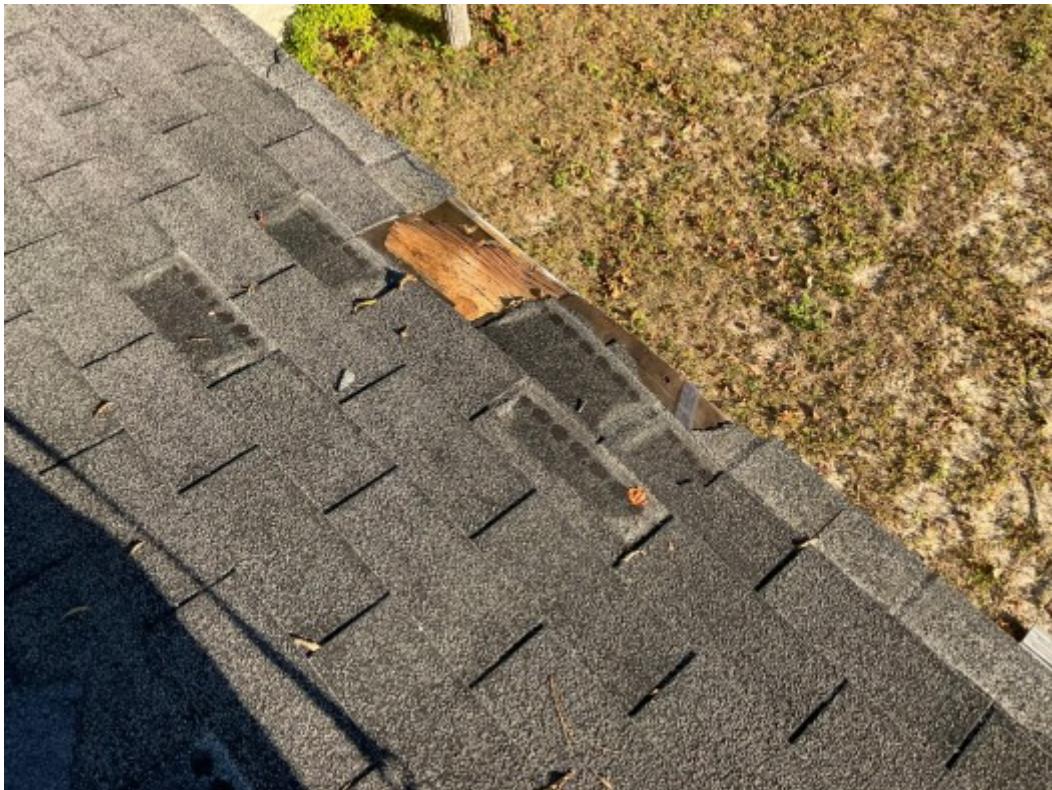
129-Shed Roof

It appears as the wind has damaged over 50 shingles on the front facing slope of the shed roof.

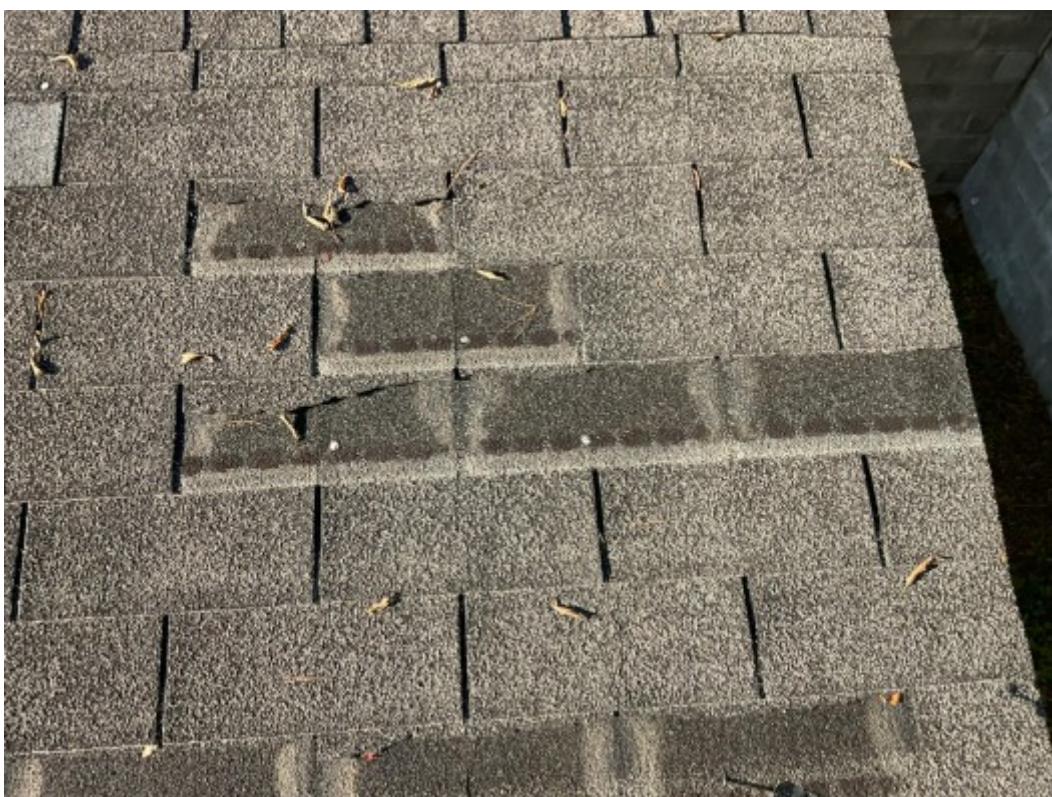
130-Shed Roof

It appears as the wind has damaged over 50 shingles on the front facing slope of the shed roof.

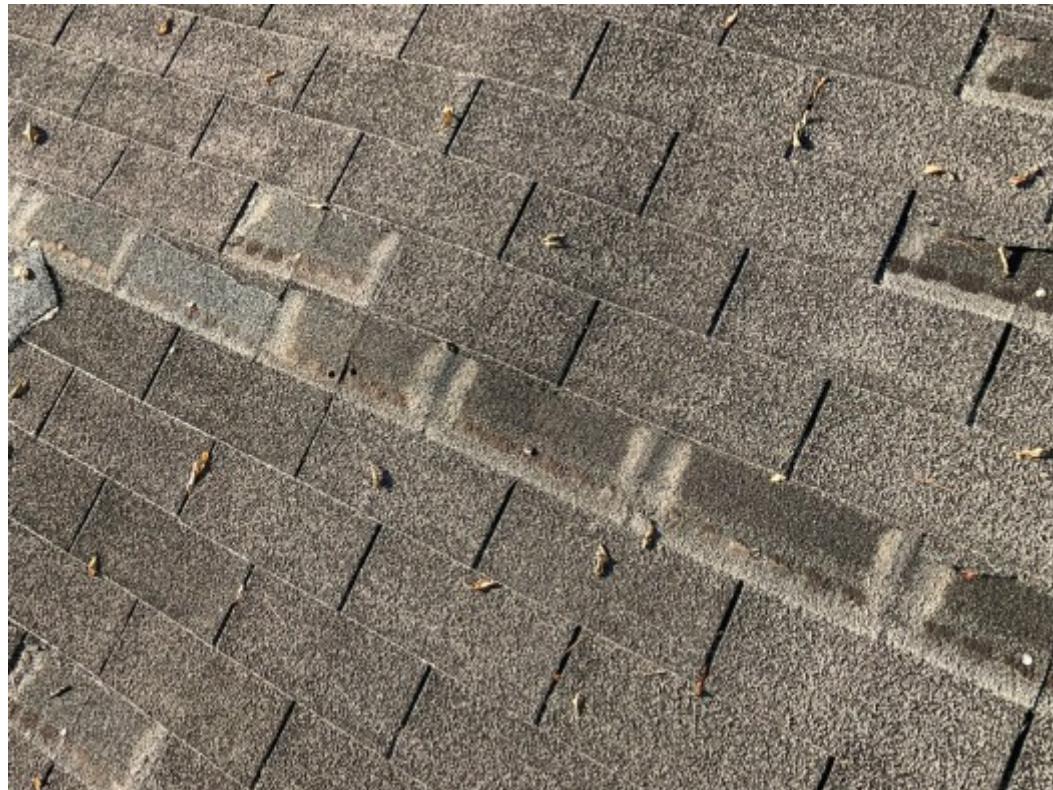
131-Shed Roof

It appears as the wind has damaged over 50 shingles on the front facing slope of the shed roof.

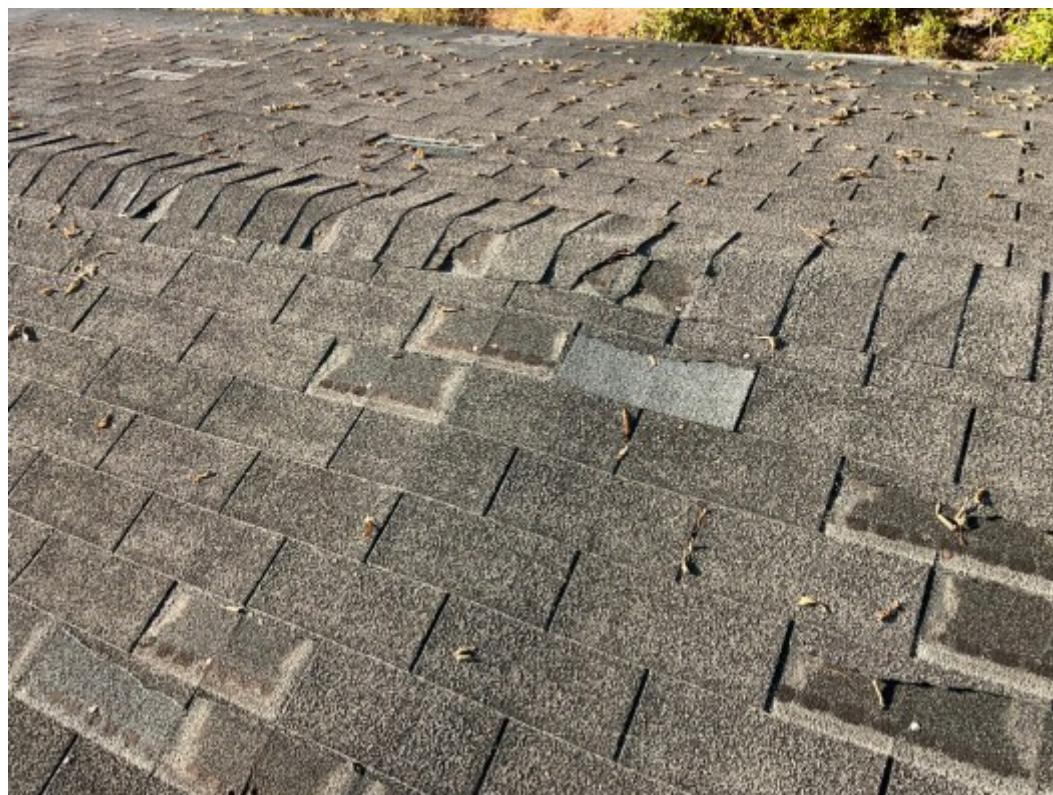
132-Shed Roof

It appears as the wind has damaged over 50 shingles on the front facing slope of the shed roof.

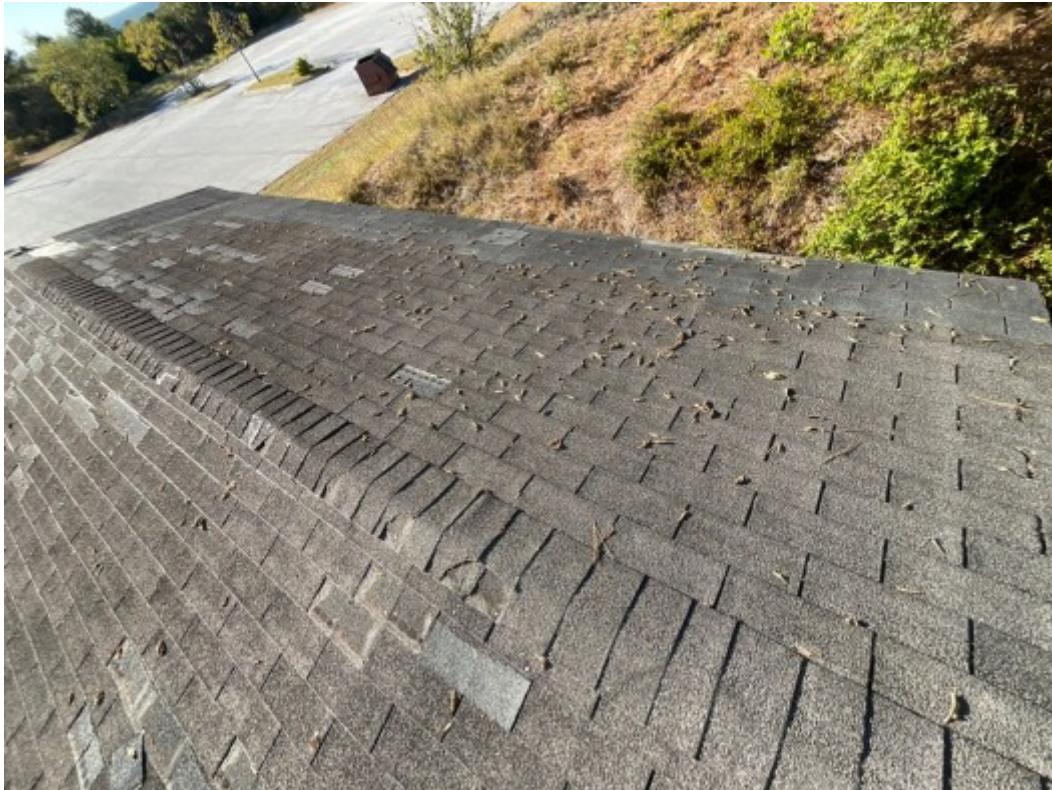
133-Shed Roof

It appears as the wind has damaged over 40 shingles on the rear facing slope of the shed roof.
