Photo Sheet

Eberl Claims Service

Insured: NEW ZION HILL MISSIONARY BAPTIST CHURCH INCORPORATED

Claim #: AA190825

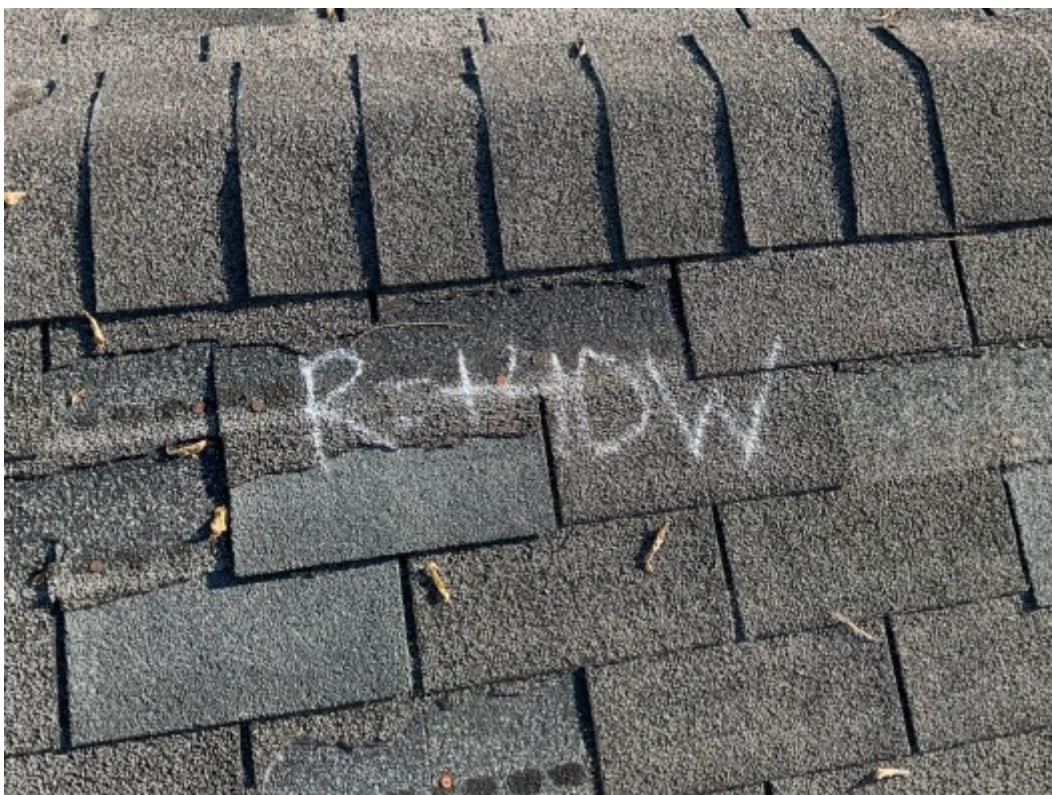
134-Shed Roof

It appears as the wind has damaged over 40 shingles on the rear facing slope of the shed roof.

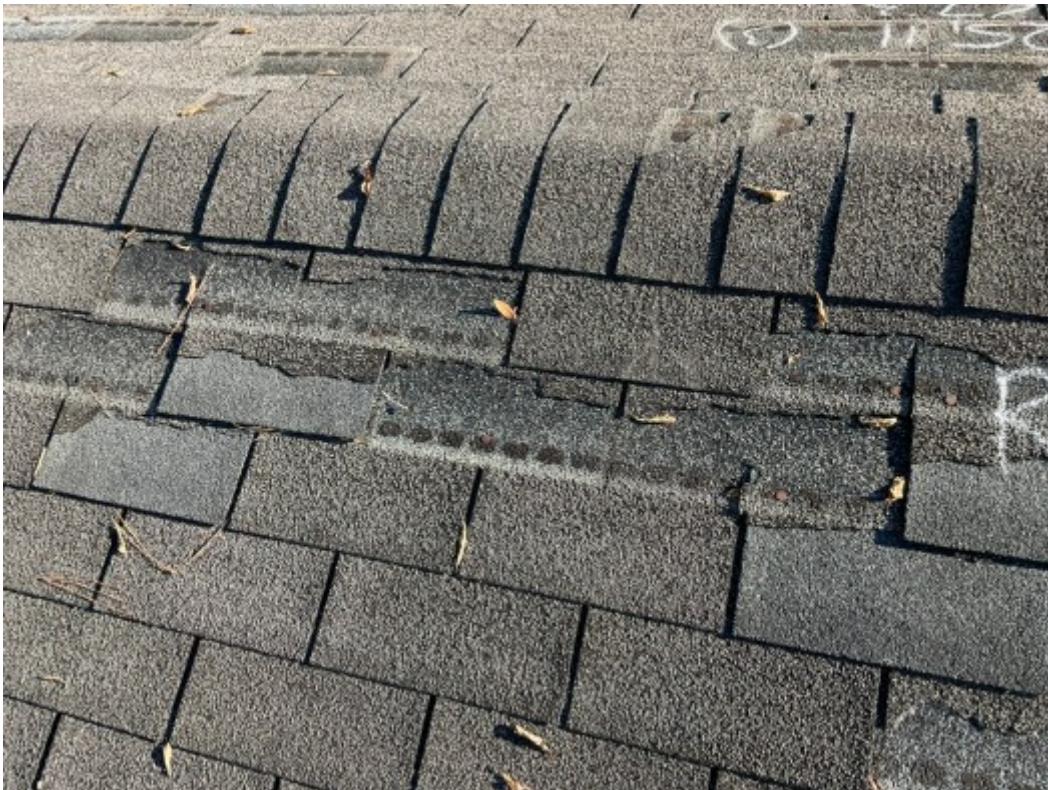
135-Shed Roof

It appears as the wind has damaged over 40 shingles on the rear facing slope of the shed roof.

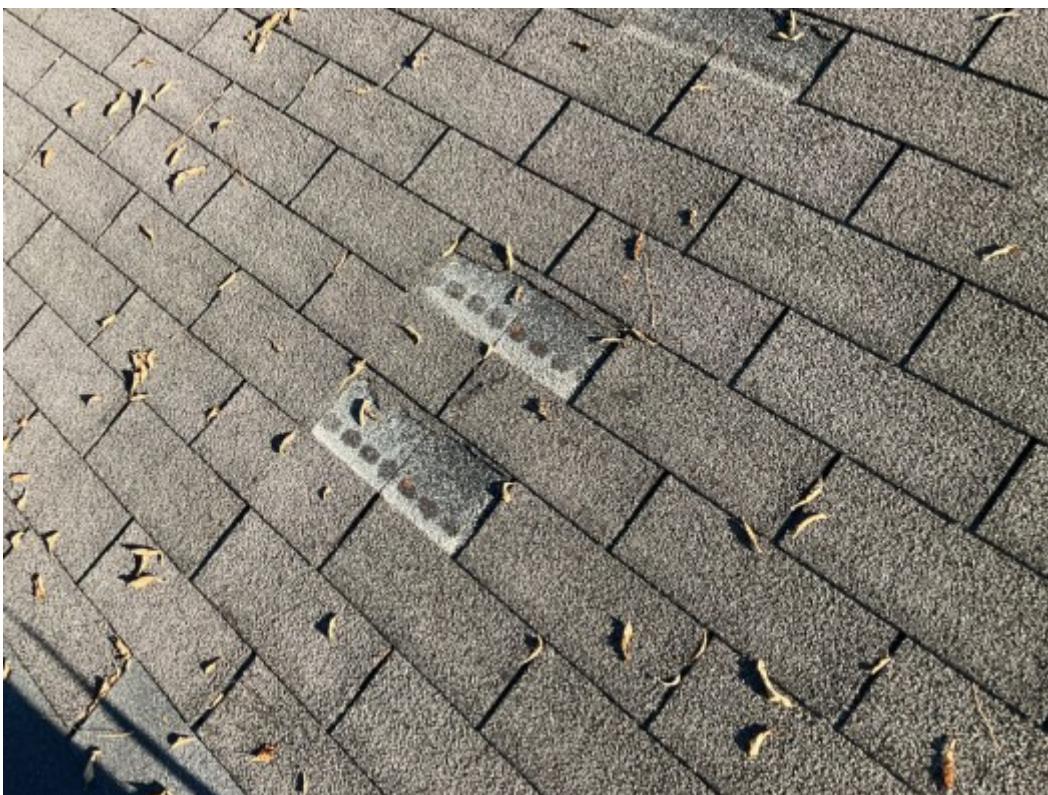
136-Shed Roof

It appears as the wind has damaged over 40 shingles on the rear facing slope of the shed roof.

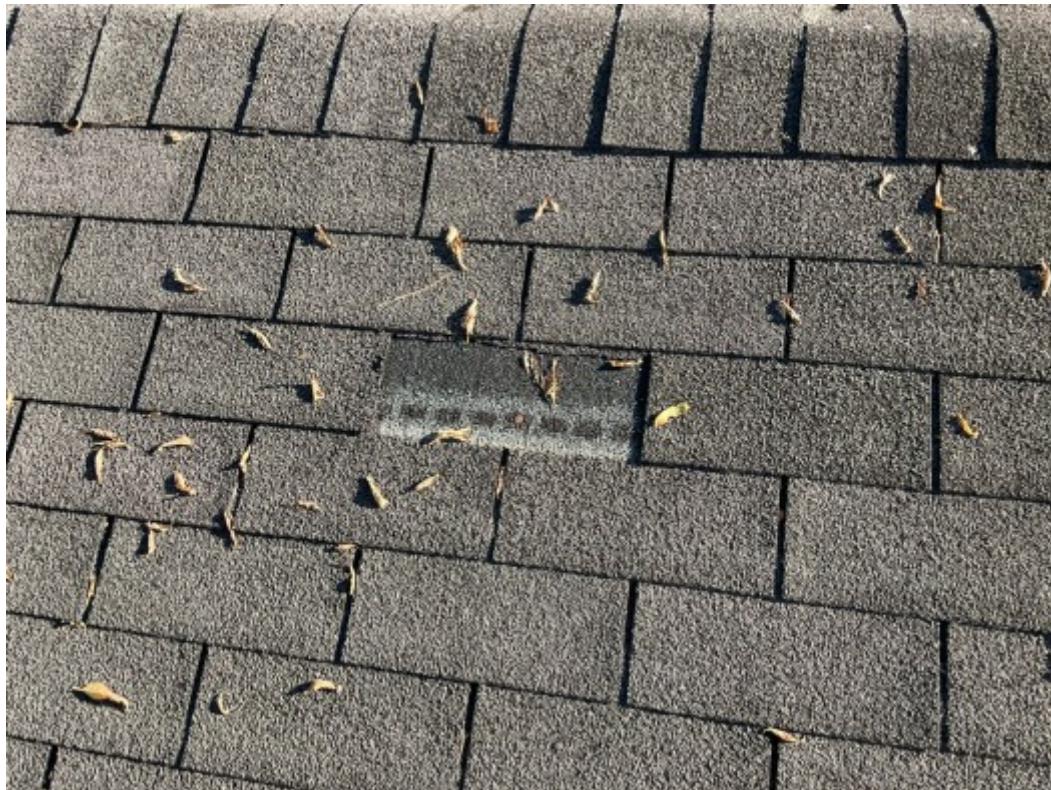
137-Shed Roof

It appears as the wind has damaged over 40 shingles on the rear facing slope of the shed roof.

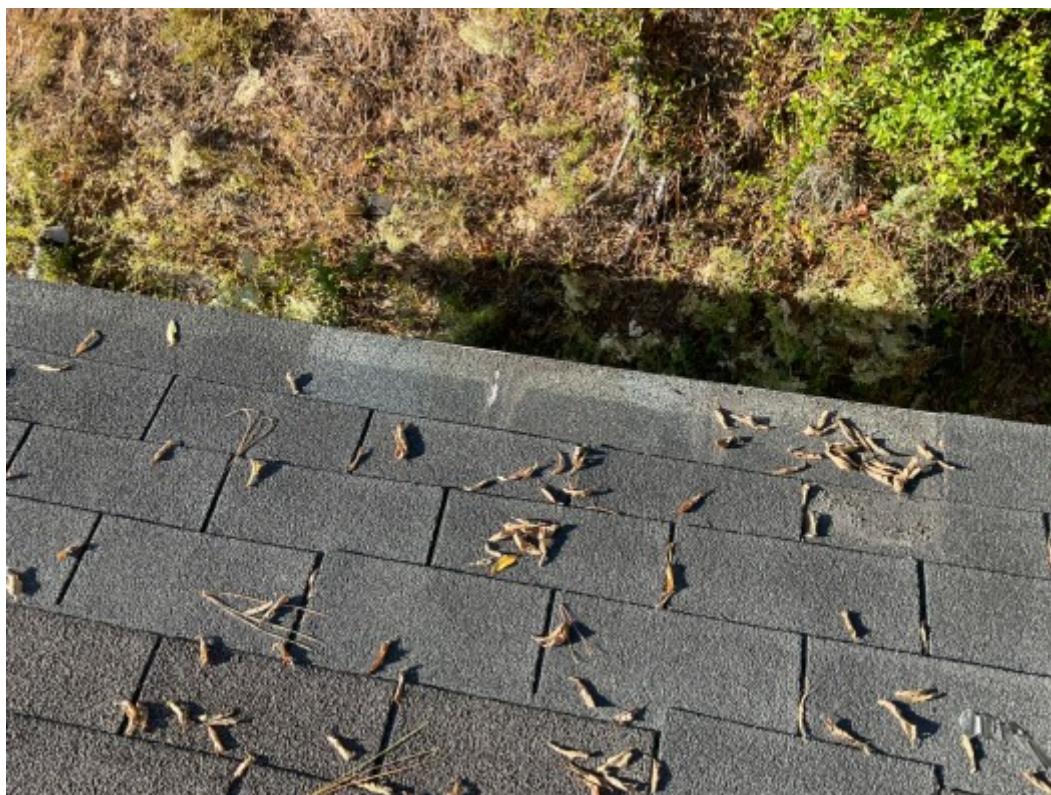
138-Shed Roof

It appears as the wind has damaged over 40 shingles on the rear facing slope of the shed roof.

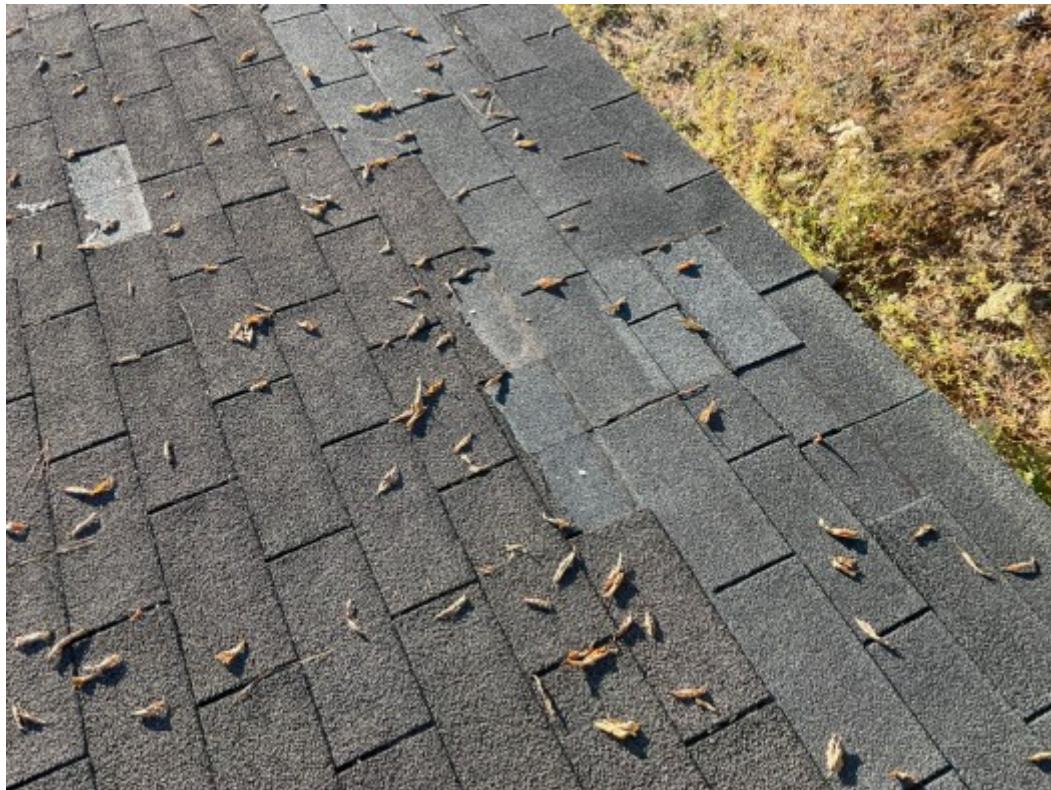
139-Shed Roof

It appears as the wind has damaged over 40 shingles on the rear facing slope of the shed roof.

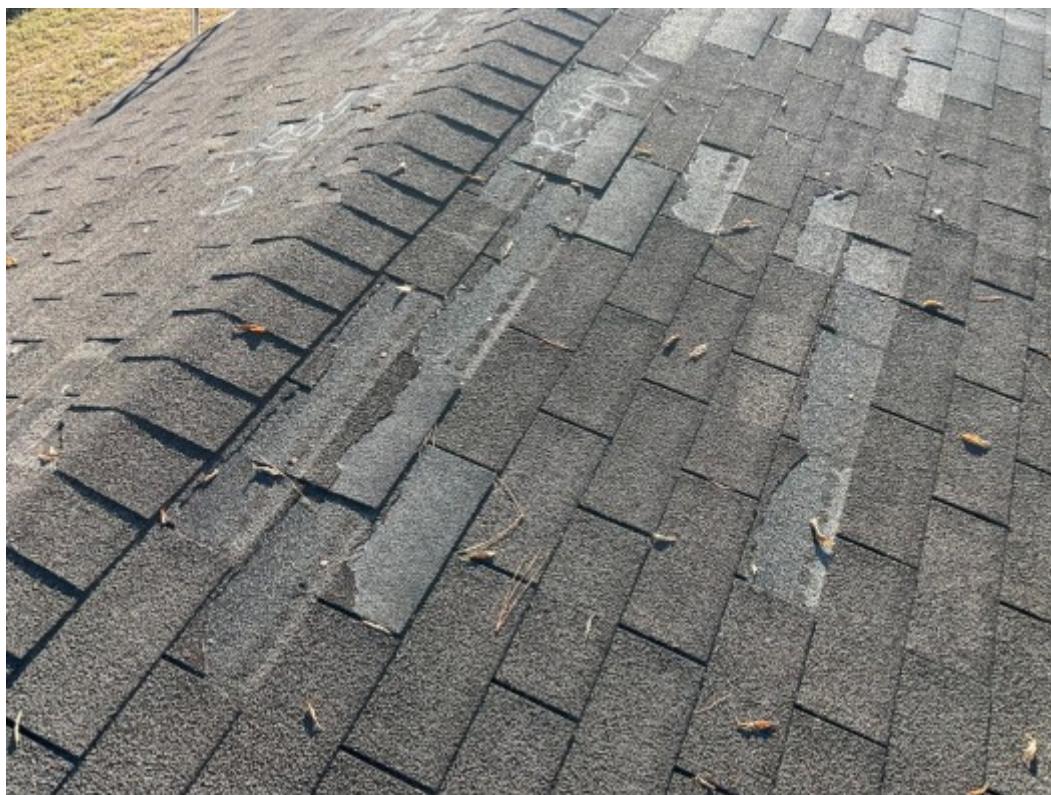
140-Shed Roof

It appears as the wind has damaged over 40 shingles on the rear facing slope of the shed roof.

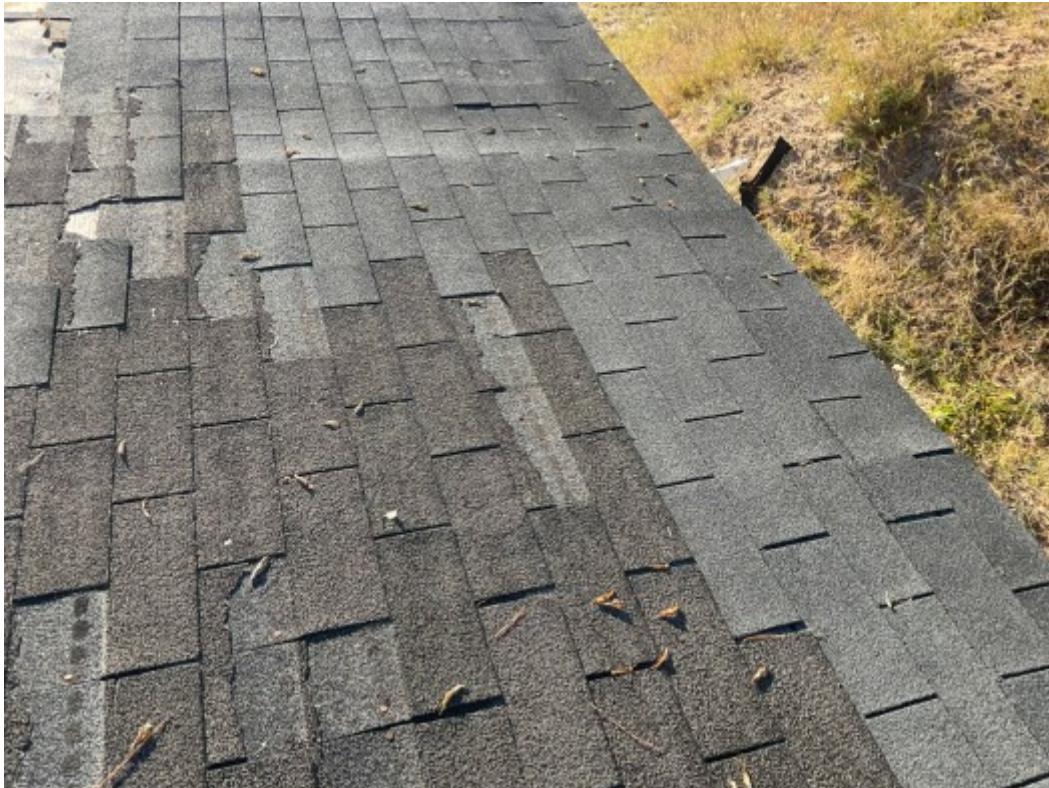
141-Shed Roof

It appears as the wind has damaged over 40 shingles on the rear facing slope of the shed roof.

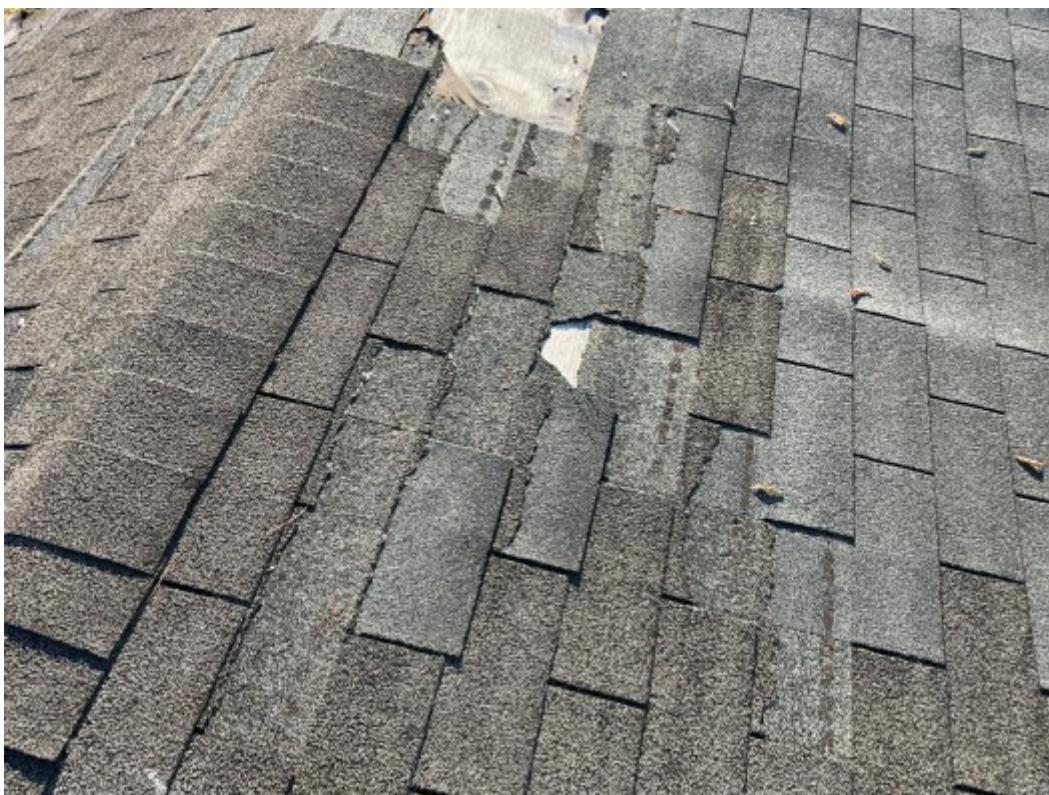
142-Shed Roof

It appears as the wind has damaged over 40 shingles on the rear facing slope of the shed roof.

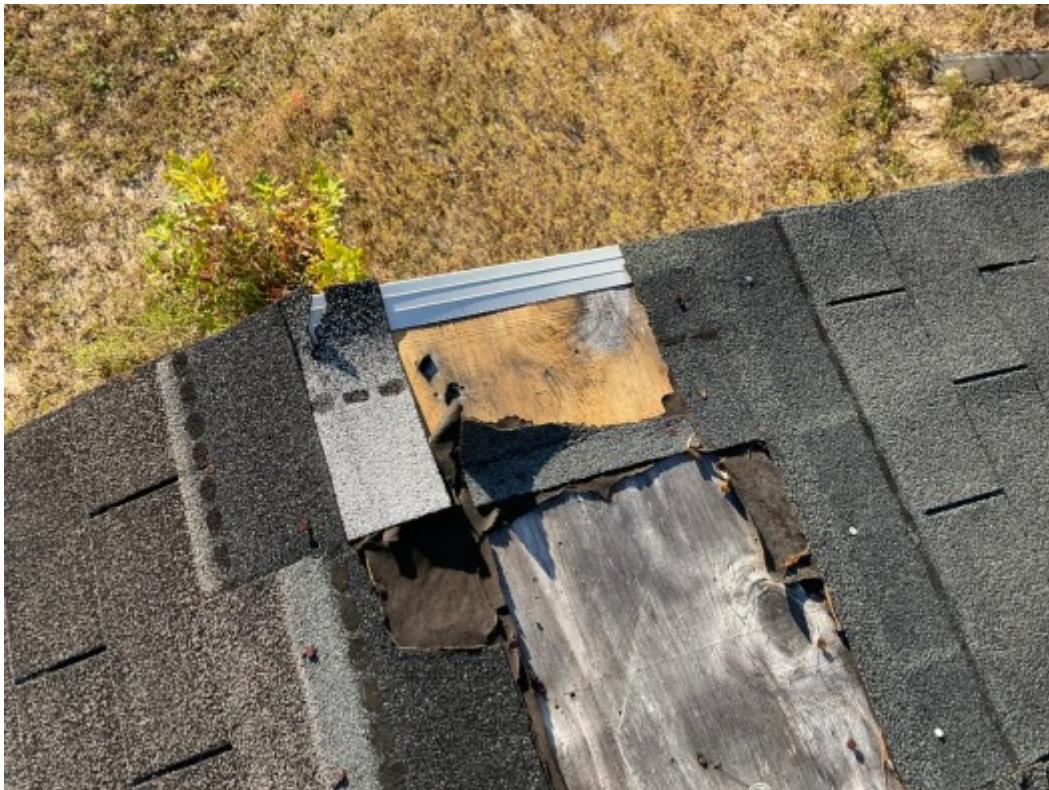
143-Shed Roof

It appears as the wind has damaged over 40 shingles on the rear facing slope of the shed roof.

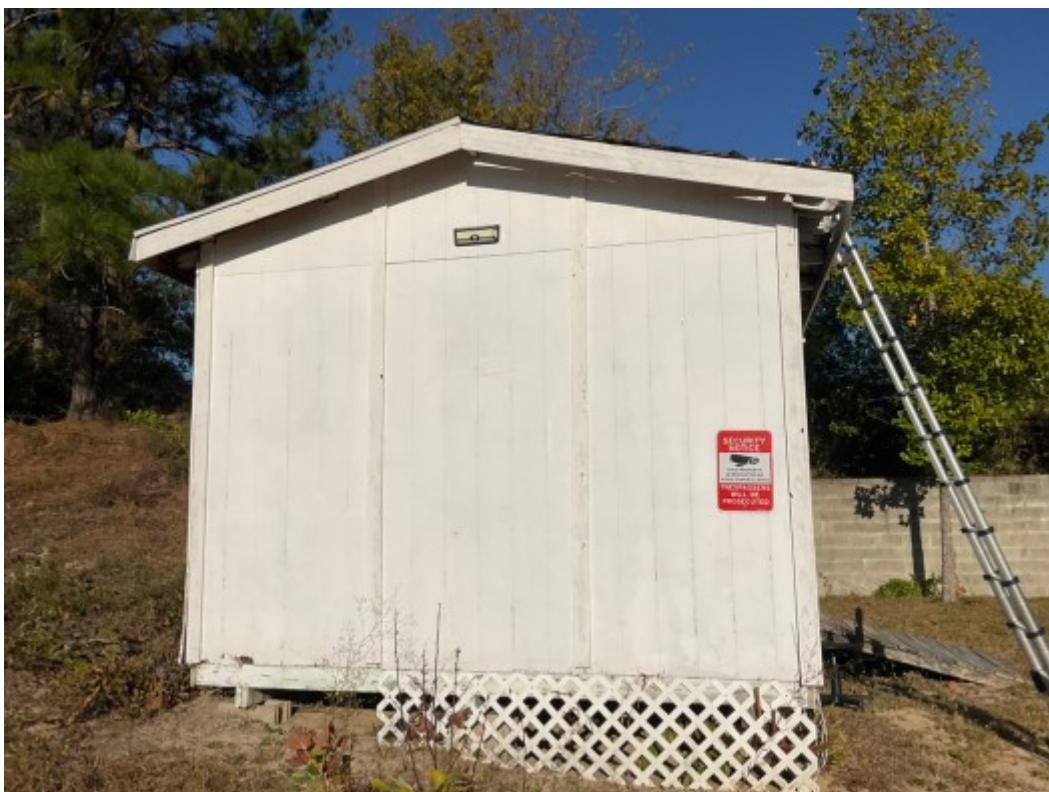
144-Shed Elevations

All elevations of the storage shed have been inspected and found to be free from storm related damage.

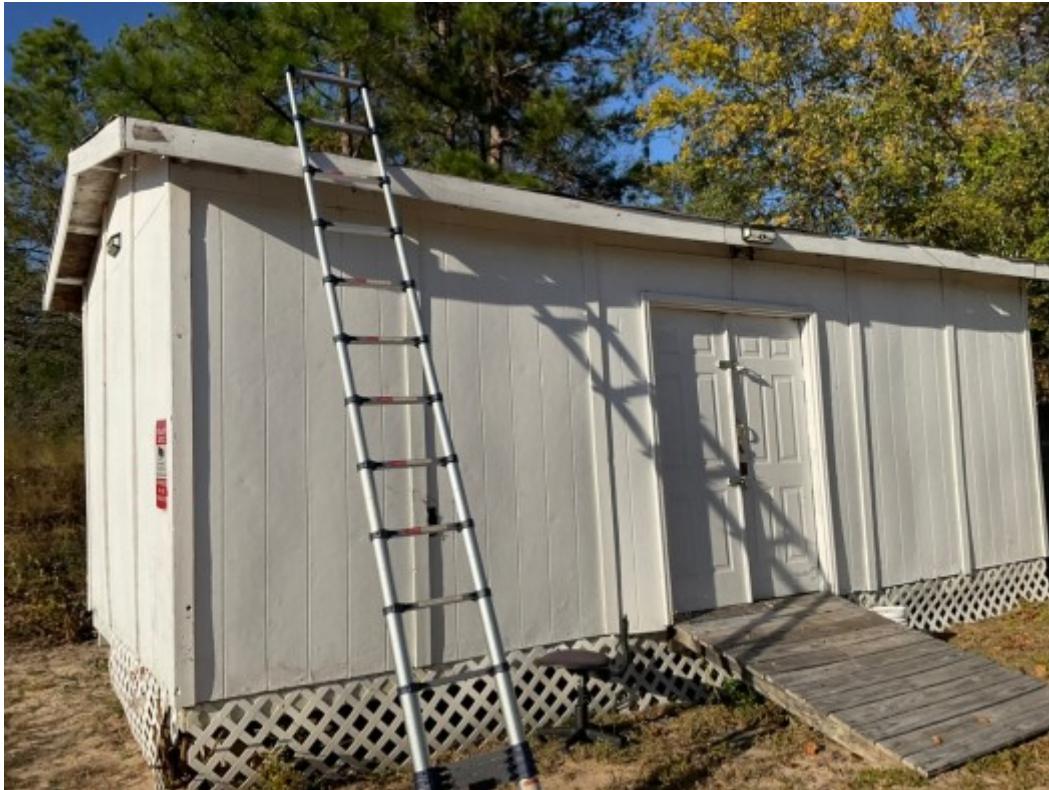
145-Shed Elevations

All elevations of the storage shed have been inspected and found to be free from storm related damage.

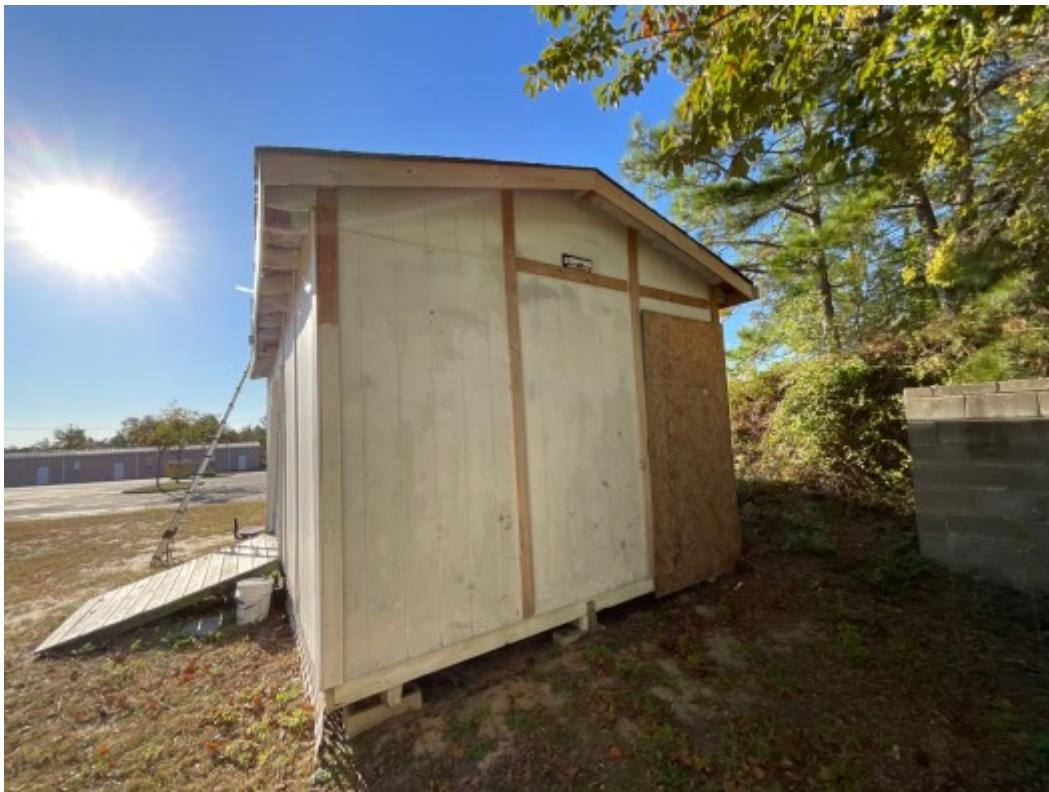
146-Shed Elevations

All elevations of the storage shed have been inspected and found to be free from storm related damage.

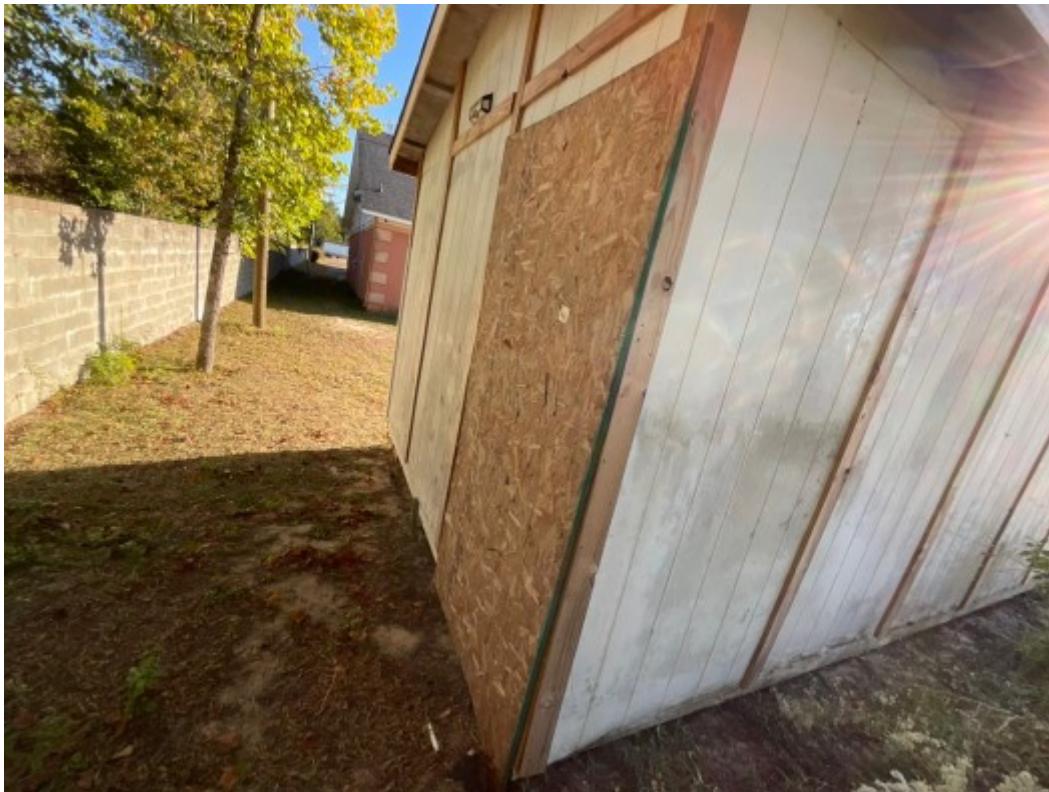
147-Shed Elevations

All elevations of the storage shed have been inspected and found to be free from storm related damage.

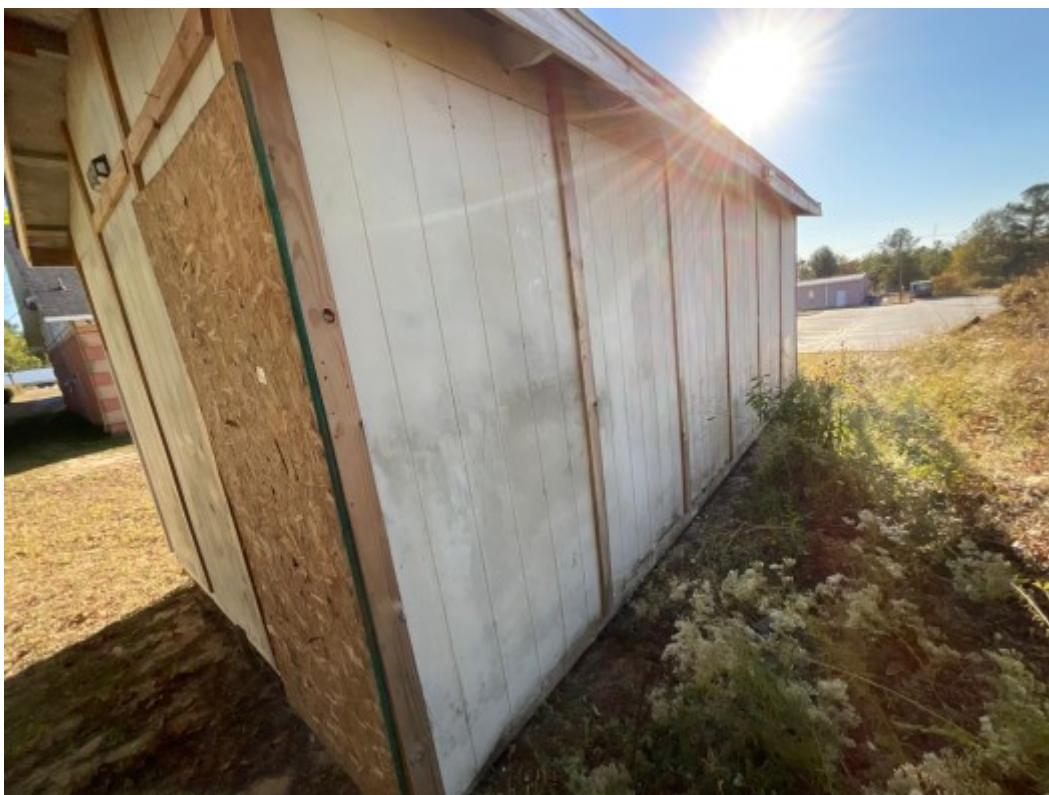
148-Shed Elevations

All elevations of the storage shed have been inspected and found to be free from storm related damage.

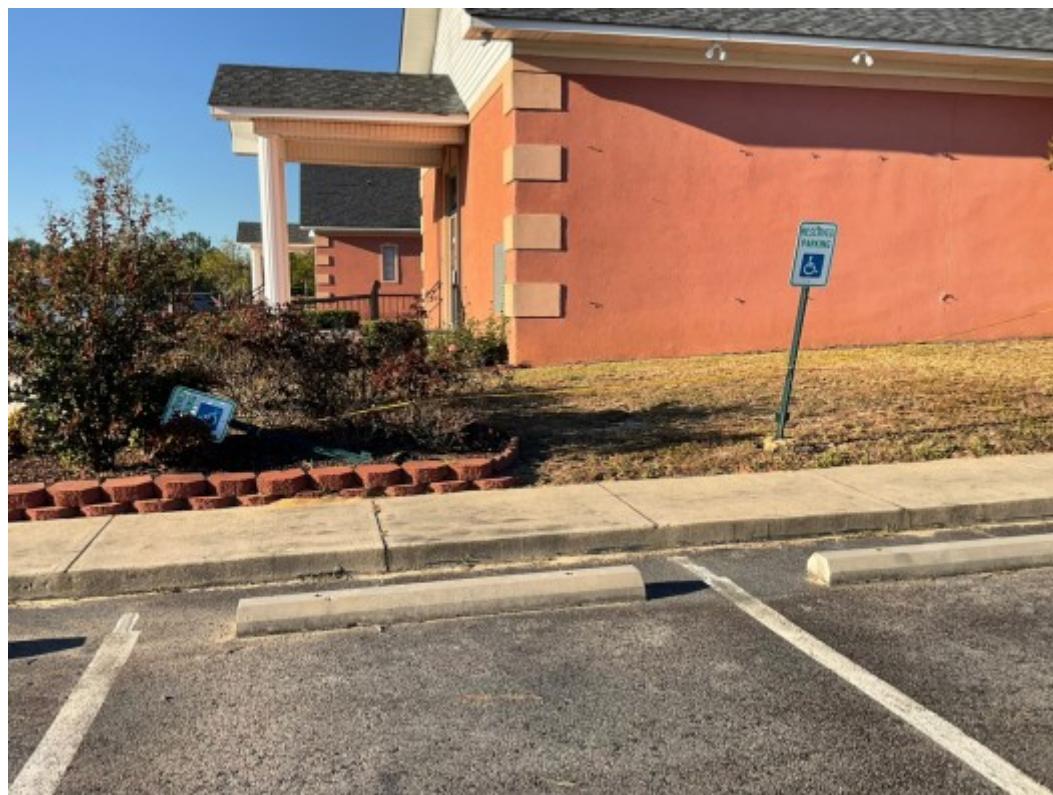
150-Signs

Eight parking signs have been blown over and need to be rectified following the storm.

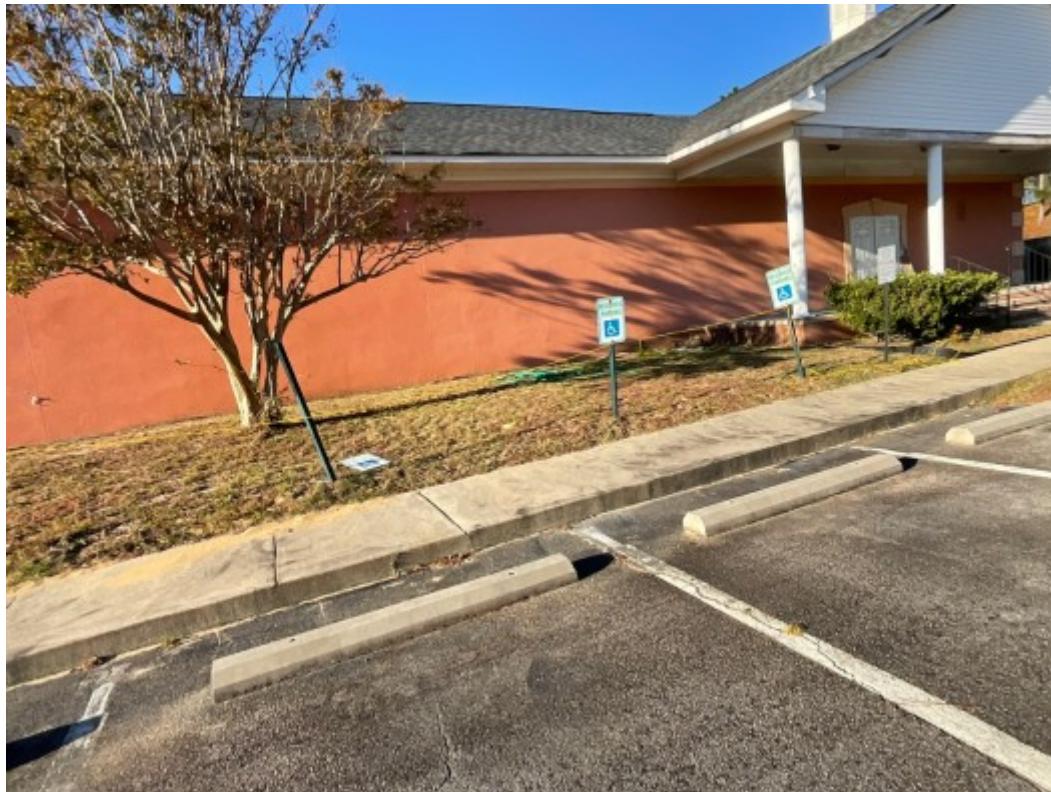
151-Signs

Eight parking signs have been blown over and need to be rectified following the storm.

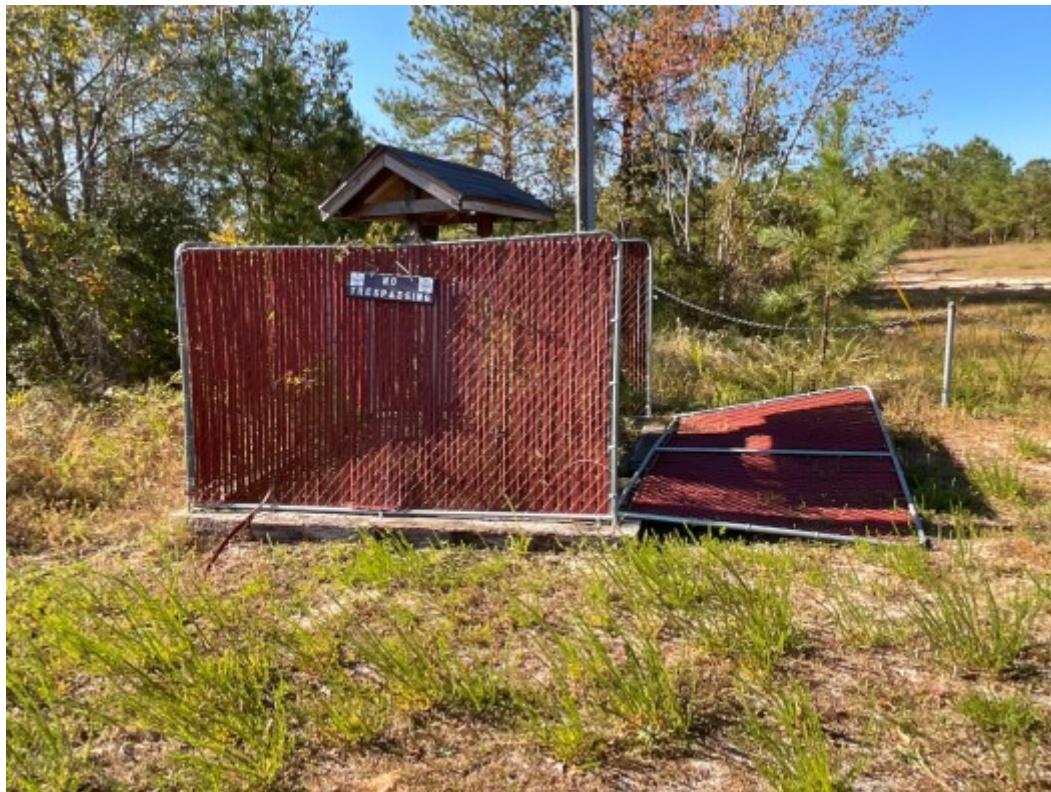
152-Fencing

40 lineal feet of chain-link fence with privacy slats surrounding the electrical feed need to be replaced following the storm.

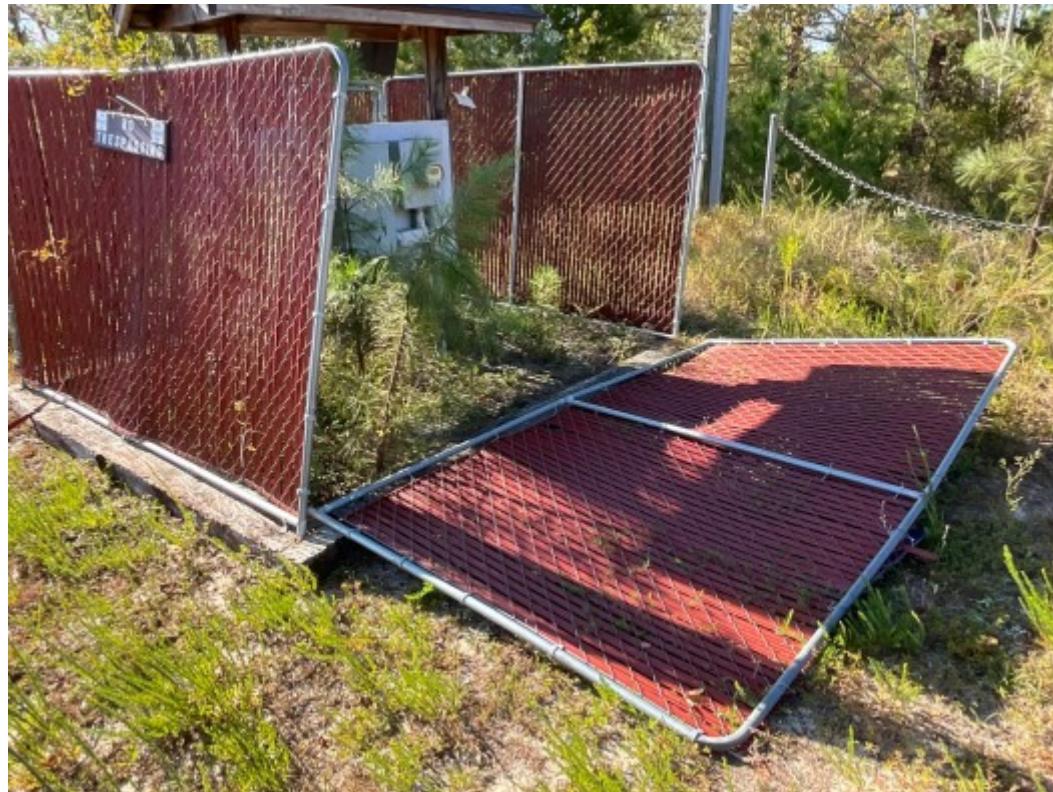
153-Fencing

40 lineal feet of chain-link fence with privacy slats surrounding the electrical feed need to be replaced following the storm.

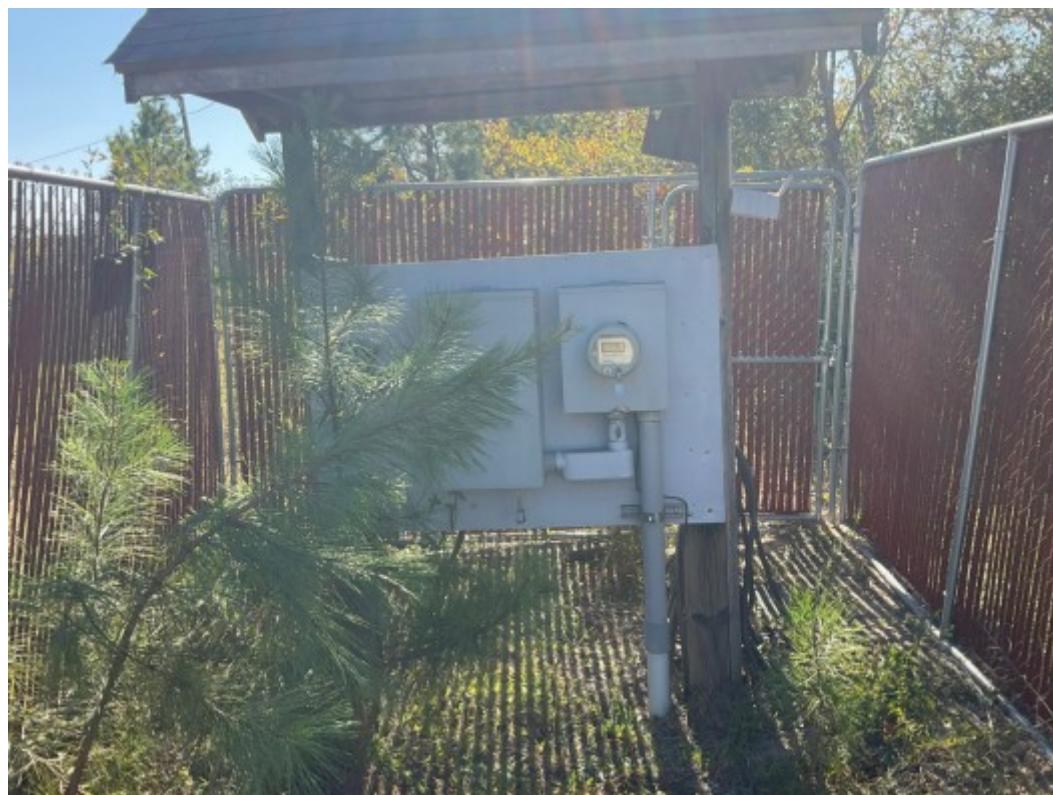
154-Fencing

40 lineal feet of chain-link fence with privacy slats surrounding the electrical feed need to be replaced following the storm.
