# Vehicle Visual Inspection Report

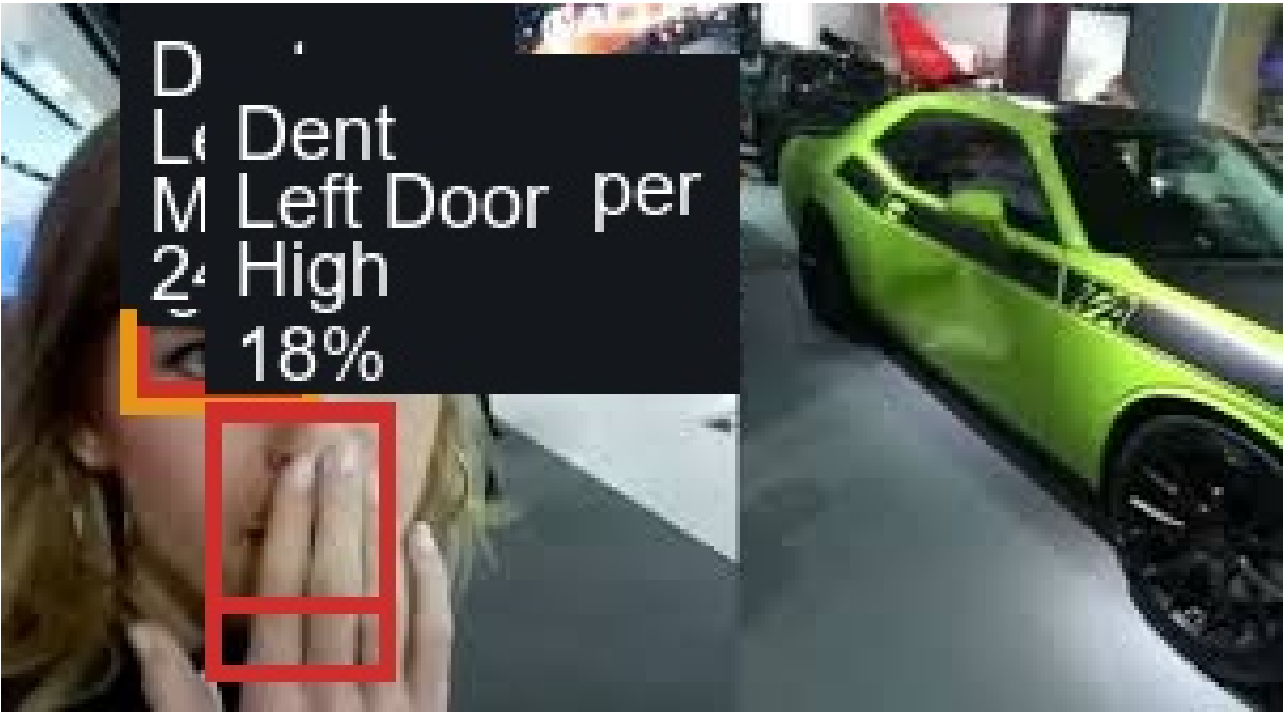
## Annotated Image

| Damage Type | crack |
| Location | left_door |
| Severity | high |

| Repair Recommendation | Repair or replace cracked component |
