Points of Improvements

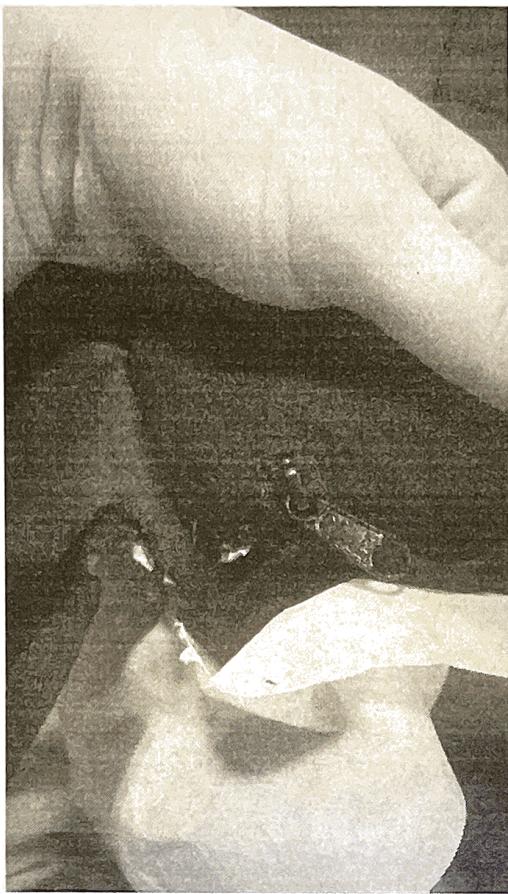
We've had a lot of nice jackets getting ruined lately that could be avoided with proper attention and care. You should automatically be checking the inside of the garment to see if there is a pocket in the way. If there is a way to embroider inside the pocket - go for it. If you will be sewing the pocket shut, stop production and consult the manager.

If the zipper is dangling near the embroidery, tape it down so it doesn't accidentally get in the way.

If the pocket is tight, clip the opening of the pocket to the frame so that it doesn't get in the way and get sewn to the embroidery.

Sometimes the frame will not fit in the pocket. Stop production. Find alternative locations that we could embroider on and alert the manager to talk to the AM.

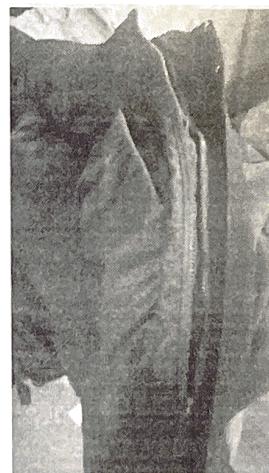
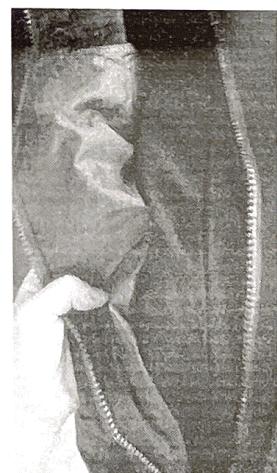
This Jacket is a two in one. That means there is an inner jacket zipped up into an outer jacket.

Do not sew the jackets together. Separate the jacket and only embroider the top shell with the embroidery.

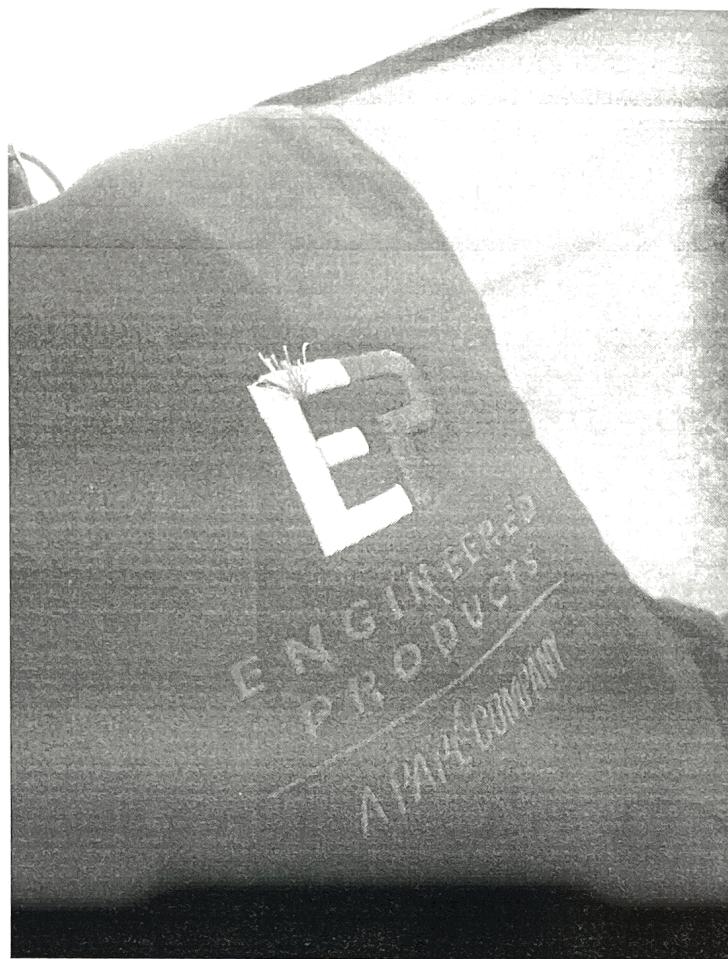
Rejected client piece.

*This garment has fraying at key points. If there are stray threads we must trim them. IF there is a fray like on the top "E" we must reject the embroidery and not ship.

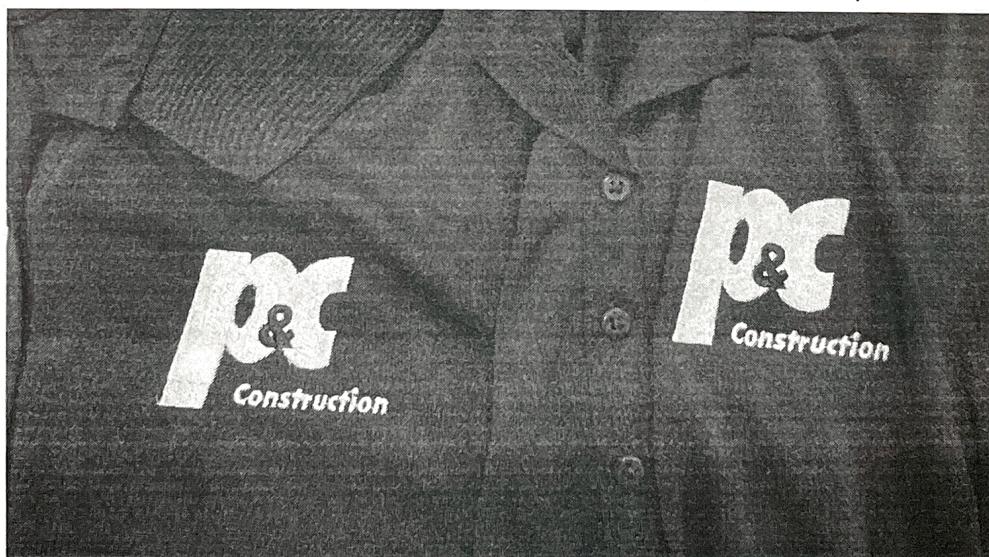
The mistake vs the standard

*On the left the embroidery was overlapped twice as thick on the "P" This is unacceptable and needs to be filed as a misprint.

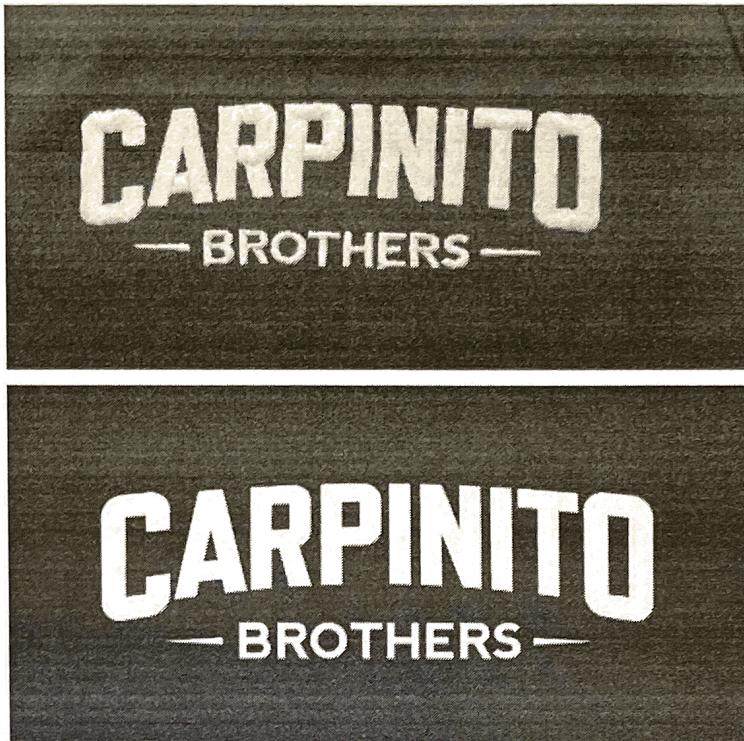
Top our embroidery vs bottom digital proof

Embroidery caused garment to pucker. We should explain to account manager that the tear away isn't stiff enough and allow them to choose between cut away and tear away on the back side of the garment. The client also was dissatisfied with the big "O". If font looks wiggly, we should ask the digitizer for a fix. A woven backing might have also fixed the way the "O" pulls.

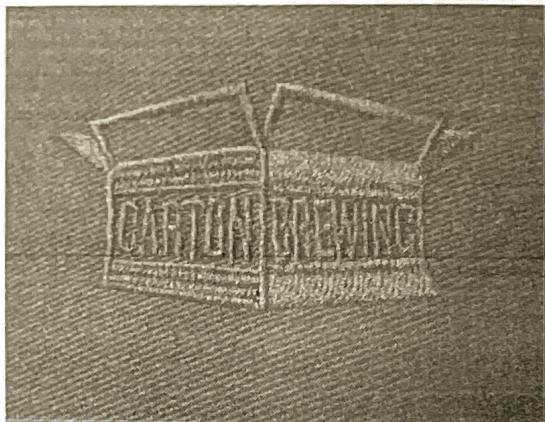
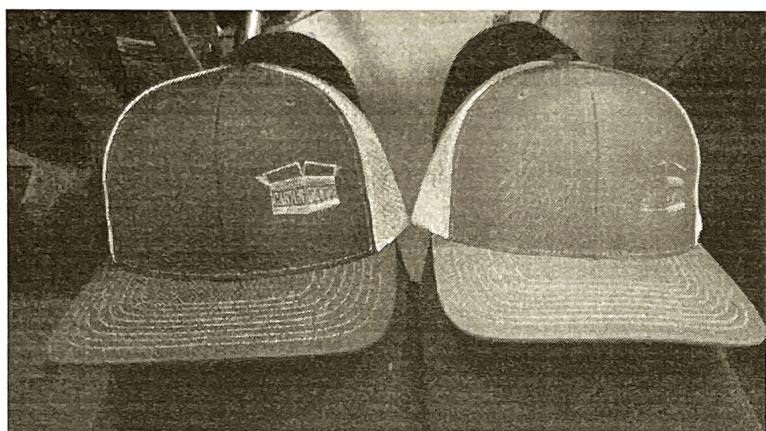
The client ended up rejecting the orange on orange hat because it was difficult to read. We must question their judgement and send a photo proof if branding is comprised by stylistic choices.

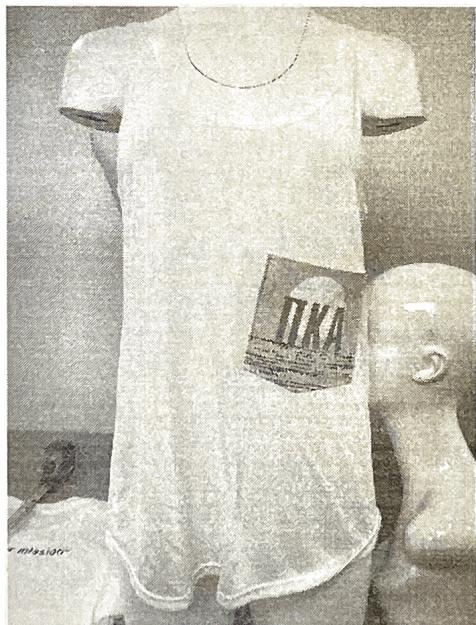
Digital Mock Up

vs Crooked and low position

On women's tanks, it's better to make sure the hang of the garment doesn't affect the pockets position and that the pocket does not fall under the breast area.

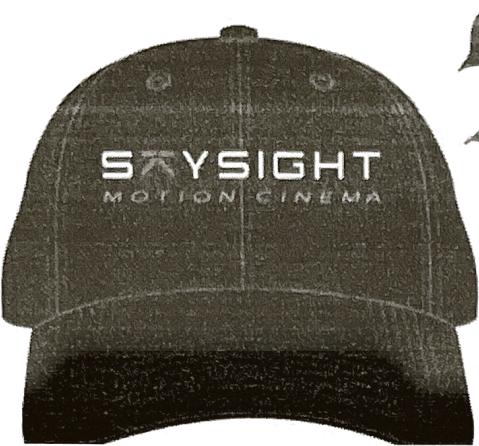
What we did

* The issue is the client's branding requires the bottom text perfectly line up with the upper text. *

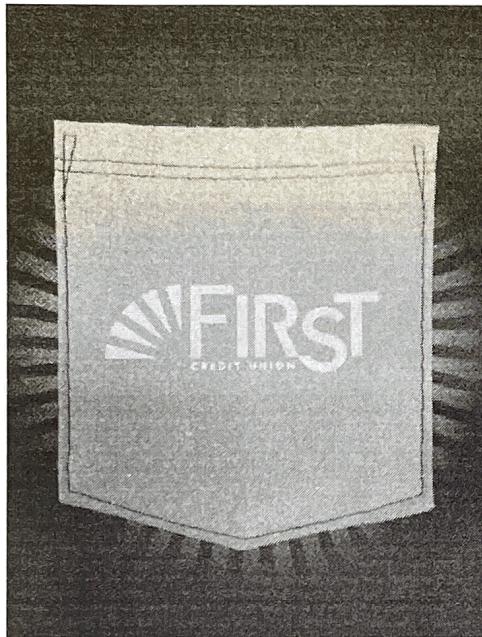
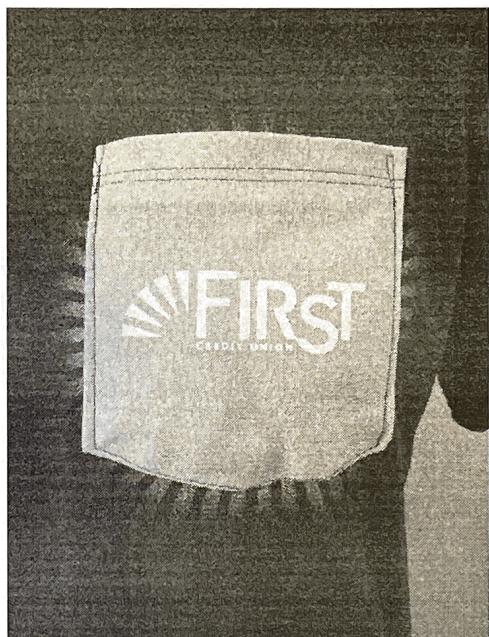
Needs improvement pocket

When sending a photo proof, we want to send a beautiful example of our best quality work. Pocket stitching needs to look centered and not wobbly!

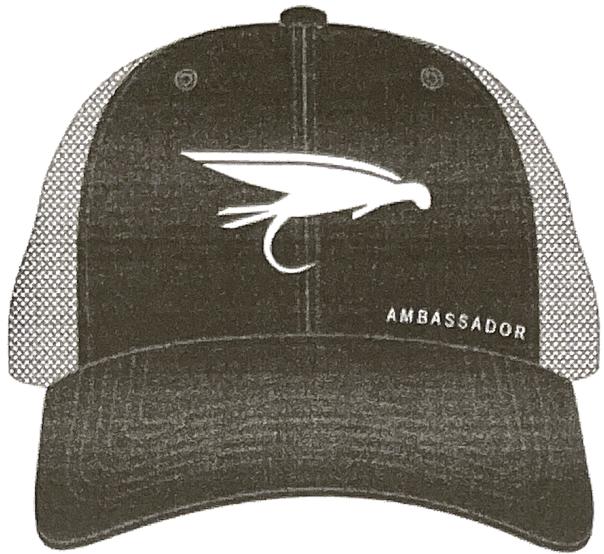
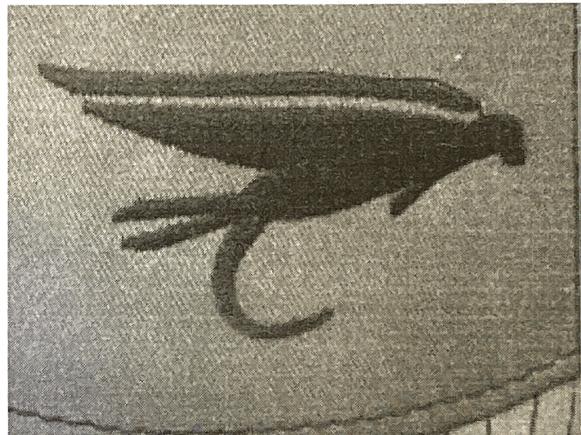
Top is Digital Proof. Bottom left is our proof. Bottom right is competitor's version from client.

*Sometimes Client's expectations are just different. This client wanted smoother gradients in the rounding of the logo. Always feel free to suggest we send a photo proof if it is a complex design. In the text "AMBASSADOR" fine lines usually have a connecting embroidery stitch where we don't cut the thread from each one. If a client has an issue with it, ask the digitizer to update the file so each letter is separate.

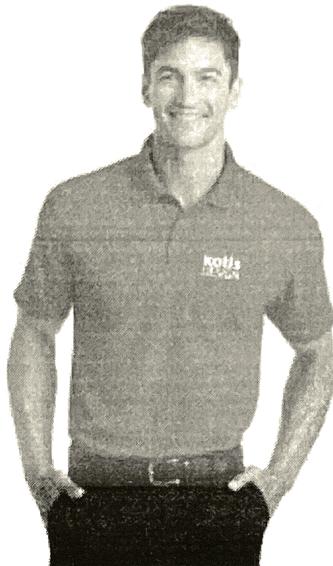
What we did

* Technically the file matched the art call out, but the embroidery felt too large to the client. It's ok to question how we can make it better if you have a gut check while working on it. *

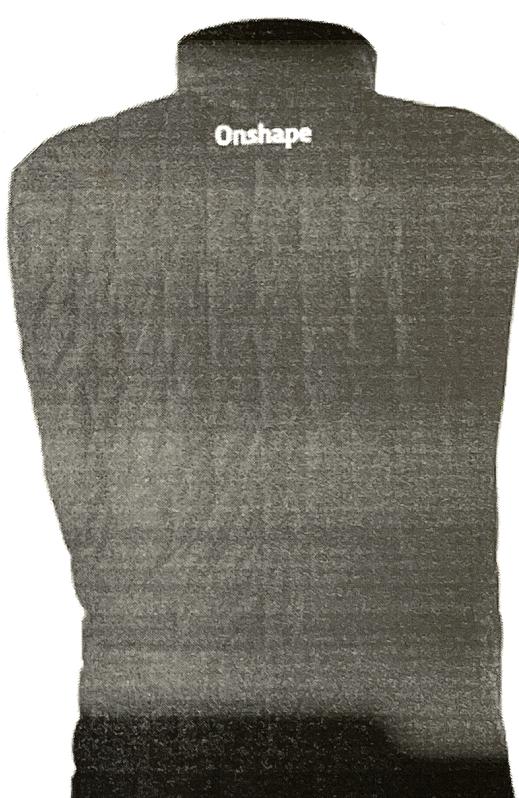
What we did

Back tags should be 1.5 inches from collar seam. This is too low, does not match photoproof.
