# STRUCTURAL HEALTH MONITORING REPORT

Timestamp: 2026-09-06 18:40:05 | Method: Deep Learning Classification

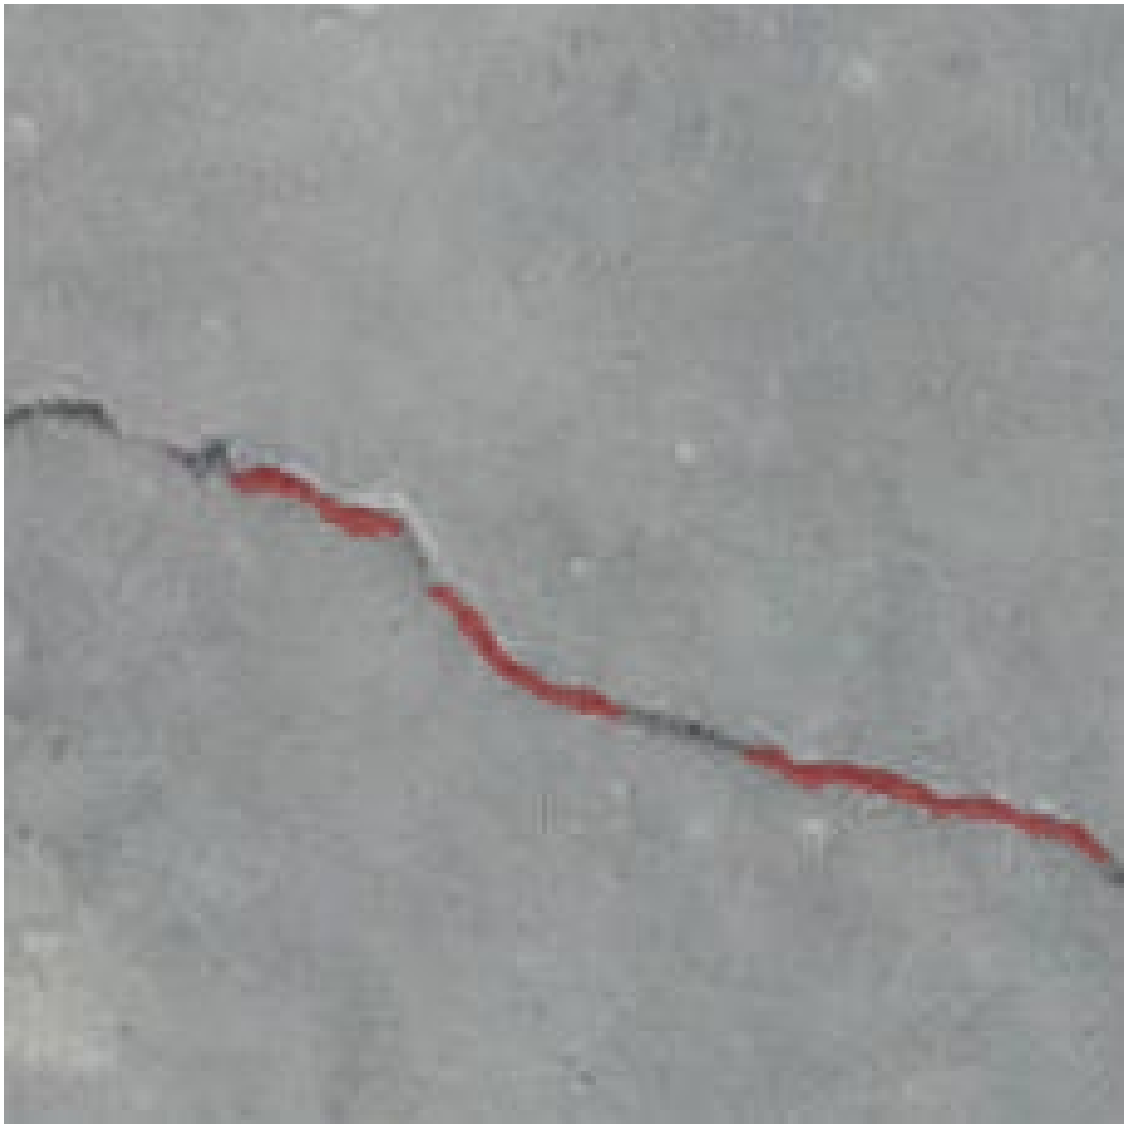
| Metric Parameter | Inspection Value |
|---|---|
| Class Diagnosis | WALL_CRACKED |
| Structure Element | Wall |
| Condition Status | DAMAGED |
| Confidence Score | 48.85% |
| Severity Assessment | Collapse_risk |

| Measured Avg Width | 7.169 mm |
| Measured Max Width | 14.000 mm |
| Crack Length | 487.5 mm |
| Crack Orientation | 24 deg |

WALL EVALUATION: EMERGENCY: Evacuate area immediately. Close structure to traffic. Emergency structural assessment required. (Critical Limit: 0.3mm | Allowable Max: 1.0mm) | Measured: 7.17mm
