# STRUCTURAL HEALTH MONITORING REPORT

Timestamp: 2026-09-06 18:40:25 | Method: Deep Learning Classification

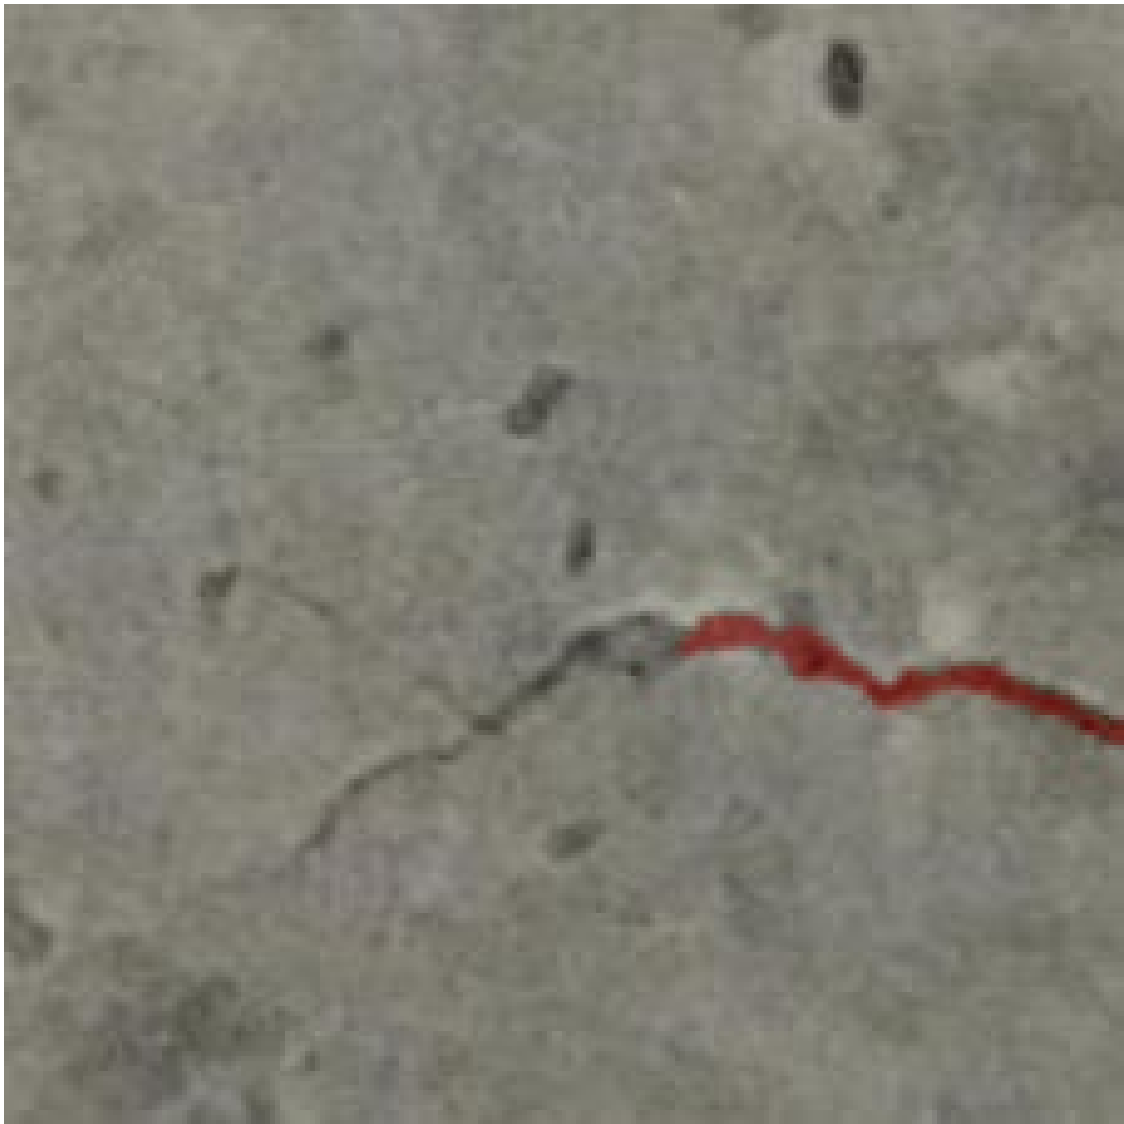
| Metric Parameter | Inspection Value |
|---|---|
| Class Diagnosis | WALL_CRACKED |
| Structure Element | Wall |
| Condition Status | DAMAGED |
| Severity Assessment | Collapse_risk |

| Measured Avg Width | 9.516 mm |
| Measured Max Width | 15.984 mm |
| Crack Length | 285.0 mm |
| Crack Orientation | 12 deg |

WALL EVALUATION: EMERGENCY: Evacuate area immediately. Close structure to traffic. Emergency structural assessment required. (Critical Limit: 0.3mm | Allowable Max: 1.0mm) | Measured: 9.52mm
