# STRUCTURAL HEALTH MONITORING REPORT

Timestamp: 2026-09-06 18:41:18 | Method: Deep Learning Classification

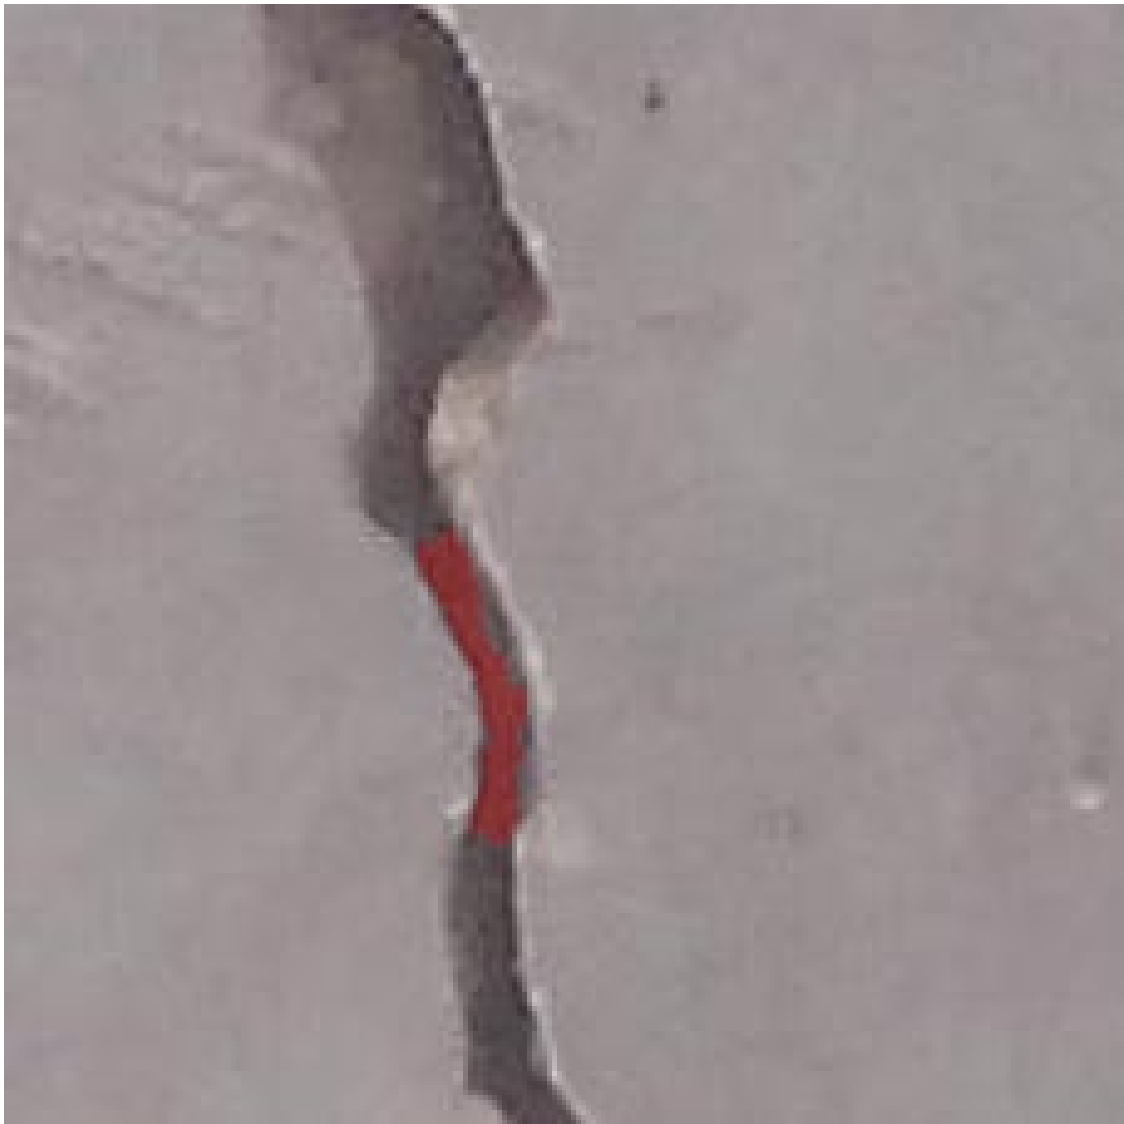
| Metric Parameter | Inspection Value |
|---|---|
| Class Diagnosis | WALL_CRACKED |
| Structure Element | Wall |
| Condition Status | DAMAGED |
| Severity Assessment | Collapse_risk |
| Safety Factor | 0.00 |

| Measured Avg Width | 14.201 mm |
| Measured Max Width | 21.969 mm |
| Crack Length | 202.5 mm |
| Crack Orientation | 78 deg |

WALL EVALUATION: EMERGENCY: Evacuate area immediately. Close structure to traffic. Emergency structural assessment required. (Critical Limit: 0.3mm | Allowable Max: 1.0mm) | Measured: 14.20mm
