# STRUCTURAL HEALTH MONITORING REPORT

Timestamp: 2026-09-06 18:41:45 | Method: Deep Learning Classification

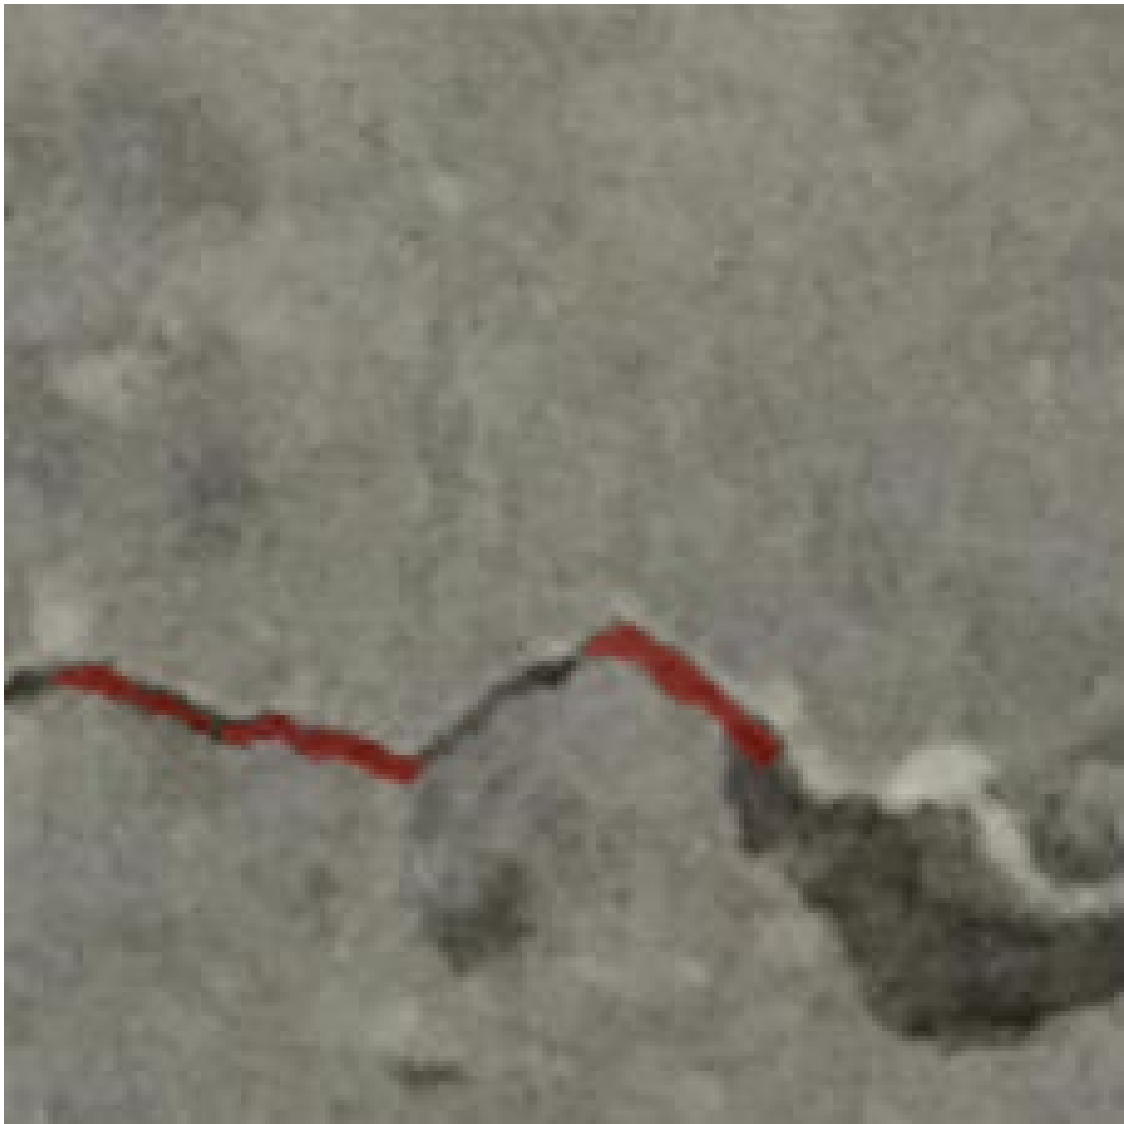
| Metric Parameter | Inspection Value |
|---|---|
| Class Diagnosis | PAVEMENT_CRACKED |
| Structure Element | Pavement |
| Condition Status | DAMAGED |
| Severity Assessment | Severe |
| Safety Factor | 0.40 |

| Measured Avg Width | 9.321 mm |
| Measured Max Width | 17.984 mm |
| Crack Length | 337.5 mm |
| Crack Orientation | 178 deg |

PAVEMENT EVALUATION: Repair required within 30 days. Restrict load if near critical members. Engineer review recommended. (Critical Limit: 6.0mm | Allowable Max: 12.0mm) | Measured: 9.32mm
