# STRUCTURAL HEALTH MONITORING REPORT

Timestamp: 2026-09-06 18:39:05 | Method: Deep Learning Classification

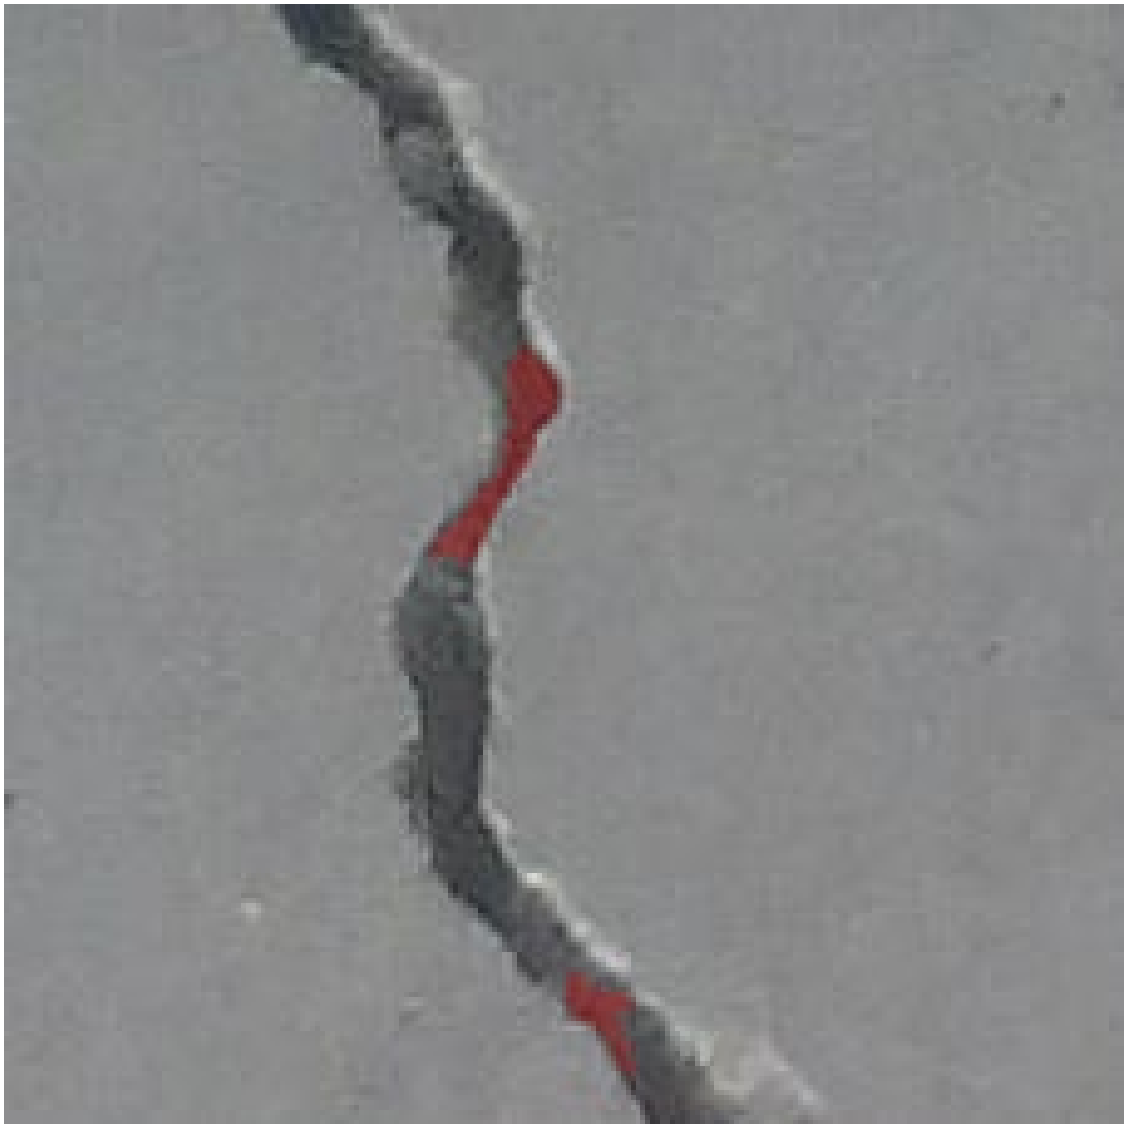
| Metric Parameter | Inspection Value |
|---|---|
| Class Diagnosis | PAVEMENT_CRACKED |
| Structure Element | Pavement |
| Condition Status | DAMAGED |
| Severity Assessment | Severe |

| Measured Avg Width | 11.291 mm |
| Measured Max Width | 21.969 mm |
| Crack Length | 210.0 mm |
| Crack Orientation | 80 deg |

PAVEMENT EVALUATION: Repair required within 30 days. Restrict load if near critical members. Engineer review recommended. (Critical Limit: 6.0mm | Allowable Max: 12.0mm) | Measured: 11.29mm
