# STRUCTURAL HEALTH MONITORING REPORT

Timestamp: 2026-09-25 22:45:57 | Method: Deep Learning Classification

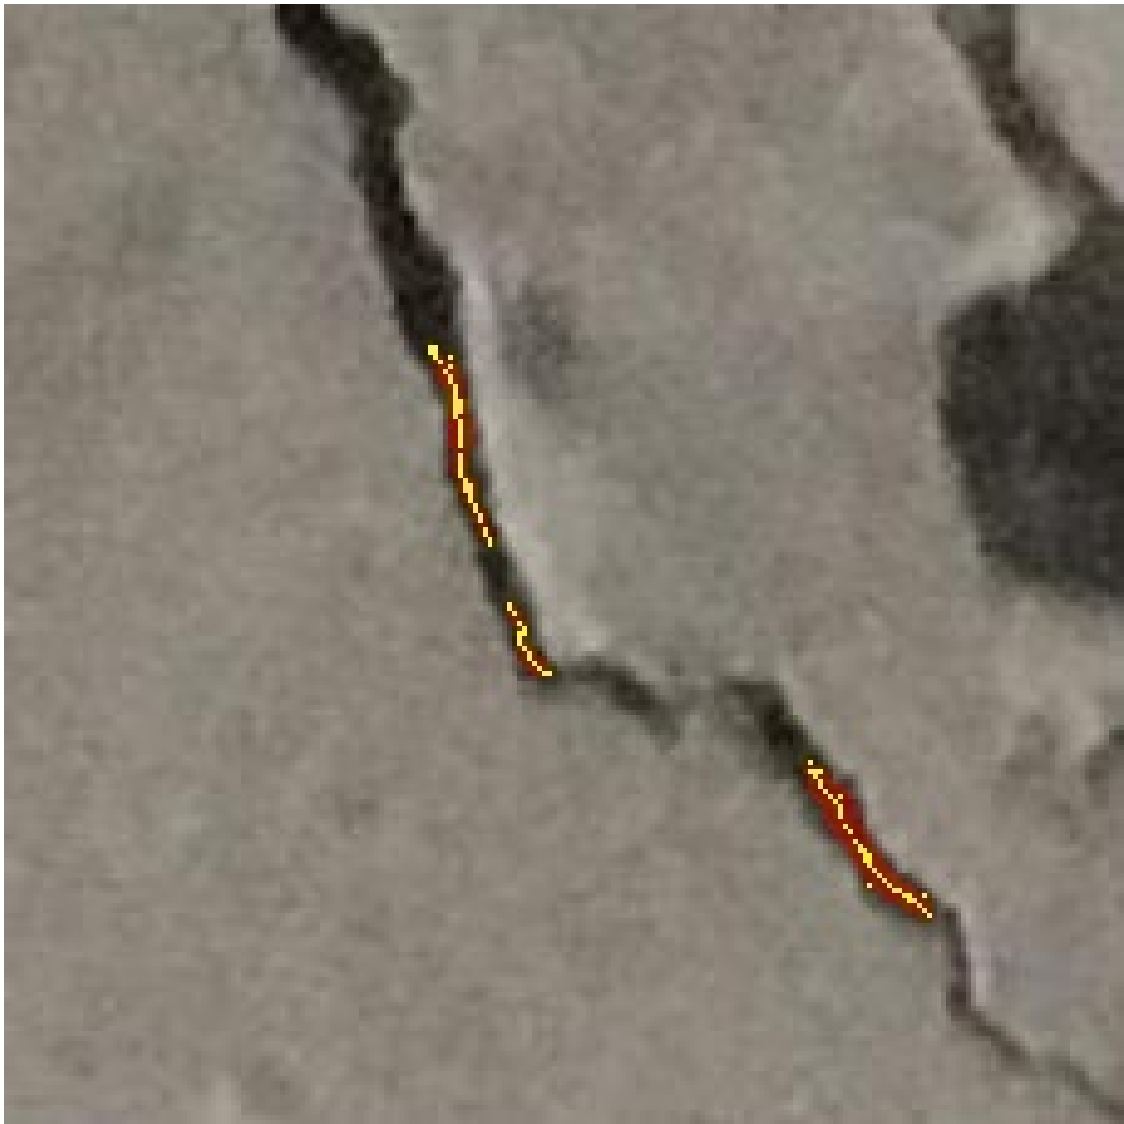
| Metric Parameter | Inspection Value |
|---|---|
| Class Diagnosis | PAVEMENT_CRACKED |
| Structure Element | Pavement |
| Condition Status | DAMAGED |
| Severity Assessment | Critical |

| Measured Avg Width | 23.696 mm |
| Measured Max Width | 31.872 mm |
| Crack Length | 257.5 mm |
| Crack Orientation | 45 deg |

PAVEMENT EVALUATION: Immediate repair mandatory. Restrict access to area. Licensed engineer review within 48 hours.  
(Critical Limit: 6.0mm | Allowable Max: 12.0mm) | Measured: 23.70mm
