# STRUCTURAL HEALTH MONITORING REPORT

Timestamp: 2026-09-25 23:41:06 | Method: Deep Learning Classification

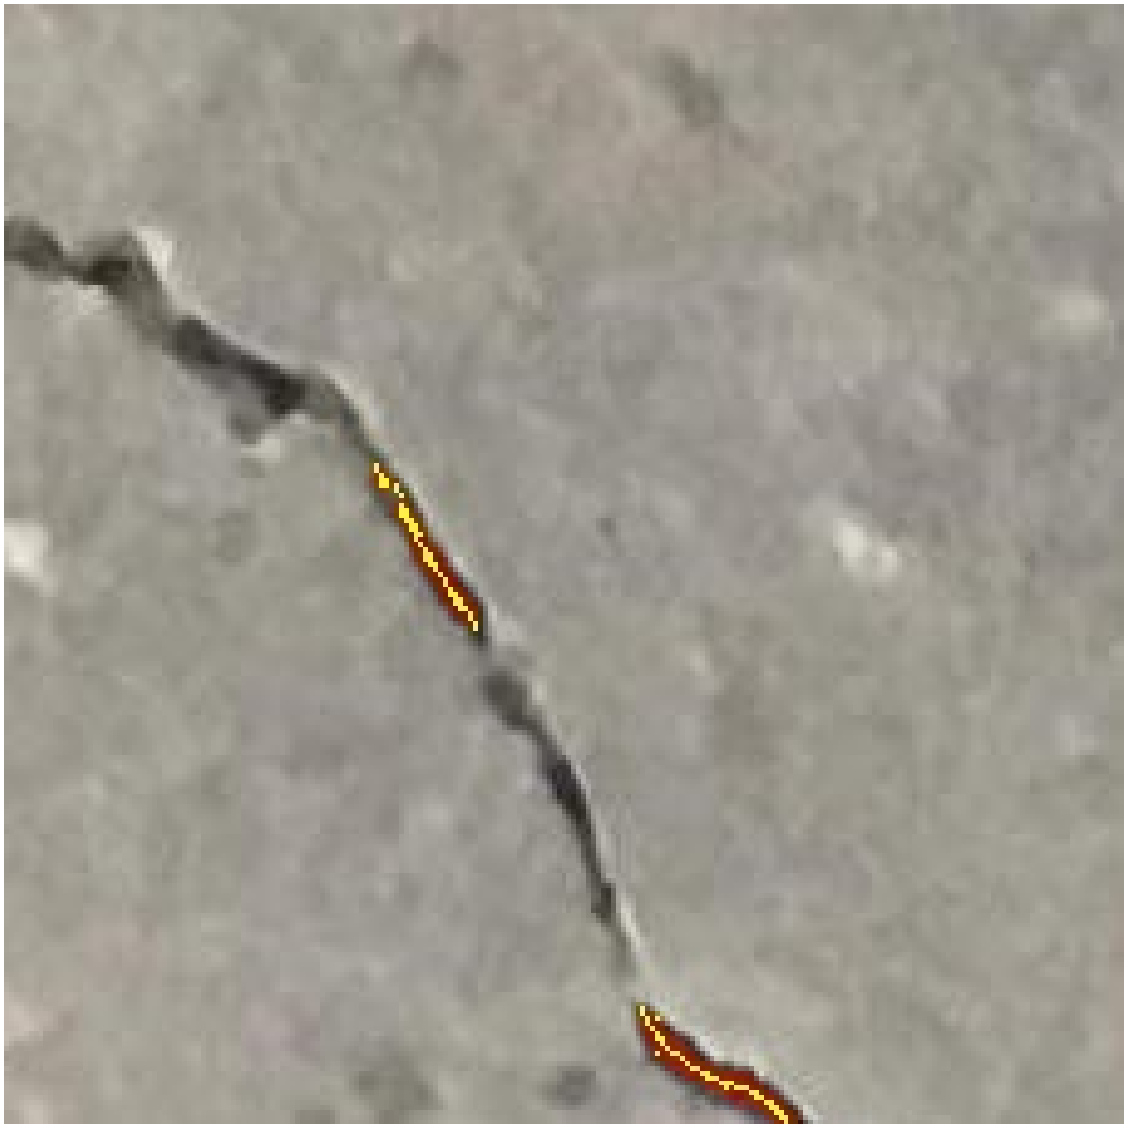
| Metric Parameter | Inspection Value |
|---|---|
| Class Diagnosis | PAVEMENT_CRACKED |
| Structure Element | Pavement |
| Condition Status | UNCERTAIN |
| Confidence Score | 67.41% |
| Severity Assessment | Uncertain |

| Measured Avg Width | 22.250 mm |
| Measured Max Width | 31.497 mm |
| Crack Length | 230.0 mm |
| Crack Orientation | 61 deg |

PAVEMENT EVALUATION: Model confidence is low. Manual inspection and physical measurement required. Do not rely solely on AI assessment. (Critical Limit: 6.0mm | Allowable Max: 12.0mm) | Measured width 22.25mm shown for reference; severity not escalated: insufficient confidence/calibration resolution.
