# HOME INSPECTION REPORT

777 Happy Lane , Sample Report City, UT

Inspection prepared for: Jason & Scott - Capstone Home Inspection

Date of Inspection: 5/28/2018 Time: 10:00am

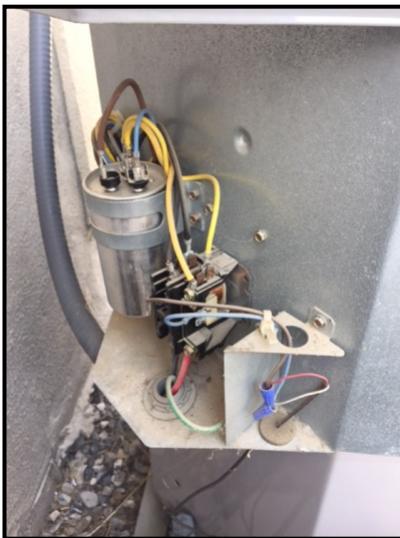
Internal compressor wiring looks fine

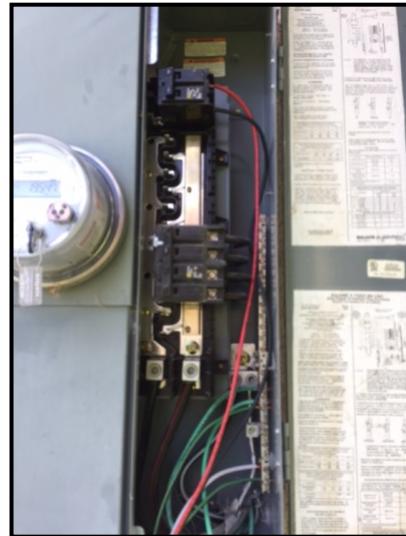
The wiring in this outside electrical panel looks great

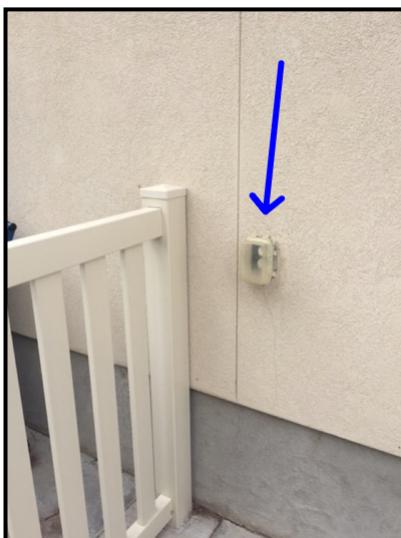
This outlet is a bit loose. No big deal as it is easy to resecure this

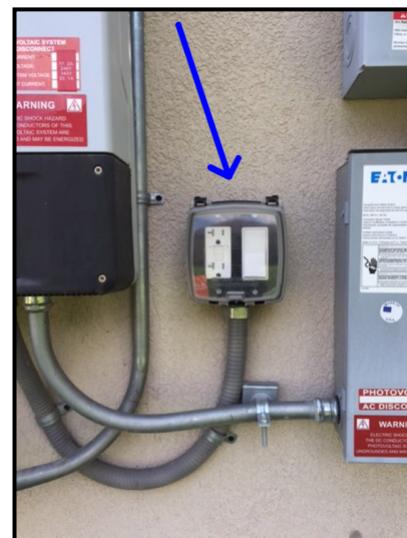
This outlet is not operable at this time. Check with homeowner as to the reason it may be shut off at this time.

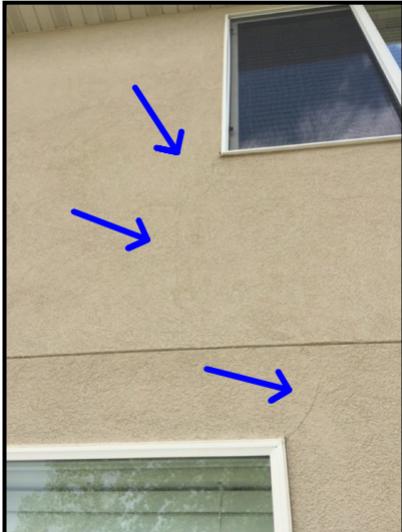
• The cracks that are present in the stucco are cosmetic only. These are caused by expansion and contraction of the sheathing underneath. We recommend monitoring these for additional movement in the future, but it is our opinion that these have moved as much as they are going to.

Some minor cracking in the stucco that was present. This is very typical and not a structural problem. We recommend monitoring this in the future for any additional movement.

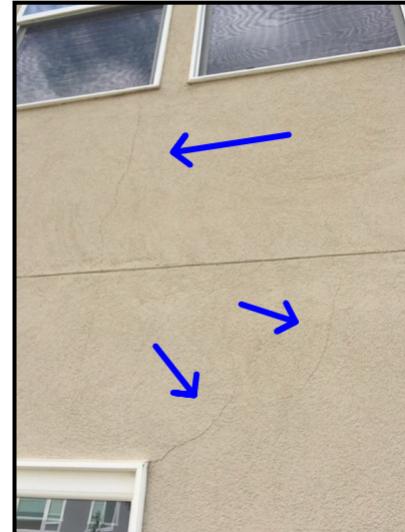
Some additional examples of cracking in the stucco. These are minor cracks and not a major structural problem. We recommend monitoring this for additional movement in the future.

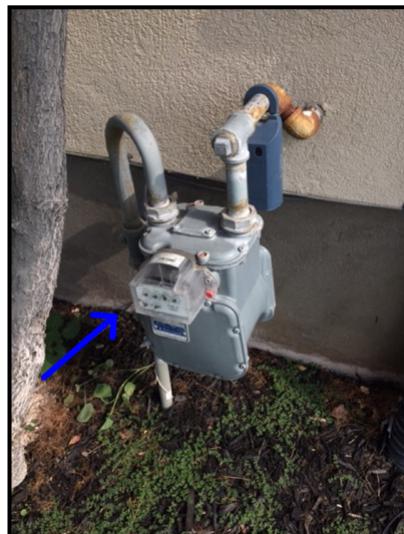
This is where your main gas shut off valve is located. Remember that you will need a wrench to close this

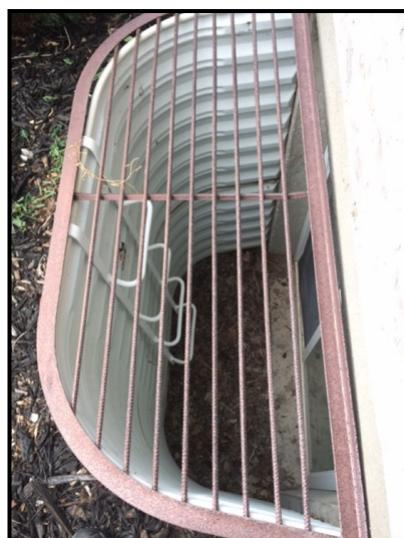
The ladder in this window well is an excellent safety feature

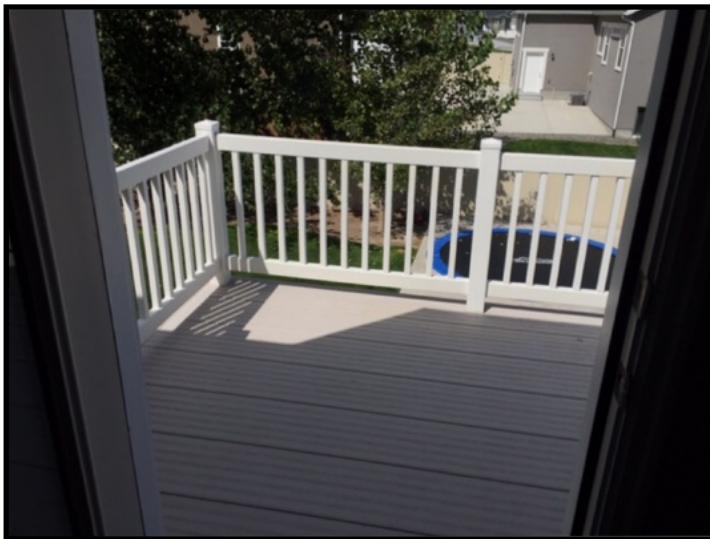
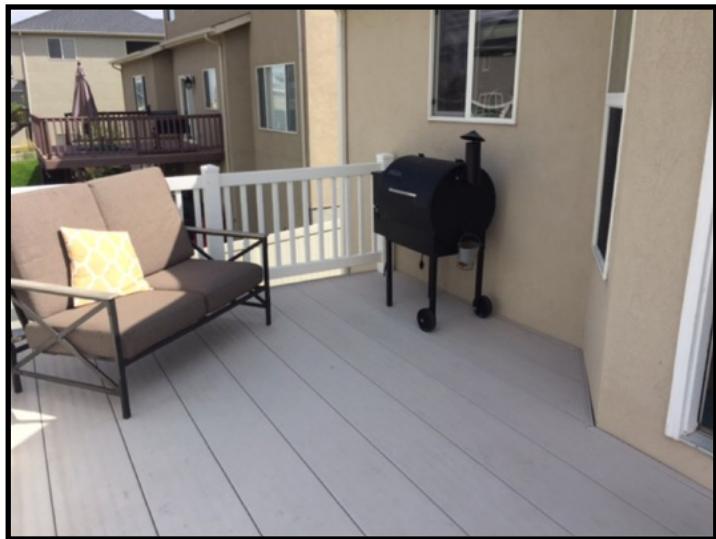
Very nice balcony. Enjoy it

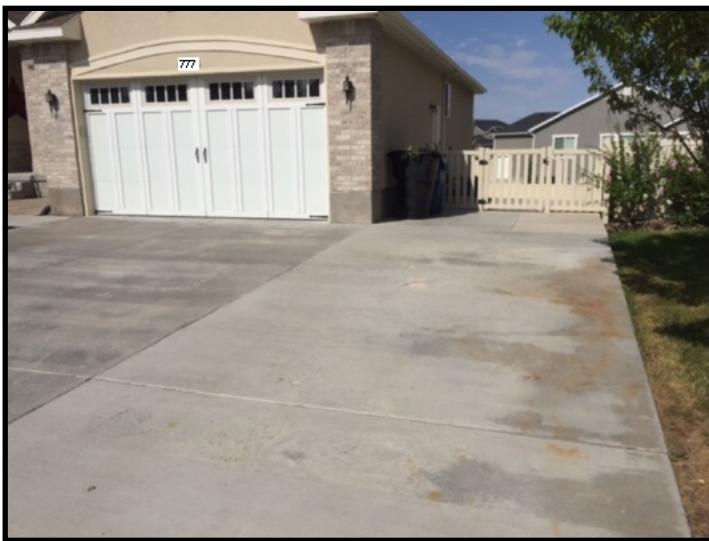
Spalling observed at driveway

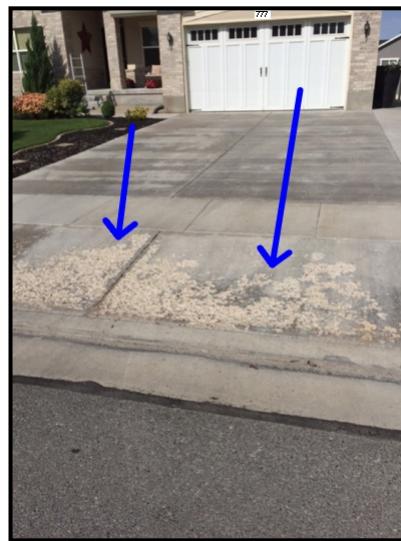
- Good- Driveway is in good shape for age. No major deficiencies noted.
- Typical cracking was observed. Monitor these cracks.
- Spalling- Surface deterioration "spalling" observed at the concrete surface.

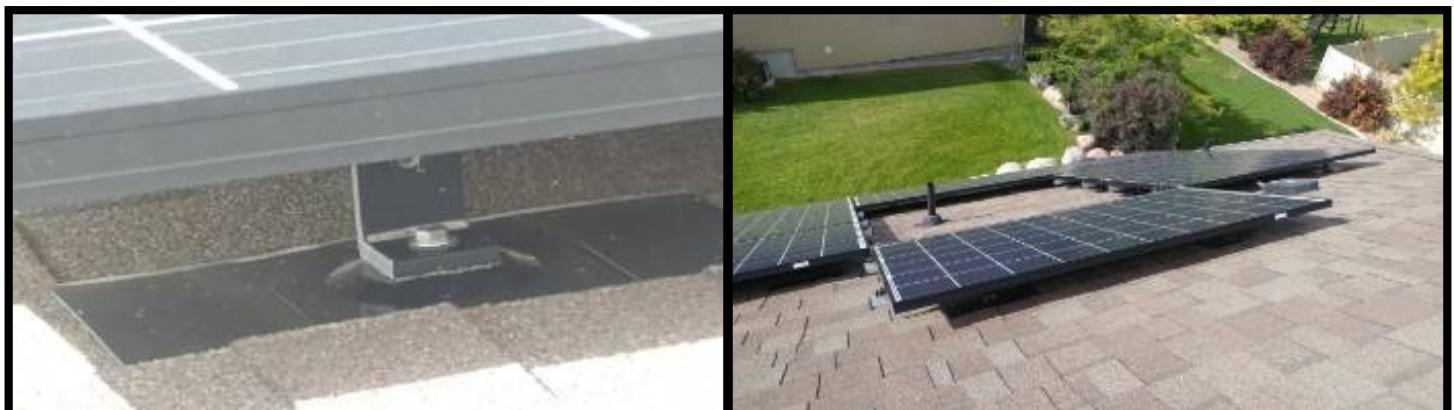
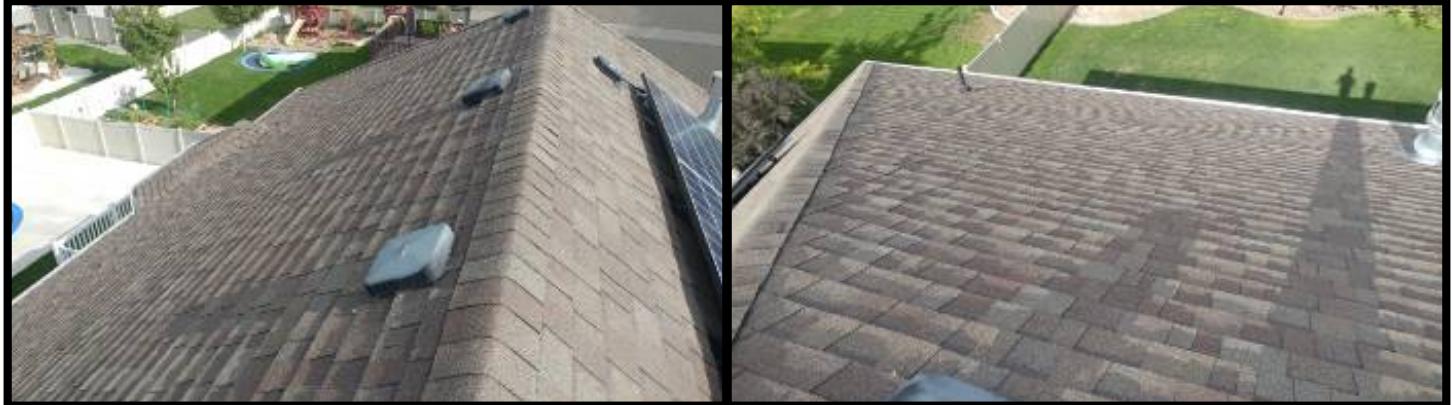
Solar panel supports are secure and properly attached.

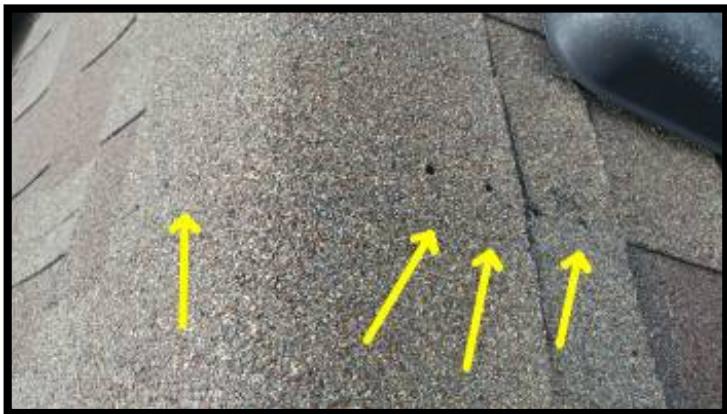
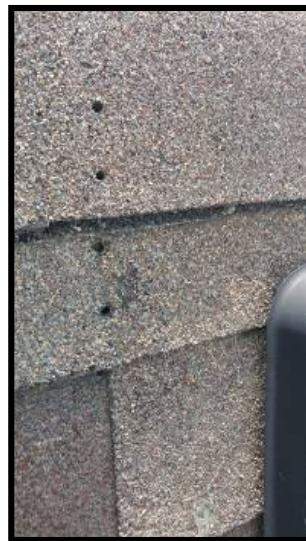
Along the top of the roof Ridgeline there are several drill holes in the shingles. It appears something was mounted in this area in the past and has been removed. Recommend sealing these holes to prevent any water penetration.

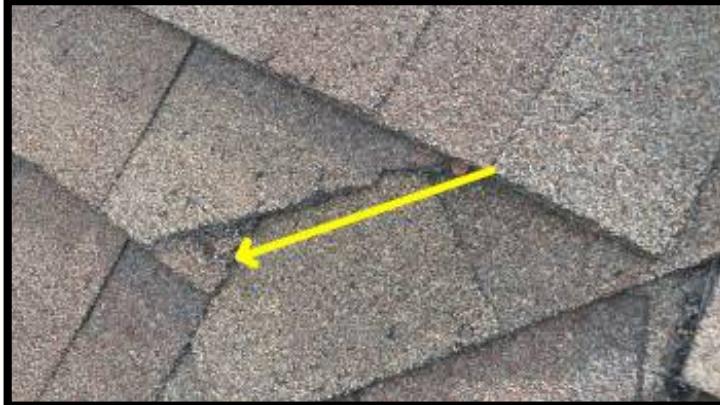
- No major system safety or function concerns observed at the readily accessible areas.
- Exposed nails on roofing material. Recommend sealing all fastener heads.
- Along the top of the roof Ridgeline there are several drill holes in the shingles. it appears something was mounted in this area in the past and has been removed recommend sealing these holes to prevent any water penetration. See pic...
- There is one torn flash damage shingle above the deck back of house. See pic.

A couple of expose Nails in the shingles above the deck back of house.

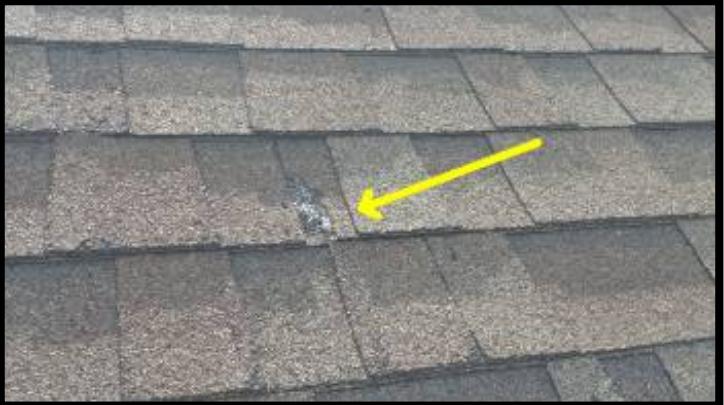
There is one torn/damaged shingle above the deck back of house.

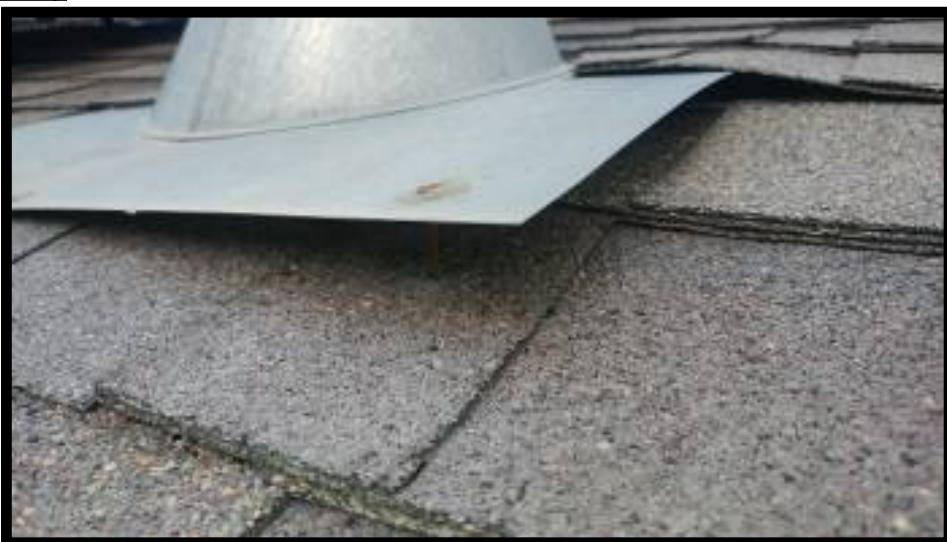
The flashing around the main exhaust stack has lifted a bit. Easy fix to re-fasten.

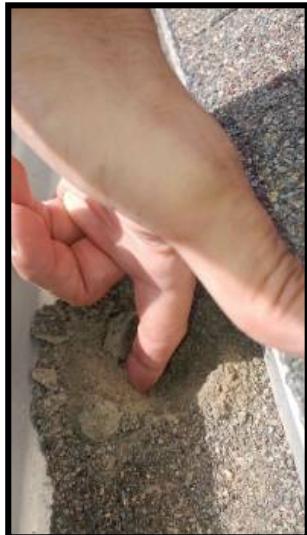
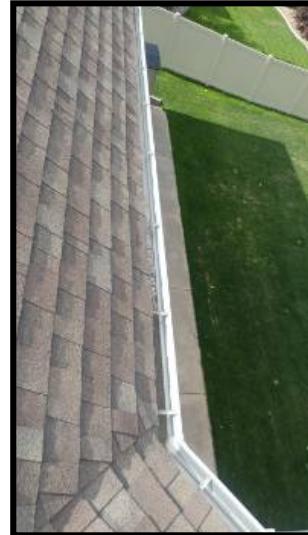
- No major system safety or function concerns observed at the readily accessible areas.
- Granules - Significant amount of granules from shingles are in the gutter.
- Debris- Significant amounts of debris evident.

Debris and some granules in the front gutter.  
recommend cleaning better for better efficiency of  
water drainage.

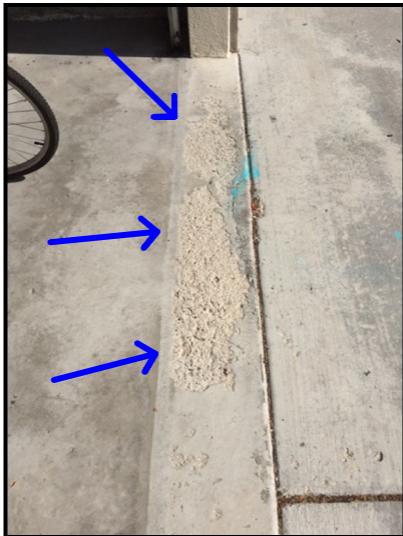
- No major system safety or function concerns observed at the readily accessible areas.
- Common cracks noted. Monitor for any additional movement.
- Spalling of the concrete is observed. This is not a structural problem.

Spalling concrete

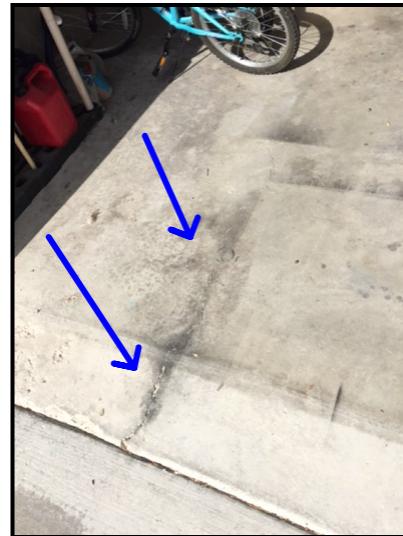
Minor cracking observed

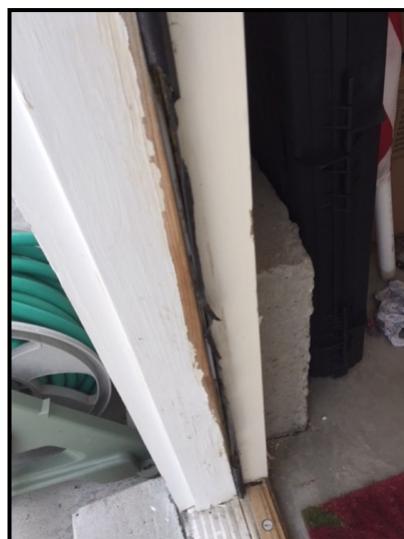
- Garage-house door weatherstrip is deteriorated.

The weatherstripping is a bit damaged on this exterior door. Replacing this is an inexpensive and easy fix.

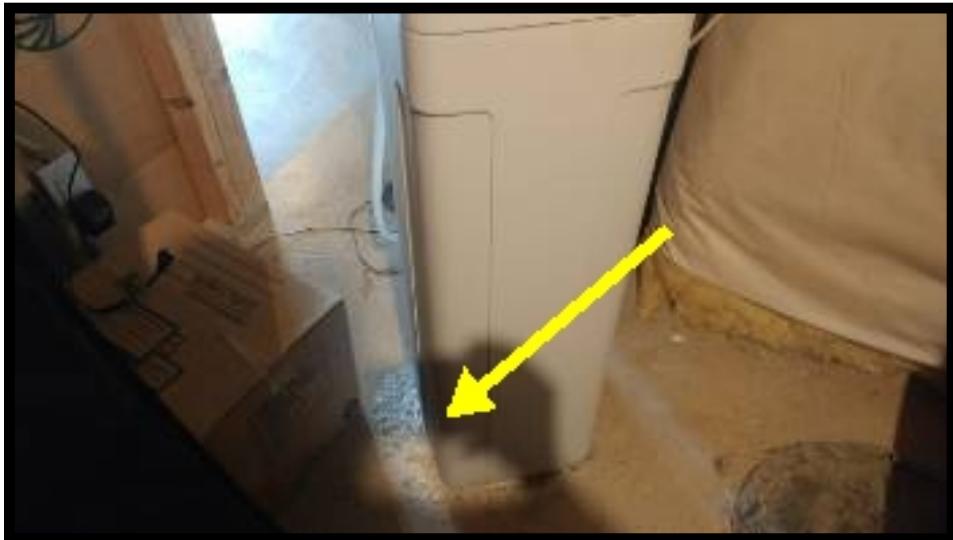
- Home is equipped with a water softener system. The inspector recommends client consult with home owner for operation instructions and proper information. Water softener systems are beyond the scope of a Home Inspection.
- The bottom of the salt container appears to be letting some salt escape.. See pic..

Salt bin has a hole at the bottom causing salt water residue on basement floor.

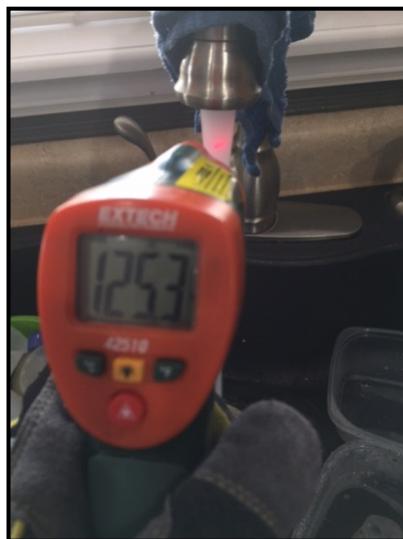
Hot water is appropriate temperature

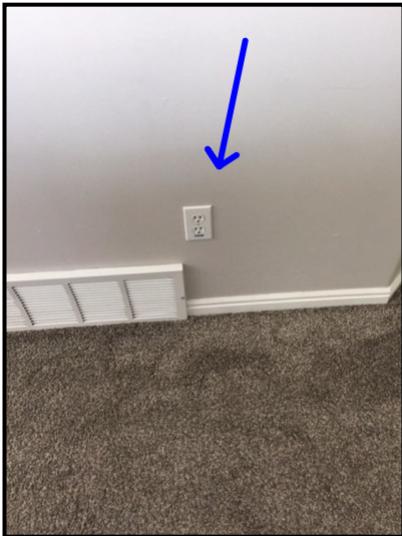
- The accessible receptacles were tested and found to be wired correctly.
  - A licensed electrician should perform any electrical work needed.
- ..Two loose receptacles were noted. See pictures

This outlet on the east wall in the living room seemed loose when I inserted my tester. It may require replacement

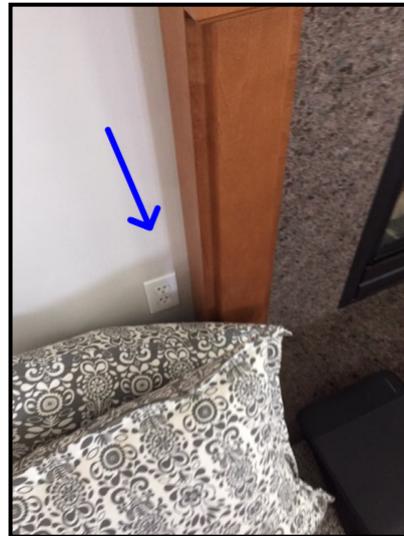
This outlet by the fireplace seemed loose when I inserted my tester. It may need to be replaced
