Elevations in the area around 1222 Constitution Avenue NE

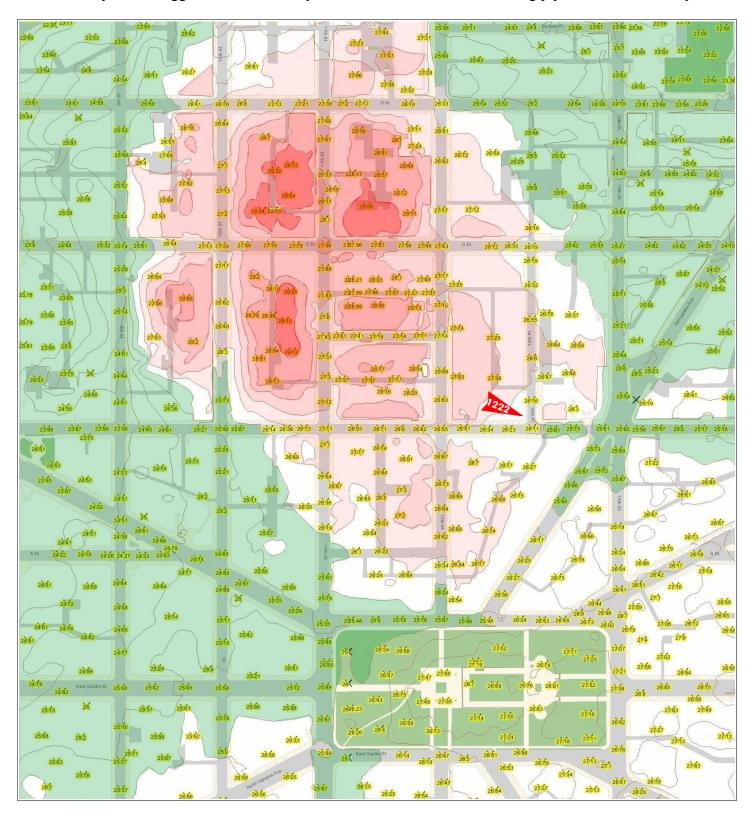
Detail

I assembled the contour map on the following page from 6 screenshots which shows spot elevations in meters (1m = 3.28 ft) and contour lines every 2 ft. Then I colored the land lower than us in green and land higher than us in shades of red getting darker at each 2 ft contour. Zoom in to see the detail. Our house at the corner of 12^{th} Place and Constitution is at an elevation of 26.1 m (85.6 ft).

Readings in Lincoln Park, a large open space where we might expect infiltration, vary from 25.9m (lower) at the north-west corner to 27.5m (higher) at the east end and around the memorial. The contours suggest it will drain to the west. Indeed, from the northern edge of the park, 12 Street goes uphill toward Constitution so it seems unlikely that water from the park flows underground in our direction.

However the land slopes uphill to the north-west from our house, peaking at 29.7m in the block bounded by 10^{th} , 11^{th} , C and D Streets. This area has substantial impermeable surfaces (roads, roofs, paths) but it is at least possible that some rain water falling there might drain through the soil in our direction.

Against this, our near-neighbors at #1208 and #1210 Constitution Ave both have basements and if there is substantial drainage from the higher ground to us, they should be similarly affected but they are not. The owner at #1210 told us his sump pump on runs during very heavy rainfall; at #1208 there is no pump at all. Their houses are dry which suggests that the water problem we have are from a leaking pipe somewhere nearby.
