Pre Purchase Inspection Report

Date completed: 03/10/2023

Hyundai i30 SLX FD

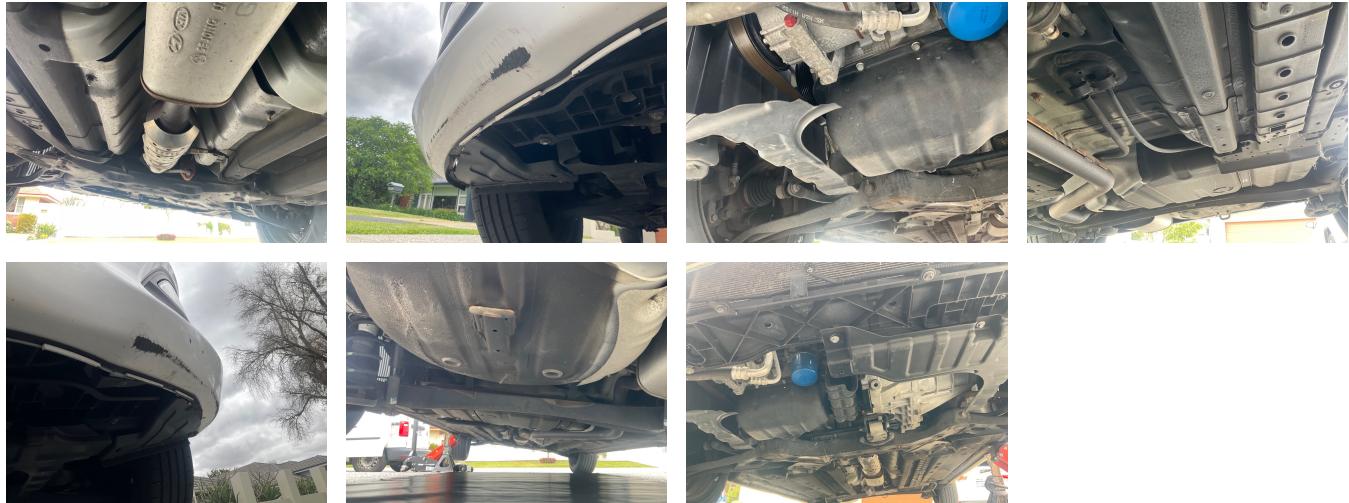
Light surface rust present, and/or scuffs to the vehicles underbody components (front bumper bar, under trays) consistent with the age and mileage. NOTE FRONT LIP AND UNDERTRAY MISSING/BROKEN

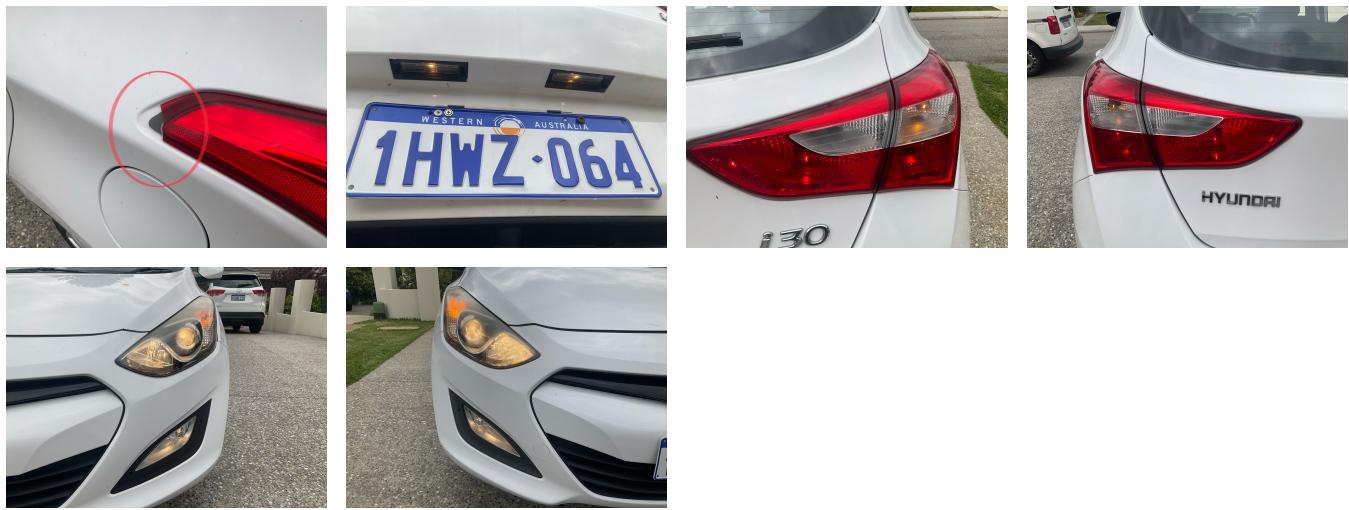
Passengers tail light cracked/broken lens, investigate further.

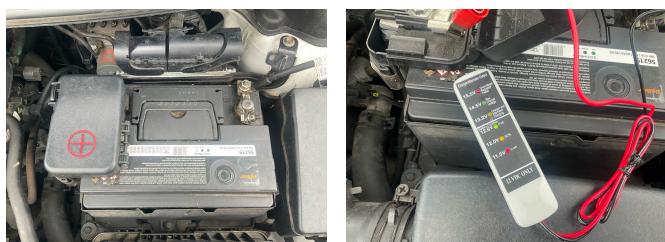
Battery test returned "OK" result at the time of inspection. This indicates the battery is working as expected, showing normal wear for age/mileage.

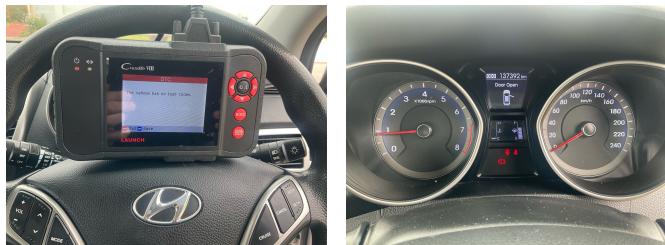
No abnormal warning lights on in the dash cluster, no faults logged into the vehicle electronics at the time. General wear to the gauges, scuffs and marks to the dashboard trims as expected.

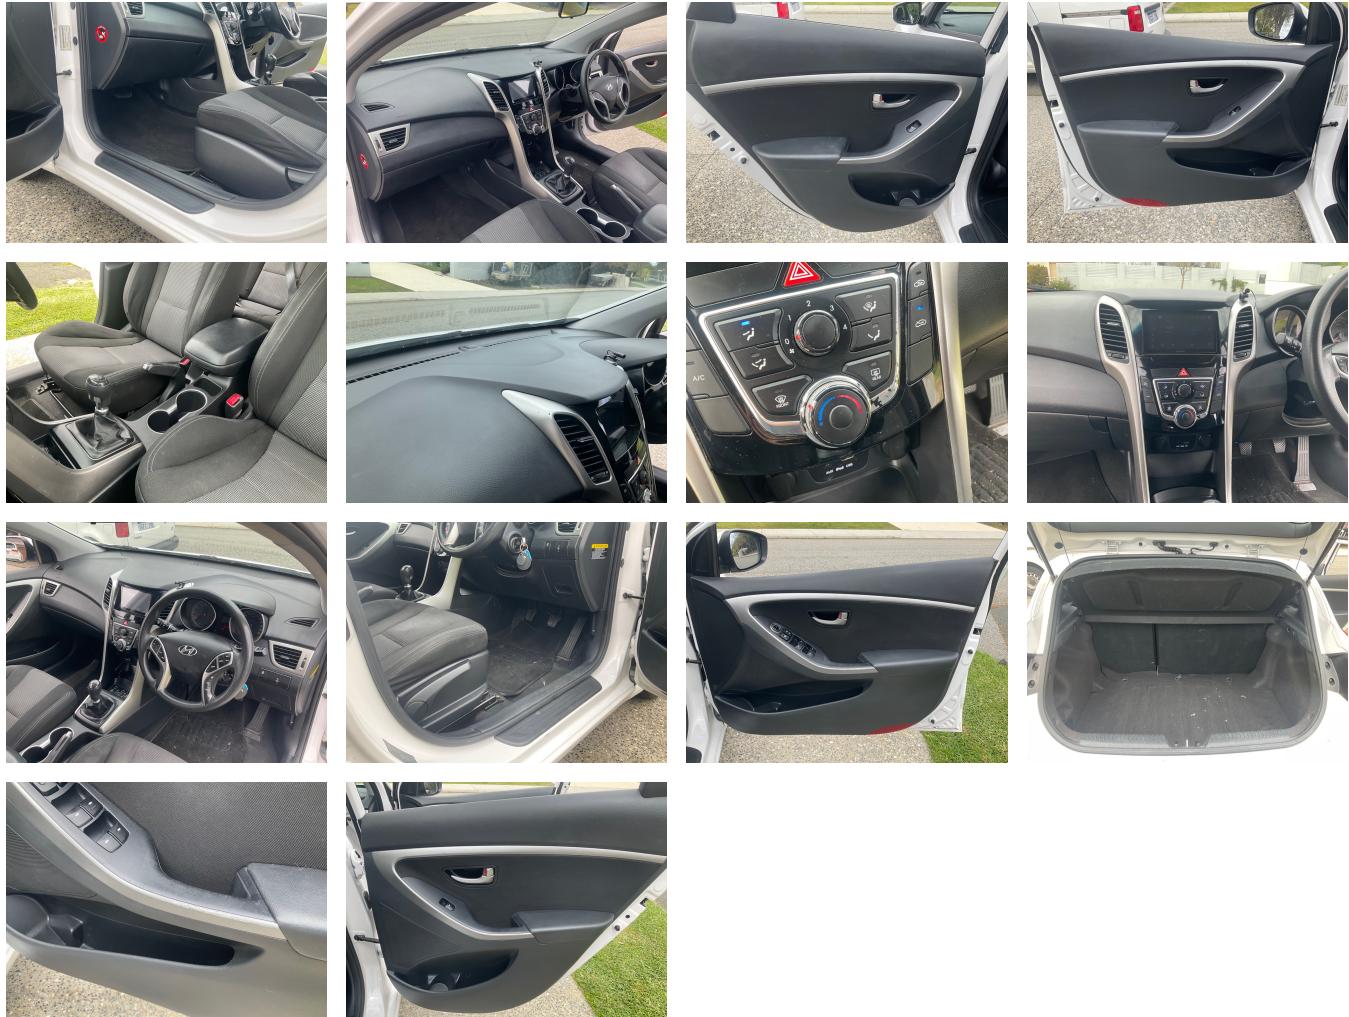
Interior trims, carpet and roof lining showing general wear, including scuffs, marks, minor stains and tears consistent with the age and mileage. Recommend buyer to view prior to purchase.

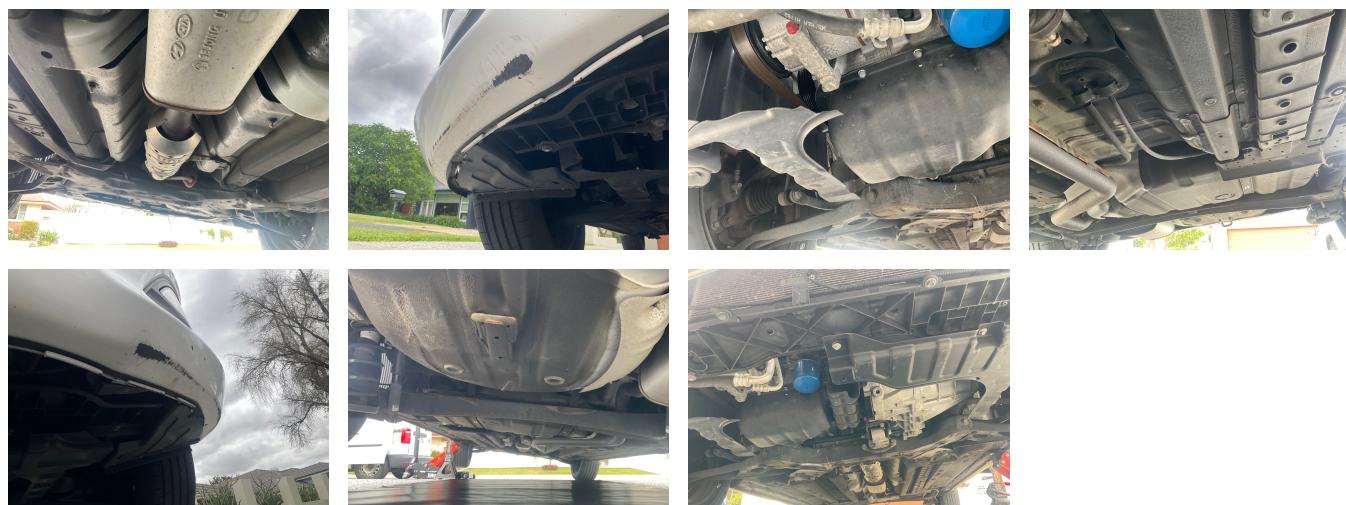
Light surface rust present, and/or scuffs to the vehicles underbody components (front bumper bar, under trays) consistent with the age and mileage. NOTE FRONT LIP AND UNDERTRAY MISSING/BROKEN

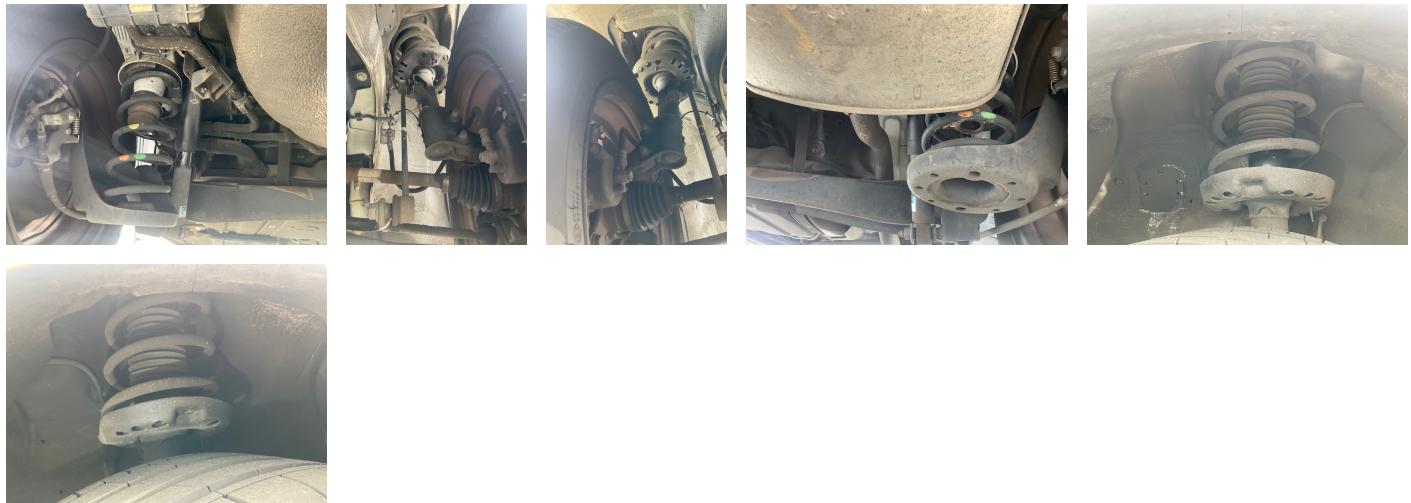
General wear (ageing) and light surface corrosion to the front and rear suspension components and visible rubber bushes consistent with the age and mileage.

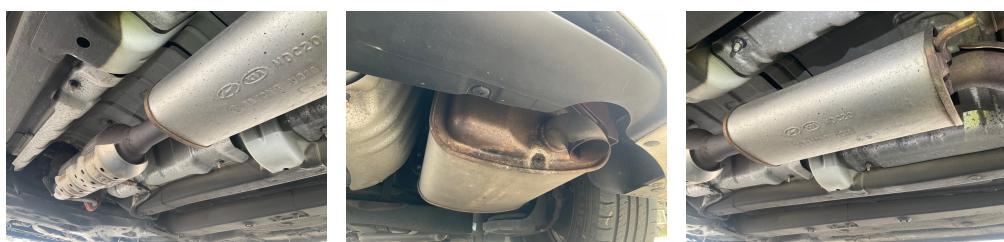
In servicable condition at the time of inspection. General wear (ageing) and surface rust to the components consistent with the age and mileage.

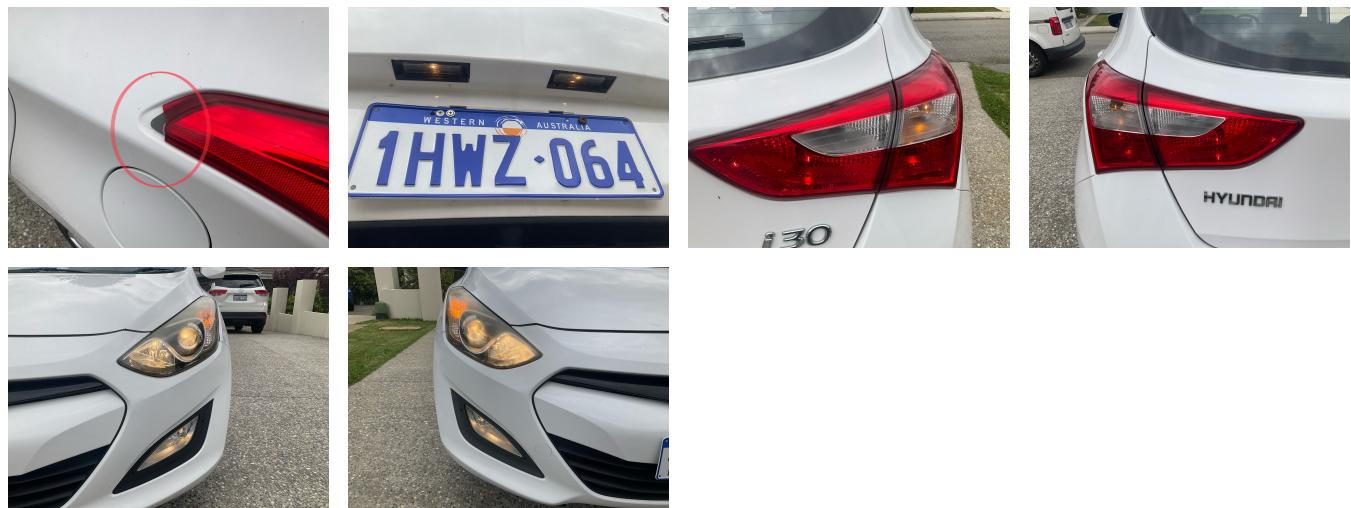
Passenger's tail light cracked/broken lens, investigate further.

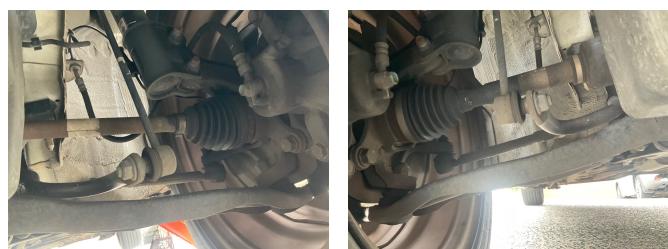
Working well at the time of inspection. General wear (ageing) evident to the visible driveshafts, boots and joint components consistent with the age and mileage.

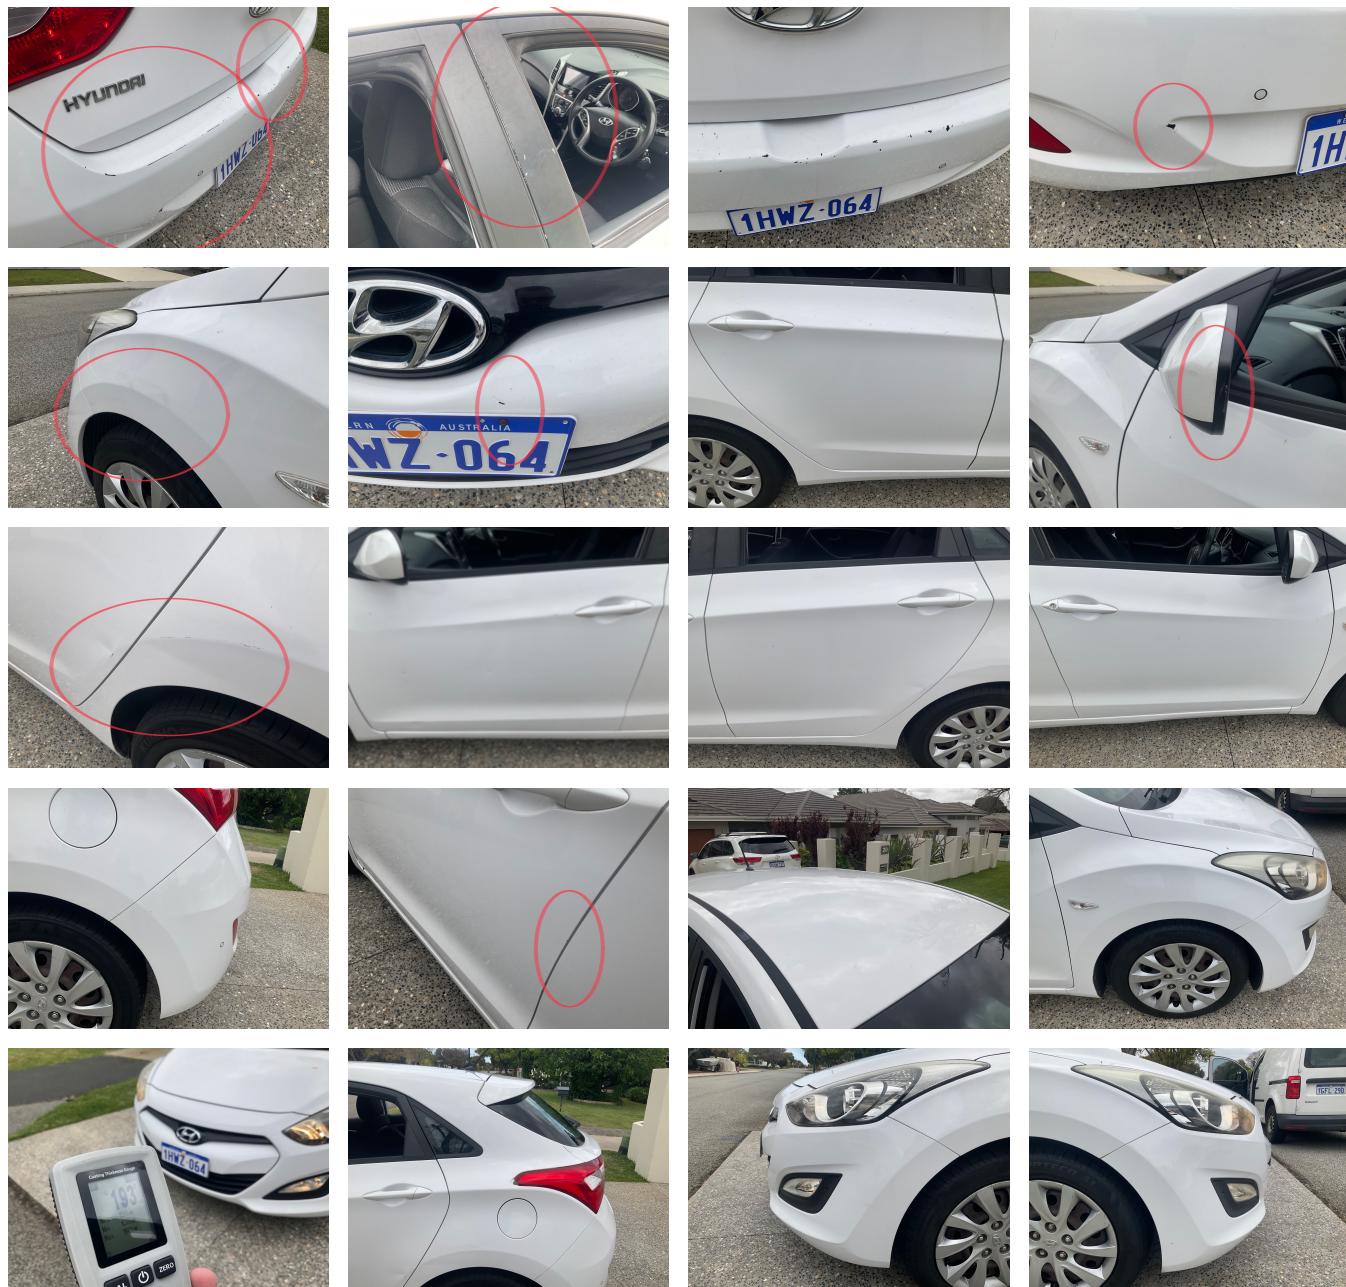
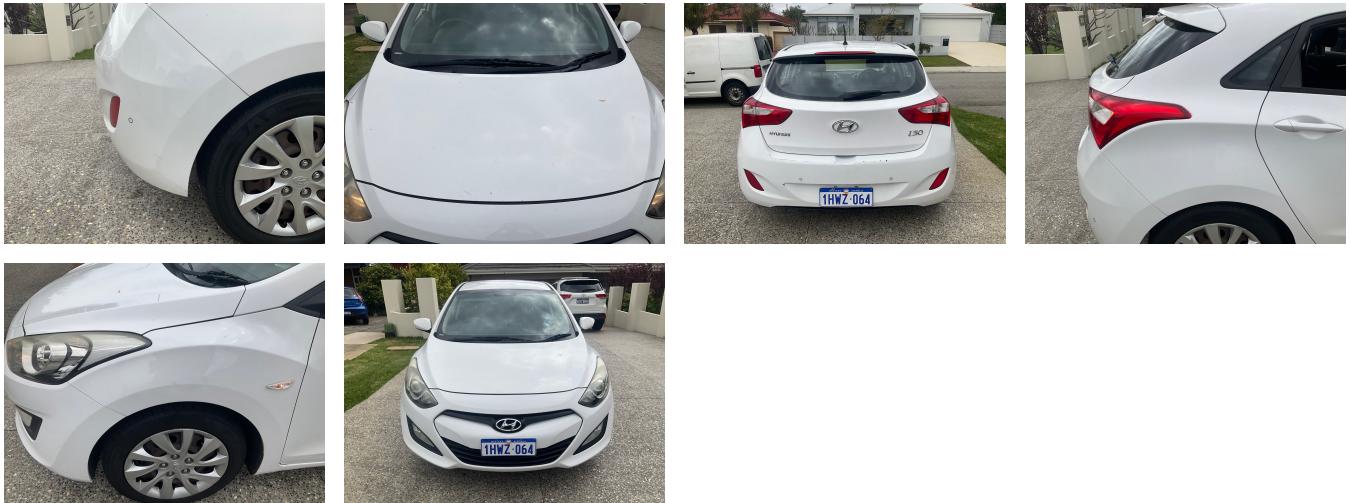
Vehicle presents in servicable condition at the time, possible previous paint repairs detected to the bonnet and boot also both sides of vehicle (paint depth inconsistent): further investigation needed. Various minor dents, scratches and marks around the paint work as expected and consistent with the age and mileage. It is the buyers responsibility to conduct a final inspection prior to purchase, as we can only advise on the condition at the time of inspection. All attempts are made to detect hail damage but weather and vehicle condition can minimize detection.

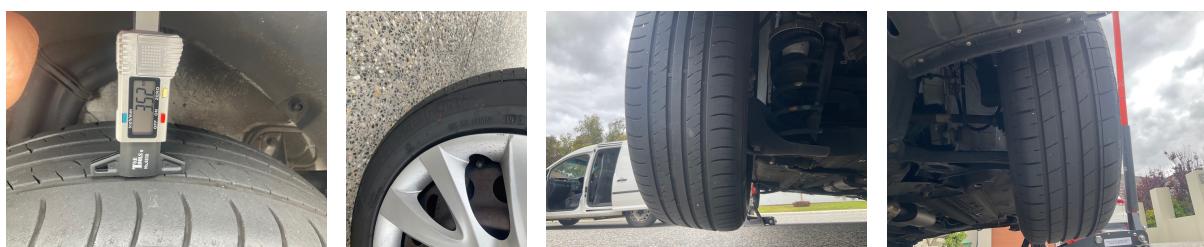
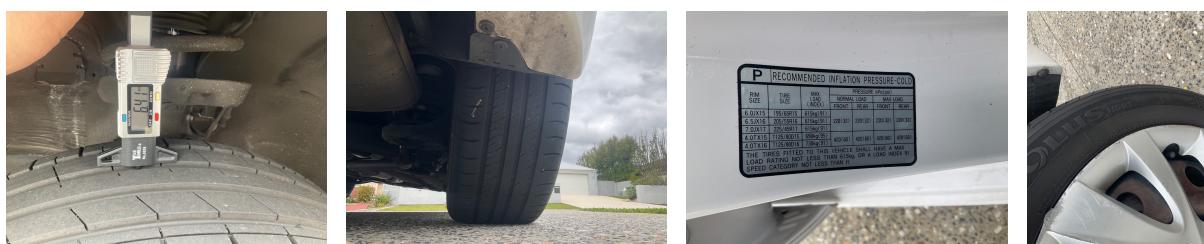
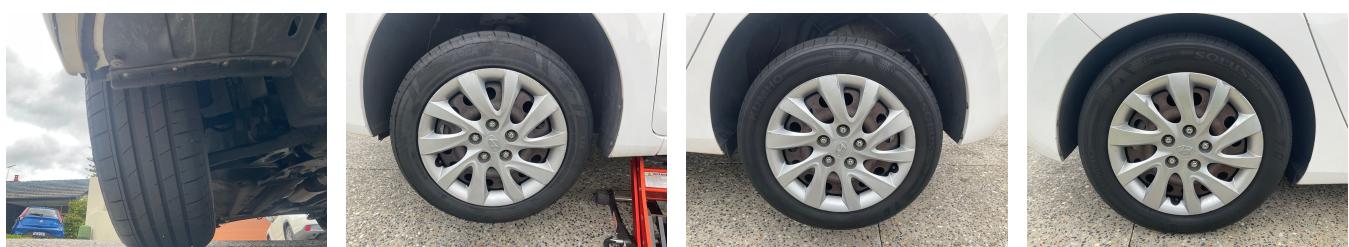
General wear to the front and rear wheel tyres with approx. 6.4mm tread remaining to the front and approx. 3.5mm tread remaining to the rear. Tyres fitted to the vehicle complies with manufacturer speed and load rating requirements. Minor wear visible to wheel rims.

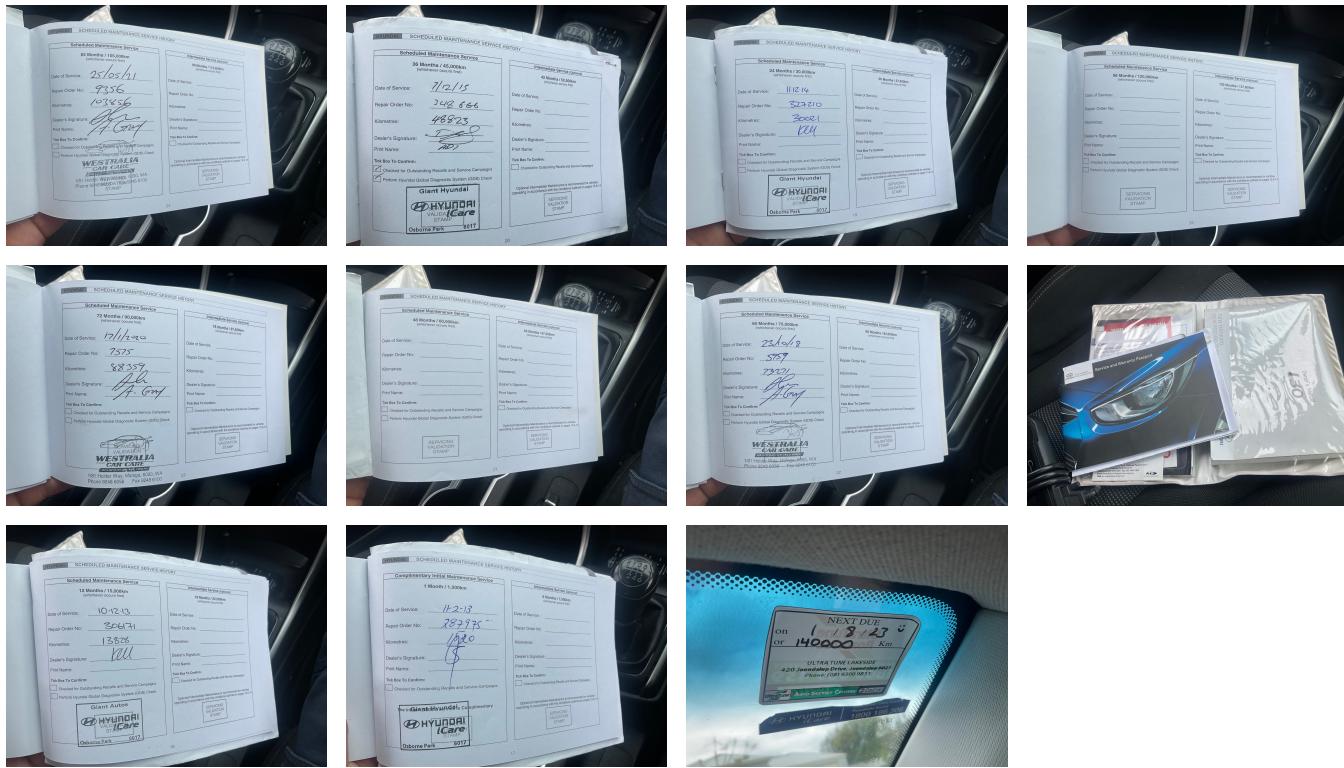
Most services stamped and documented into the booklet, owners manuals and folder present. Next service due at: 140,000km.
