## TECHNICAL SERVICE BULLETIN

### Engine Overheating And/Or Poor Air Conditioning (A/C) Performance With DTC P0480 And/Or P0217

**26-2099**

10 June 2026

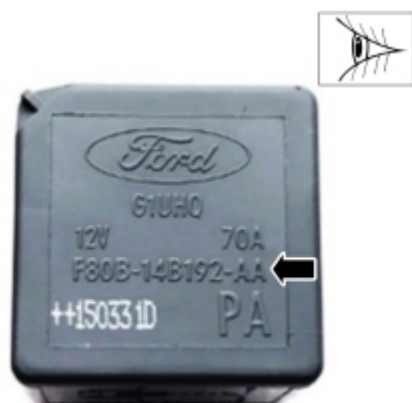
E440894

- (1). If the installed relay is part number F80B-14B192-AA (Figure 3) – go to Step 5.
- (2). If the installed relay is part number RU5T-14B192-FEA (Figure 4) - this article does not apply. Refer to the Workshop Manual (WSM) DTC or Symptom Chart for diagnosis.

Figure 3 – Tin Relay F80B-14B192-AA

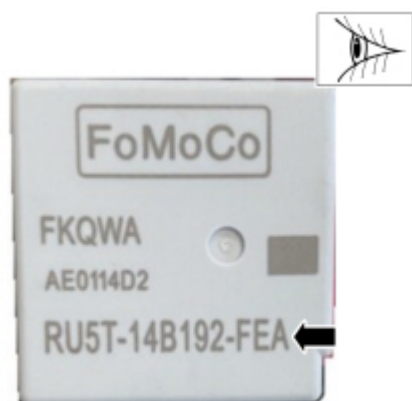
E440895

Figure 4 – Silver Relay RU5T-14B192-FEA

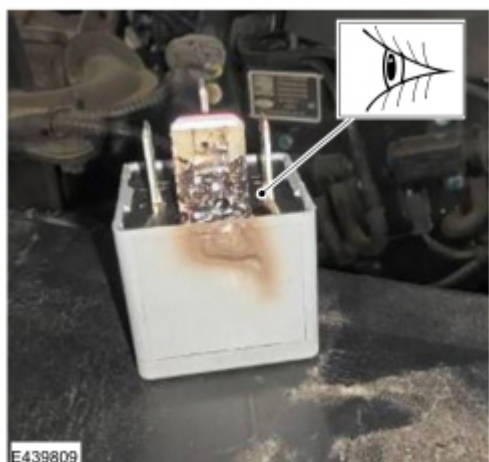
**NOTE: The illustrations below are a guide only. In some cases, the damage to the relay and/or relay holder may not be as immediately obvious as that shown in the illustrations, careful inspection is recommended. (Figure 5 to 7)**

Figure 7 - Cooling fan relay and wiring damage - Relay side

8. Replace both the cooling fan relay and terminal connector using the released service pigtail kit Part Number MB3Z-14S411-E (Figure 8). Refer to the **Wiring Repair and Splice Operation Procedure** below and the recommended splicing method shown in the Professional Technician System (PTS) - Wiring tab - Cell 005 Connector Repair Procedures - Pages 5 to 9 and refer to the Wiring Pigtail Kit/Wiring Terminal Kit Guide shown in PTS.

**NOTE:** When completing a repair under this TSB it is essential to ensure that **BOTH** the relay and the pigtail connector are replaced with the improved parts provided in the service kit. **BOTH** the relay and the pigtail connector **MUST** be replaced to ensure a robust repair on the vehicle.
