# TECHNICAL SERVICE BULLETIN

## Left Hand Rear Leaf Spring Squeak, Scraping Or Knocking Noise

**26-2232**

| <b>Ford</b><br>2021-2026 Next-Generation Ranger |

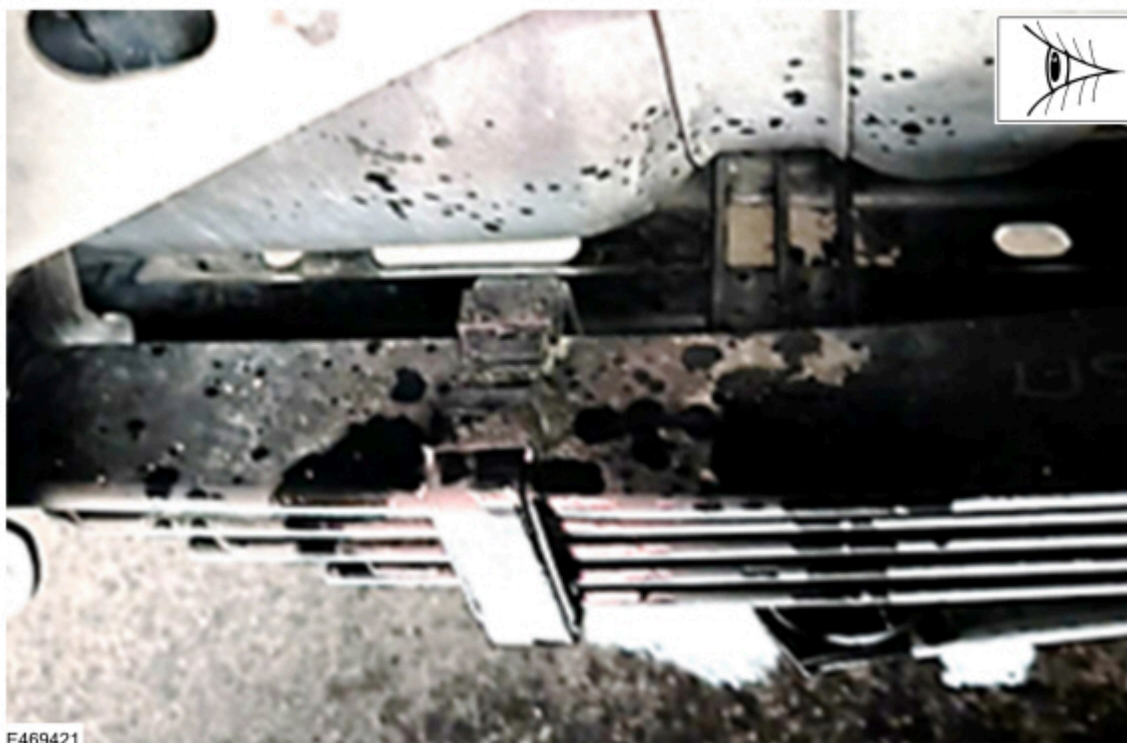
Figure 1

2. Inspect the LH rear leaf spring for diesel fuel contamination caused by overflow. (Figure 1)
