## TECHNICAL SERVICE BULLETIN

**26-2136**

### No Start, LH Headlamp Fogging And Heated Systems Always On Due To Water Ingress At Ground Connection G110 - DTCs B1D00-15, B1097-14, B147C-14, B1C83-14

| <b>Ford</b><br>2024-2025 Transit | Assembly Plant: KOCAELI PLANT BUILD (AAGBX)<br>Built on 06-May-2024 and through 18-Mar-2025 |

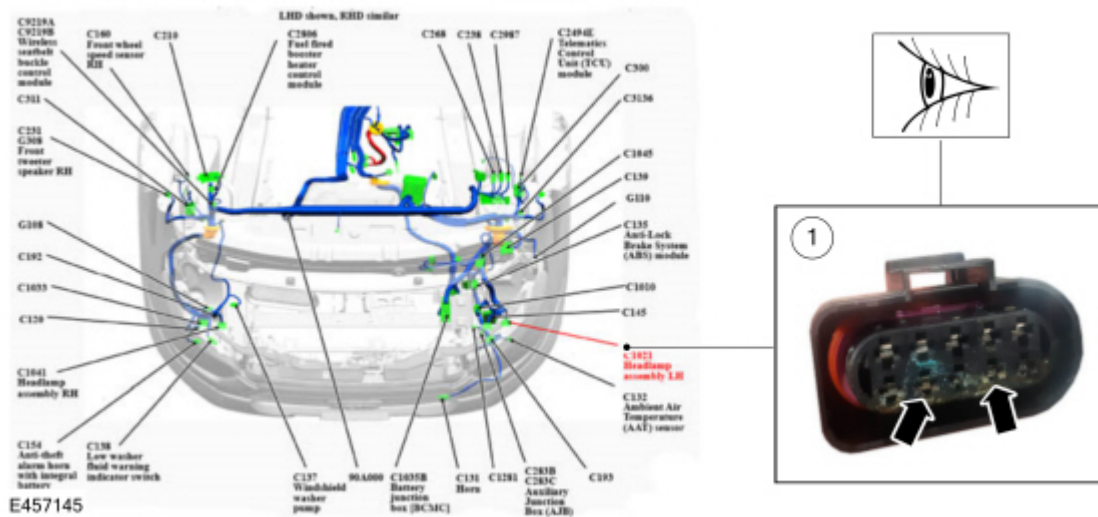
**Issue:** Should a customer express a concern that the vehicle does not start or about water ingress into the left-hand side headlamp assembly (fogged) or that the heated windshield glass and exterior mirrors are permanently switched ON in conjunction with the following DTCs, the probable cause is water ingress via the ground connection **G110** into the wiring harness / electrical connectors.

1. Remove the left-hand side headlamp assembly. For additional information, refer to 2024 Transit Workshop Manual Section 417-01.
2. Check the headlamp electrical connector **C1021**.
  - (1). If moisture / corrosion is observed inside the electrical connector, clean / repair as required. For detailed information refer to the corresponding Workshop Manual Section under the Wiring tab in the PTS.
    - Connect the cleaned / repaired connector.
    - Go to next step.

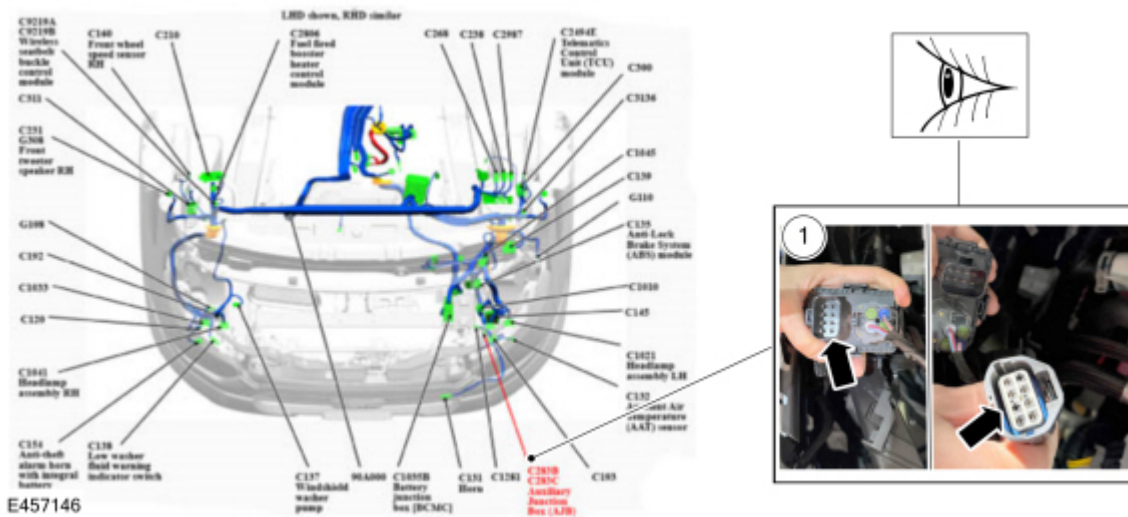
4. Check the AJB electrical connector **C283B** and **C283C**.

(1). If moisture / corrosion is observed inside the electrical connector, clean / repair as required. For detailed information refer to the corresponding Workshop Manual Section under the Wiring tab in the PTS.

- Connect the cleaned / repaired connector.
- Go to next step.

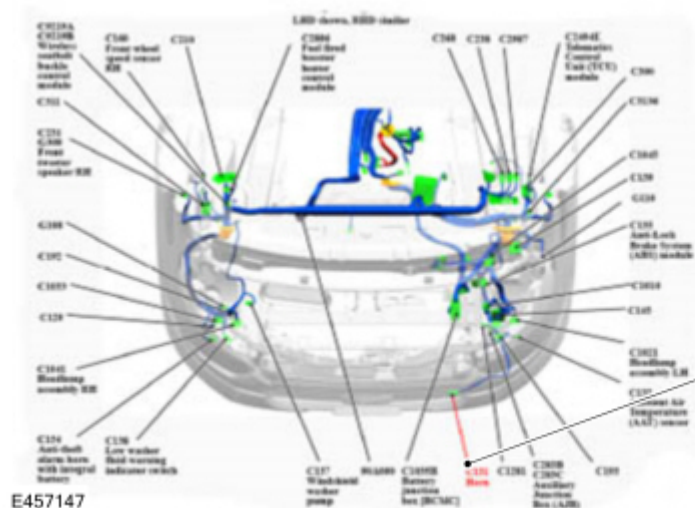
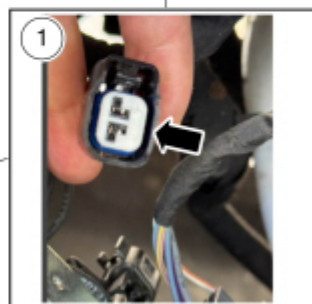
E457147

6. Check the horn electrical connectors **C131**.

(1). If moisture / corrosion is observed inside the electrical connectors, clean / repair as required. 'For detailed information refer to the corresponding Workshop Manual Section under the Wiring tab in the PTS.

- Connect the cleaned / repaired connector.
- Go to next step.

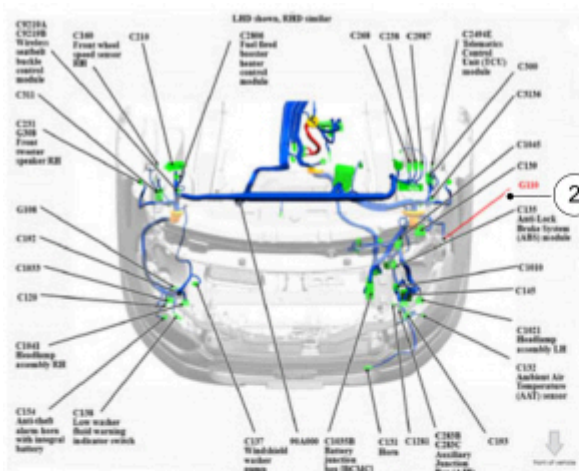
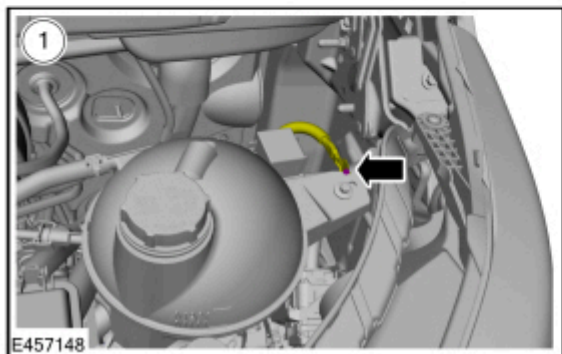
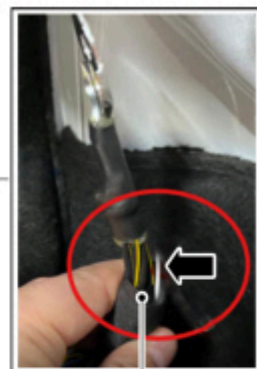
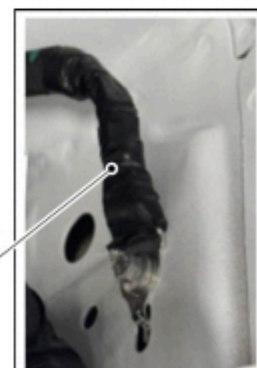
E457148

(2). Locate the area of insufficiently protected individual wires.

1. Apply sealant and PVC tape to insufficiently protected individual wires of the ground connection **G110** (see Parts Required).

(1). Locate the ground connection (eyelet) **G110** in the left-hand side of the engine compartment and unscrew the bolt. Torque: 10.5 Nm

(3). Apply the sealant by starting at the back of the eyelet. Sealant should be applied on all insufficiently protected wires.

- Allow the sealant to dry.
- Apply the PVC tape above the sealant and make sure all insufficiently protected wires are fully taped.
